Smoke emergency involving a Boeing 737-488, EI-BXI, on June 3, 1999 at Dublin Airport

FINAL REPORT

AAIU Synoptic Report No: 2004-003

Aircraft Type and Registration:	B737-448,	EI-BXI
No. and Type of Engines:	Two CFM 56 Turbofans	
Aircraft Serial Number:	25052	
Date of Manufacture:	April 1991	
Date and Time (UTC):	3 June 1999 @ 05.45 hrs	
Location:	Stand 34, Dublin Airport	
Type of Flight:	Public Transport	
Persons on Board:	Boarding in progress	
Injuries:	Nil reported	
Nature of Damage:	Nil	
Commanders Licence:	ATPL	
Commanders Flying Experience:	15,000 hours, of which 12,000 were on type.	
Information Source:	Station Manager, ATC Dublin

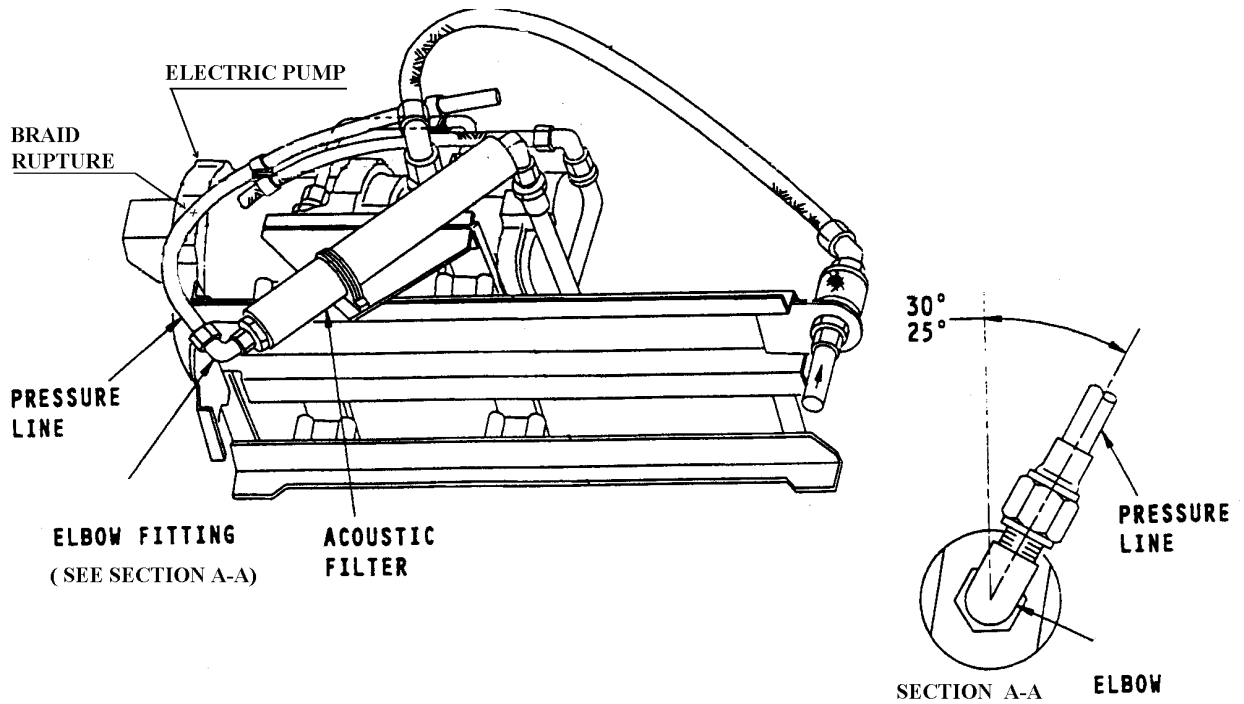
The distance between the hydraulic pressure hose and the electrical cable was insufficient to ensure safety.

Diagram from the Maintenance Manual showing correct "clocking" of the pressure line when fitting the hydraulic pump to the aircraft.

4.1 The Maintenance Organisation should instruct their staff to always ensure reference to the current issue of the fitting instruction when completing a specific task. **(SR No. 7 of 2003)**

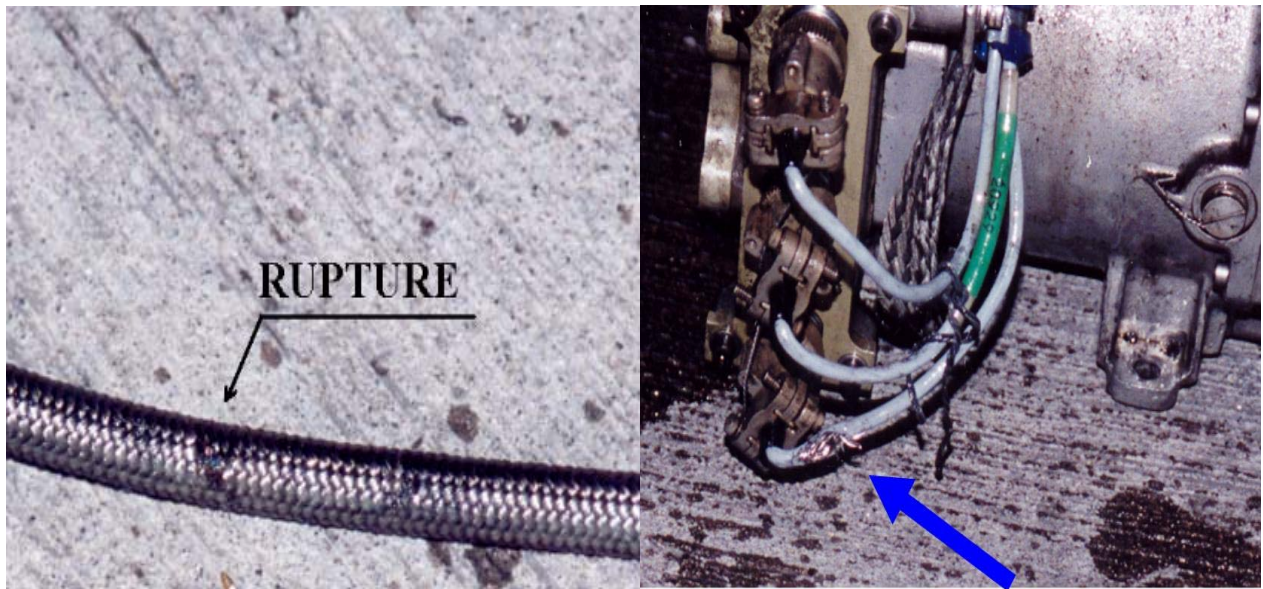
In the follow-up technical examination, it was found that metal braid on a hydraulic flexible pipe had caused a chaffing of the insulation of the “C” phase wire of the electrical supply to the “B” Systems hydraulic pump. This pump is located in the right main wheel well (see photo, **Appendix A**). As the insulation wore away in service, the wire became exposed. During this incident the voltage on the wire arced across to the metal braid, puncturing the hydraulic pipe and causing the hydraulic fluid to escape. This resulted in a large amount of smoke/vapour emanating from the wheel well.

An electrical short between the supply to the “B” System hydraulic pump and the metal braid on the flexible hydraulic pipe caused that pressure line to burst.

Left photo, showing part of the ruptured flexible pressure hose which chaffed the insulation of phase "C" supply to the electrical hydraulic pump. The arrow at right indicates the resulting damage to this insulation.

The pressure line and the hydraulic pump were replaced. An operational and leak check were carried out and both found satisfactory. The aircraft was then released back to service.
