Hard Landing, Royal Jordanian Airlines Airbus A310-300 (JY-AGK) at Shannon Airport, Ireland, December 17, 1999

Investigative Body: Air Accident Investigation Unit (AAIU), Ireland

AAIU Report No. 2001-005
AAIU File No. 19990080
Published:19/04/2001

Name of Operator:	Royal Jordanian Airlines
Manufacturer:	Airbus
Model:	A310-300
Nationality:	Jordanian
Registration:	JY-AGK
Place of Accident:	Shannon Airport, Ireland
Year of Manufacturer:	1991
Date/Time :	16.09 hrs UTC; 27 December 1999

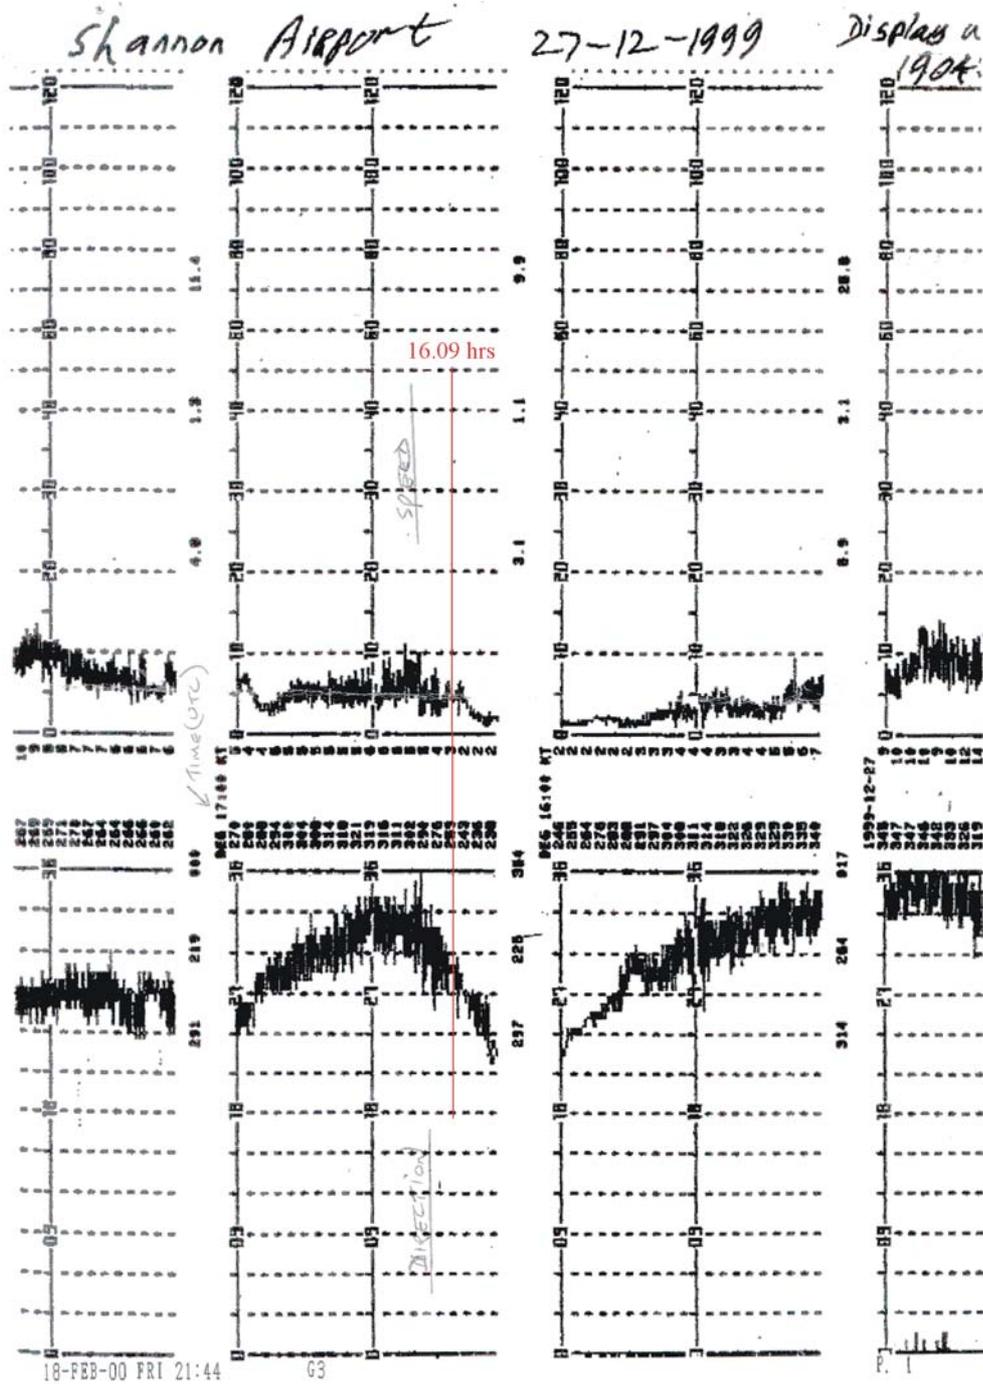
1.7.8 Met Eireann also provided recorded readings from Anemometer Mast B in Shannon Airport, which was the anemometer in use at the time of the event on 27 Dec 1999. This anemometer is located 230 metres south of the centre-line of Runway 06 approx 900 metres before the end of the Runway. The anemometer is located 10 metres above ground level. The anemometer recordings are shown in Annex A.

These recordings show that the wind speed did not exceed 5 kts between 15.30 and 16.15 and did not exceed 10 kts between 16.15 and 16.30. At 16.09 it was 270° at 3 kts.

The recorded wind direction at 15.45 was 290°. It gradually backed to 260° by 16.00 and then veered to 315° by 16.30. At 16.09 it was 285°.

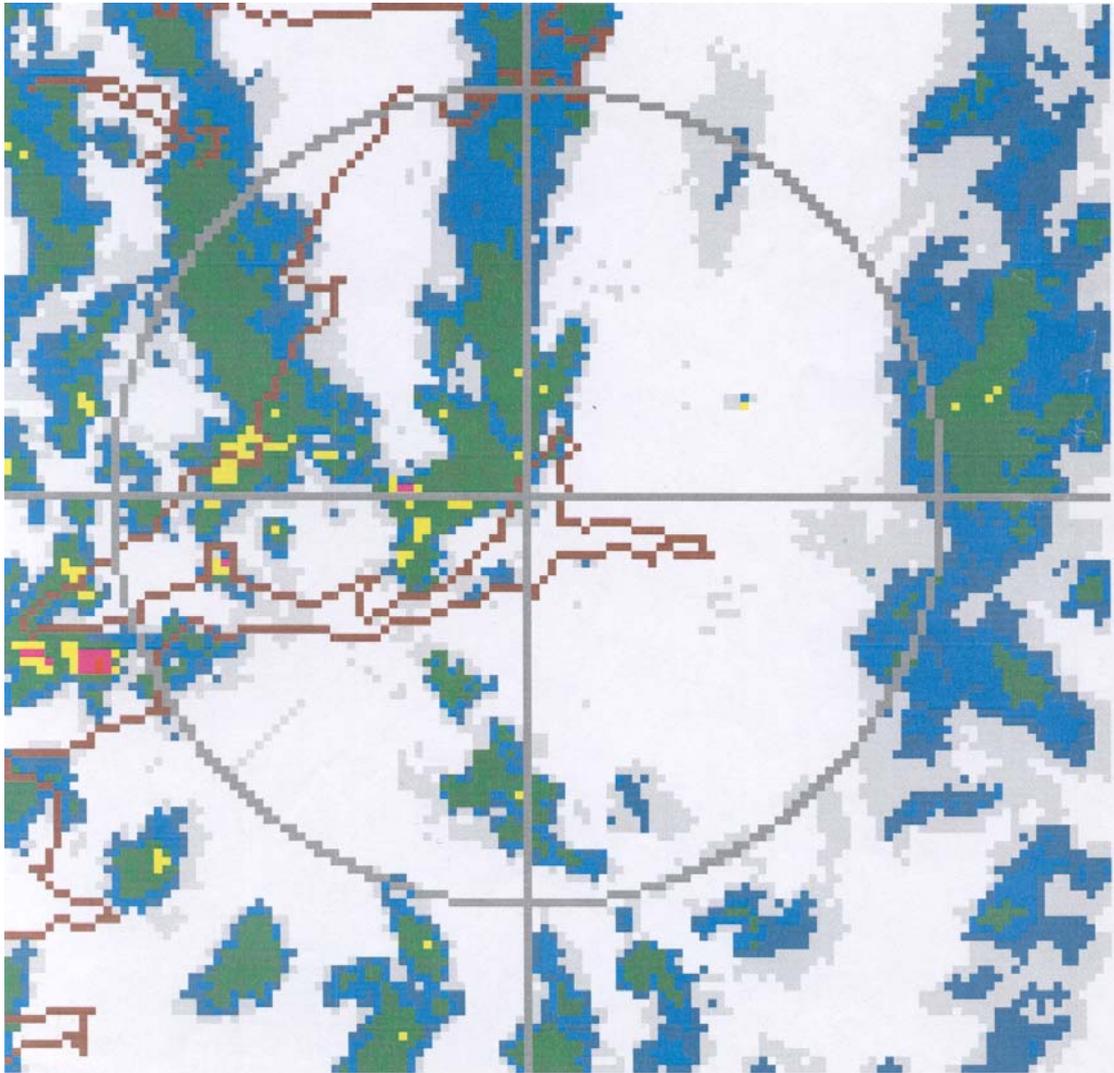
ANNEX B

There was Cb activity in the vicinity of the aerodrome at the time of the incident, as indicated by radar analysis and the METAR report for 1600 UTC. However, the shower activity from these Cb's was registered by radar at a maximum of 3.7 mm/hour, a rate sufficient to produce light to moderate showers. Such showers would not be expected to produce severe downdraughts. This contention is supported by the fact that no gusts were reported in the METARs around the time of the incident."

Shannon weather radar as recorded at 16.01 hrs UTC on 27 December 1999

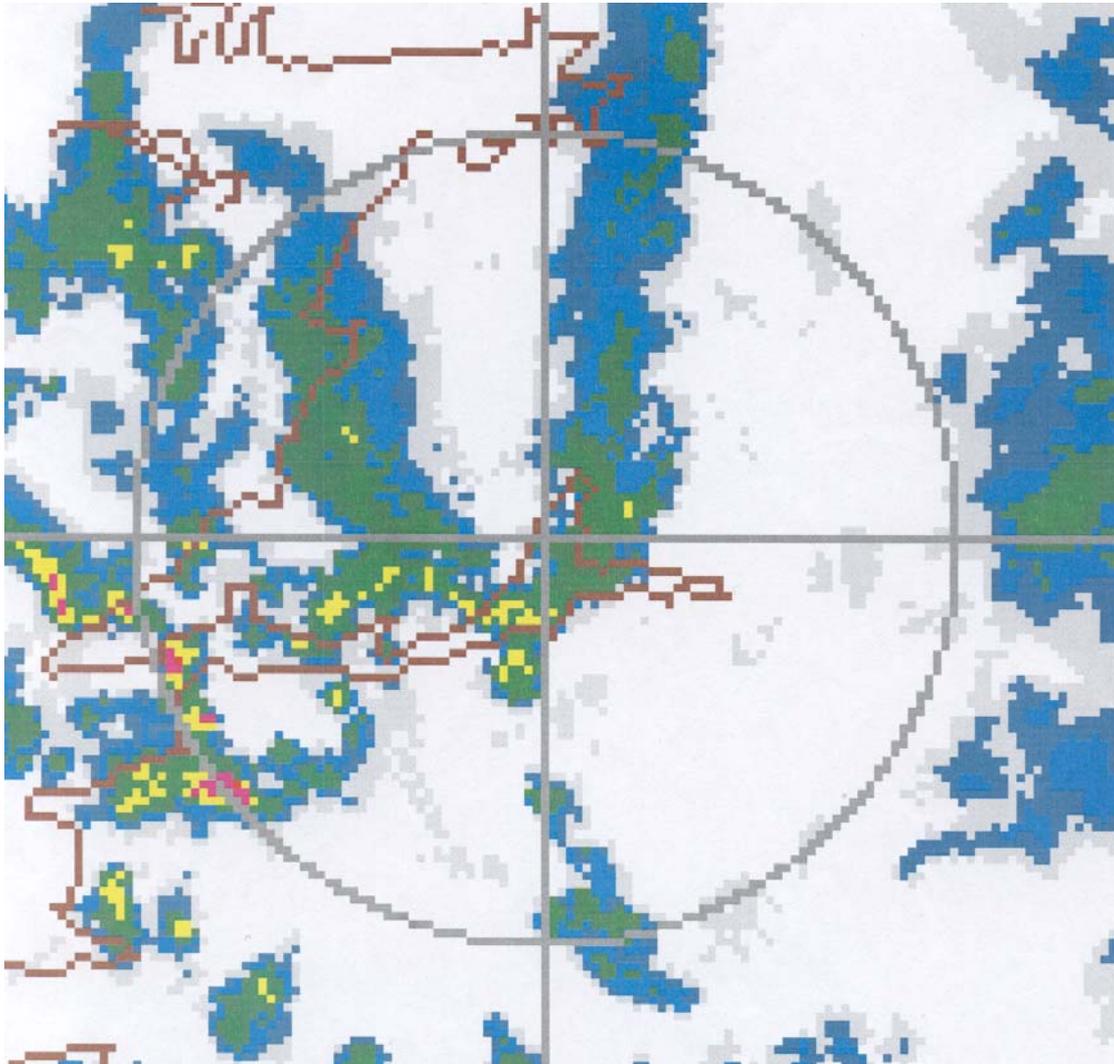
ANNEX C

Shannon weather radar as recorded at 16.16 hrs UTC on 27 December 1999
