Collision with tug, Airbus A321-200, January 15, 2000 at Dublin Airport

AAIU Report No. 2000/0006
AAIU File No. 2000/0002
Published: 21/06/12

Aircraft Type and Registration:	Airbus 321-200 G-MIDH
No. and Type of Engines:	Two V2527-A5 Turbofans
Aircraft Serial Number:	968
Year of Manufacture:	1999
Date and Time (UTC):	15 January 2000, 07.55
Location:	Stand 40 Dublin Airport
Type of Flight:	Scheduled Public Transport
Persons on Board:	36
Injuries:	Nil
Nature of Damage:	Damage to Aircraft Radome
Commanders Licence:	ATPL
Commanders Age:	33 yrs
Commanders Flying Experience:	4300 hours total 400 hours on type
Information Source	Aer Rianta Duty Officer, Dublin Airport, AAIU Field Investigation

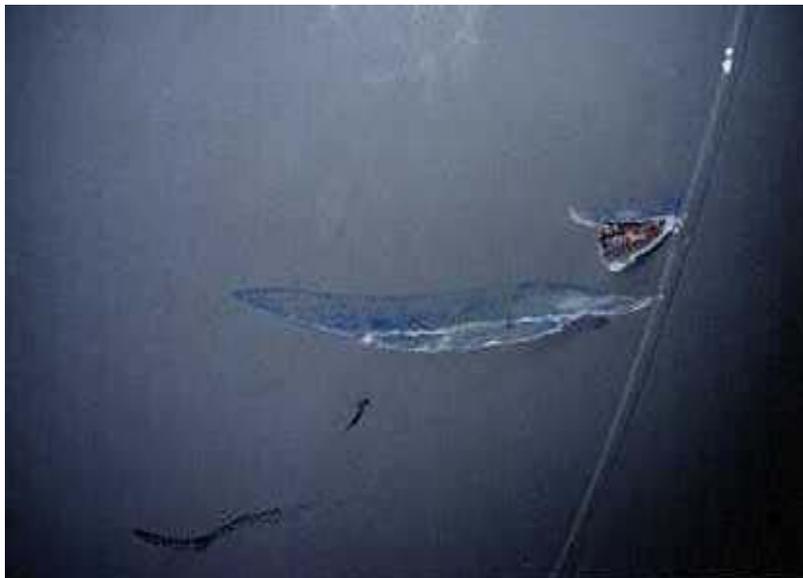
The radome was scratched on the underneath starboard side approximately 30 cm from the base of the radome. The LH corner at the top of the cab penetrated the radome leaving an indent of approximately 6 cm to expose the honeycomb interior.(Fig.1)

An incorrect towbar, of insufficient length, was used for the pushback. This was the cause of the incident.

Fig. 1 Damage to Radome of G-MIDH 6cm I----I

The towbar authorised for use with this aircraft type should have a longitudinal separation of at least 1 metre between the nose of the aircraft and the front face of the cab. **(SR 6 of 2000)**
