Runway excursion involving an Aer Lingus Fokker 50, EI-FKD, at Cork Airport, Ireland, on October 29, 2000.

AAIU Report No. 2001/0012
AAIU File No. 2000/0058
Published: 10 Sep 2001

Name of Operator: Aer Lingus
Manufacturer: Fokker Aircraft B.V. The Netherlands
Model: Fokker 50
Registration: EI-FKD
Nationality: Irish
Location: Runway 17, Cork Airport (EICK)
Date and Time (UTC): 29 October 2000, 1619 hrs

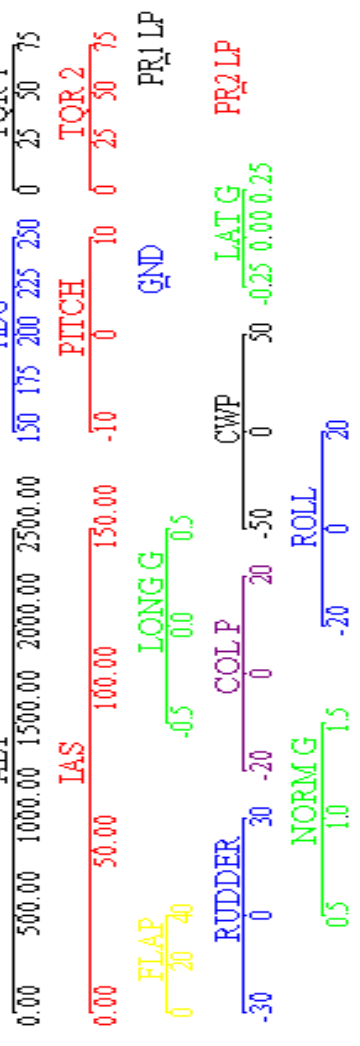
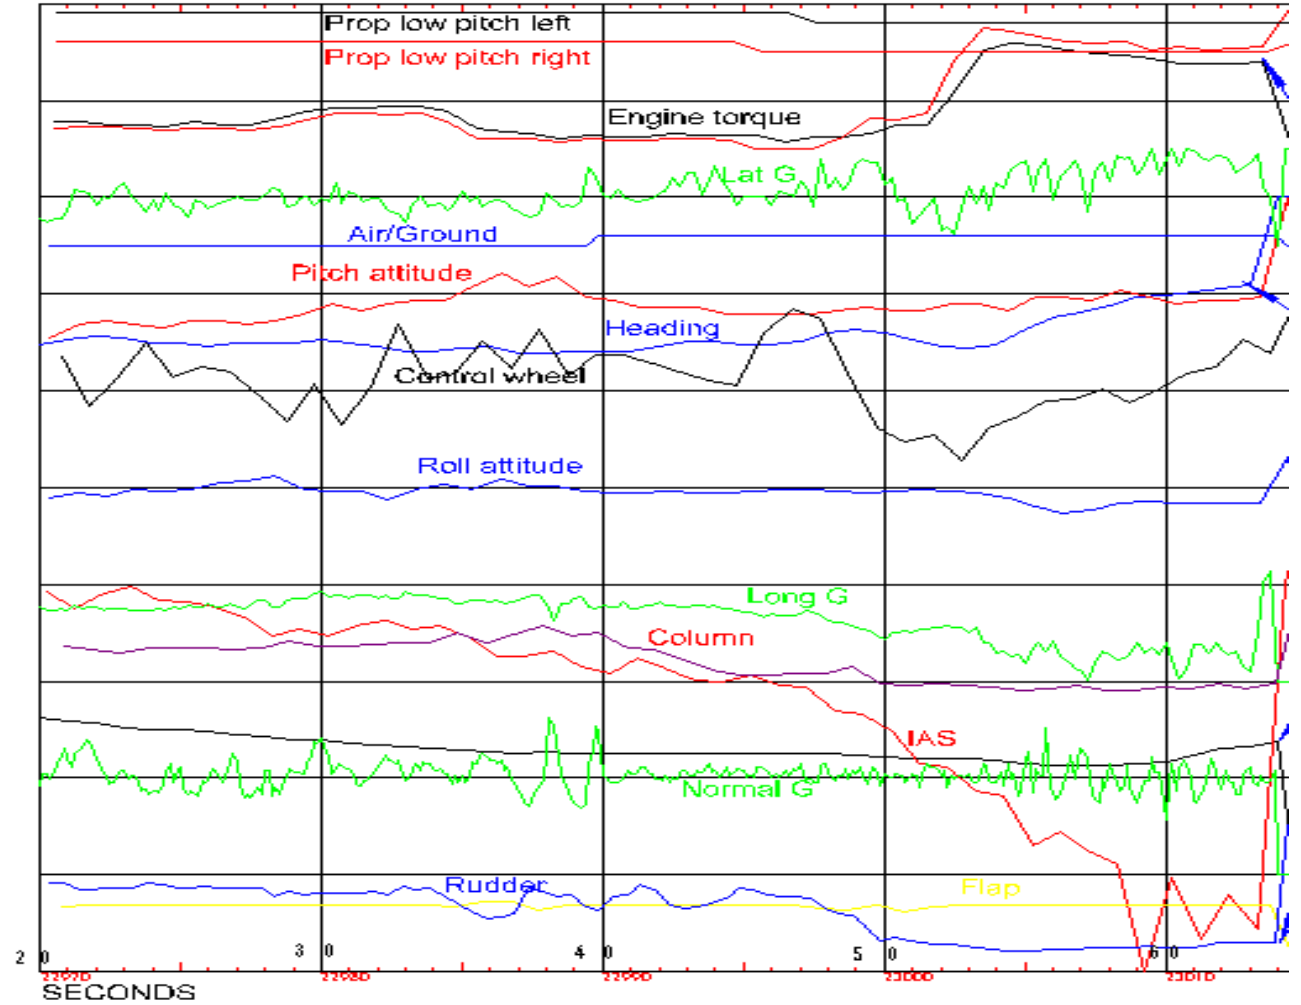
APPENDIX F

A total of 4 previous landings on the aircraft's FDR were analysed by the investigation. Generally it was found that all these landings were very similar to each other. It was noted that in each case, the Low Propeller Pitch (LP) indication occurs just after activation of the air/ground switch (W.O.W). In addition it was recorded that on each landing, the LP 1 and LP 2 light came on simultaneously and engine torques were well matched with each other, during travel. It should be noted that each light is activated by a micro-switch in the Pitch Control Unit (PCU) through a double contact solenoid when the propeller blades reduce to less than + 10°. One pair of contacts operates the cockpit indication and the other is fed to the flight data acquisition unit (FDAU). Each system left and right is completely separate. It is possible, therefore, to have a small time interval between the right propeller assembly blades reaching +10° and the left set reaching the same angle.

Eight (8) seconds after W.O.W, just as both propellers have reached ground idle, a sharp increase in heading and lateral G to the right is recorded. Under normal runway conditions, the influence of the actual crosswind component, combined with a slight asymmetric reverse thrust in favour of a right swing, should not have an adverse effect on the directional controllability of the aircraft.

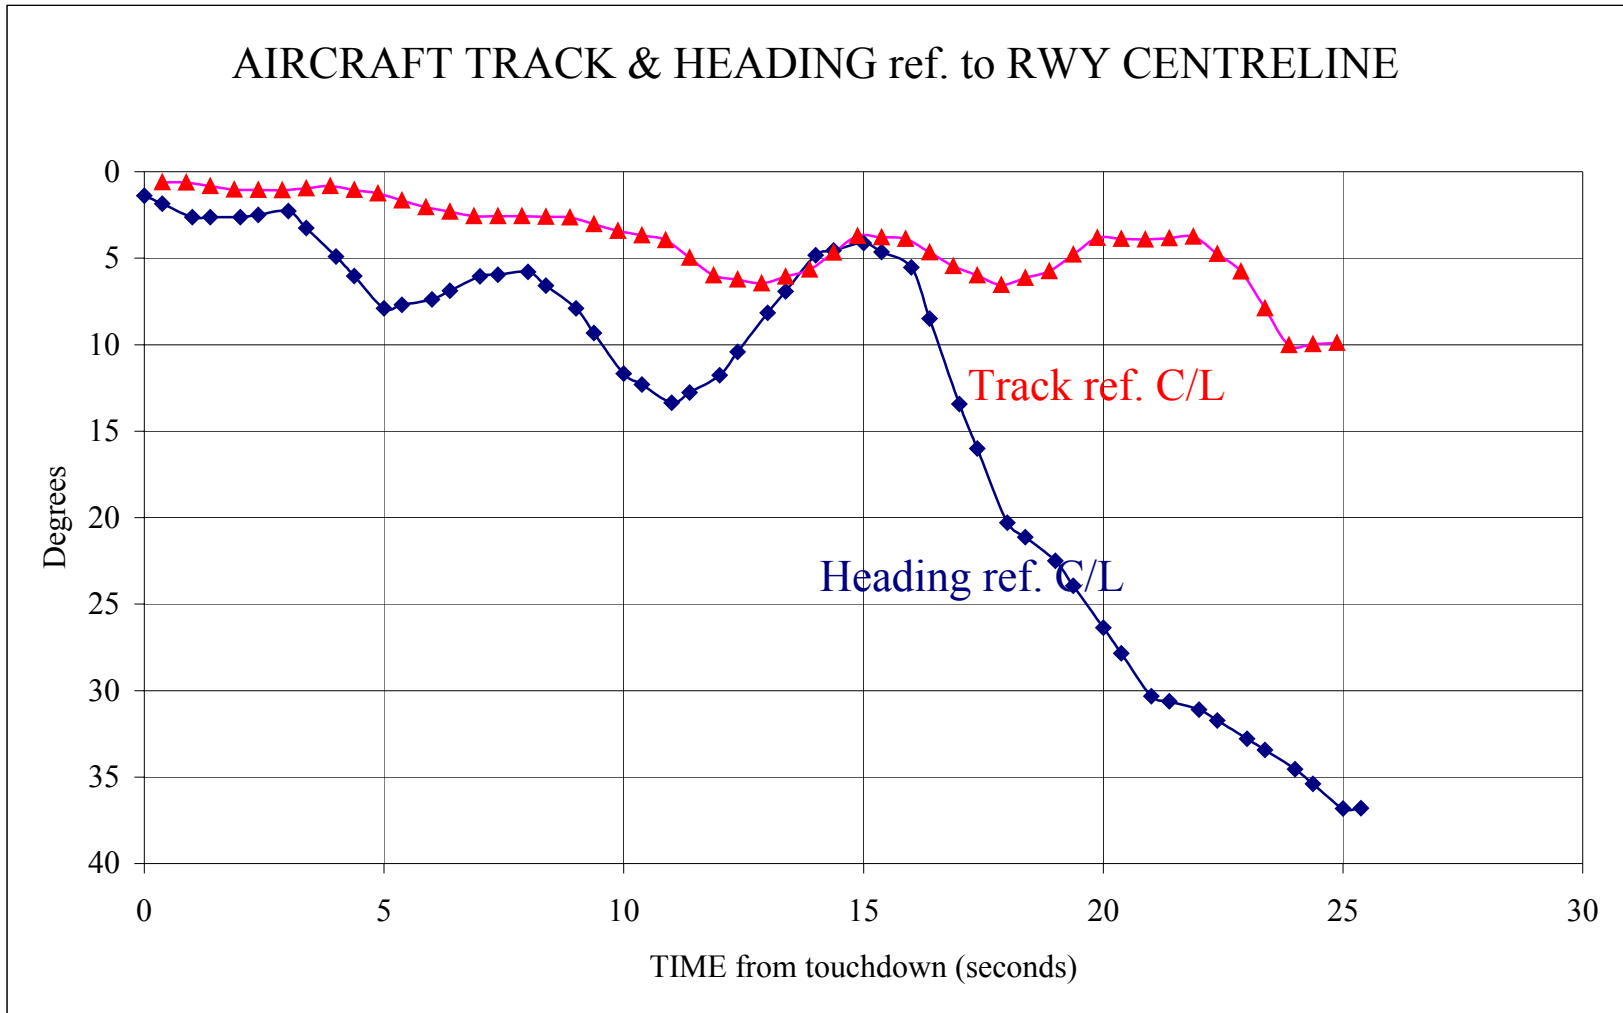
APPENDIX G

When the aircraft track and heading is referenced against the runway centreline (**Appendix G**), it can be seen that the aircraft is continuously moving towards the right hand edge of the runway from just after touchdown and the aircraft heading oscillates about the aircraft track. When in the air, an aircraft is allowed to freely rotate about its axes because it is not fixed to any point. If influenced by wind, the heading can vary about the track (drift). On the ground, in particular under dry or non-slippery conditions, the aircraft’s undercarriage will restrict lateral movement about the central axis, so heading and track remain the same. Under reduced runway friction or aquaplaning, the aircraft is less restricted in lateral movement and heading can increase or decrease about the aircraft track.

When the aircraft track and heading are referenced against the runway centreline (**Appendix G**), the aircraft is seen to be continuously moving towards the right hand edge of the runway from just after touchdown and the heading oscillates about the track. This is a clear indication that the aircraft is suffering from a lack of traction with the runway surface. The cause of this lack of traction is considered to have resulted from a combination of the wet runway, crosswind, landing roll out technique used by the PF and the presence of standing water in the general area of the intersection of both runways.
