Nosewheel collapse, Futura Boeing 737-800 (EC-HMK), Shannon Airport, Ireland, November 30, 2000

*AAIU Report No.2001-010
AAIU File No.2000-0062
Published 30 August 2001*

Operator:	Futura
Aircraft Type and Registration:	B737-800, EC-HMK
No. and Type of Engines:	Two, CFM 56-7B27
Aircraft Serial Number:	28624
Year of Manufacture:	2000
Date and Time (UTC):	30 November 2000, 1236 hrs
Location:	Shannon Airport, Co. Clare, Ireland
Type of Flight:	Public Transport
Persons on Board:	Crew - 6 Passengers -189 + 13 infants
Injuries:	Crew- One, minor Passengers – Eight, minor
Nature of Damage:	Extensive. Nose landing gear collapsed, deformation of fuselage skin, both engines damaged by FOD. Other collateral damage.
Commanders Licence:	Airline Transport Pilot Licence (Spain)
Commanders Age:	46 years
Commanders Flying Experience:	7680 hours Last 90 days: 206 hours Last 28 days: 52 hours
Information Source:	ATC Watch Manager, Shannon Airport. AAIU Field Investigation

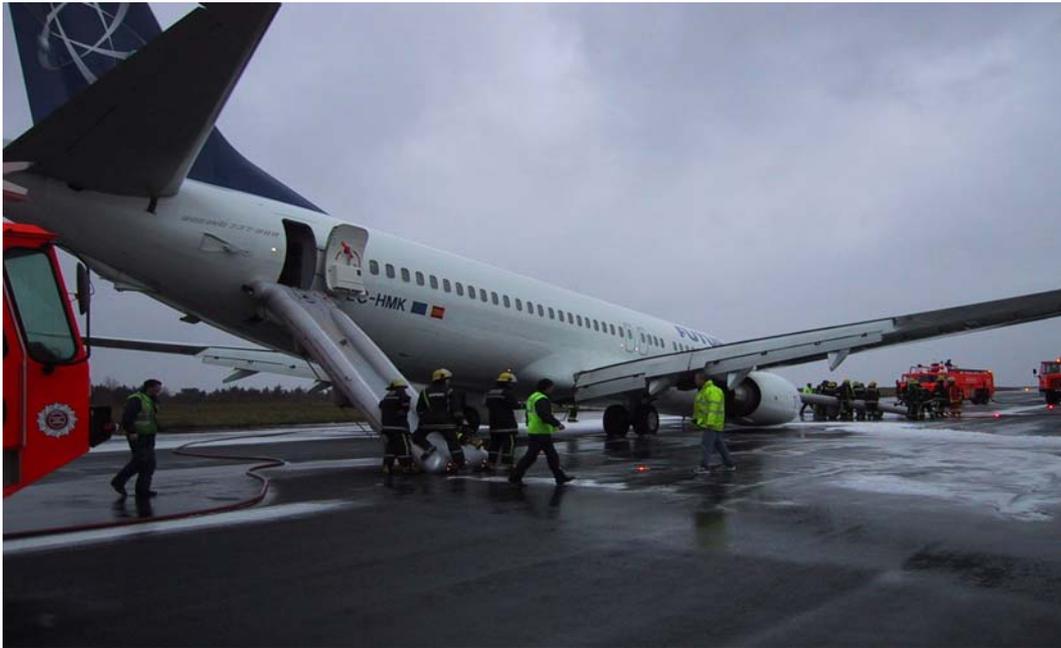
The cabin crew recalled that some of the overhead luggage bins in the cabin opened on the aircraft’s initial impact with the ground. When the aircraft came to rest they supervised the evacuation of the aircraft through the front right and rear right exit doors, using the two deployed escape slides. Because of the nose-down attitude of the aircraft, the front door exit was considerably closer the ground than the rear door exit (*Photo.1*).

Photo 1. Showing the escape slides deployed on the right hand side of the aircraft

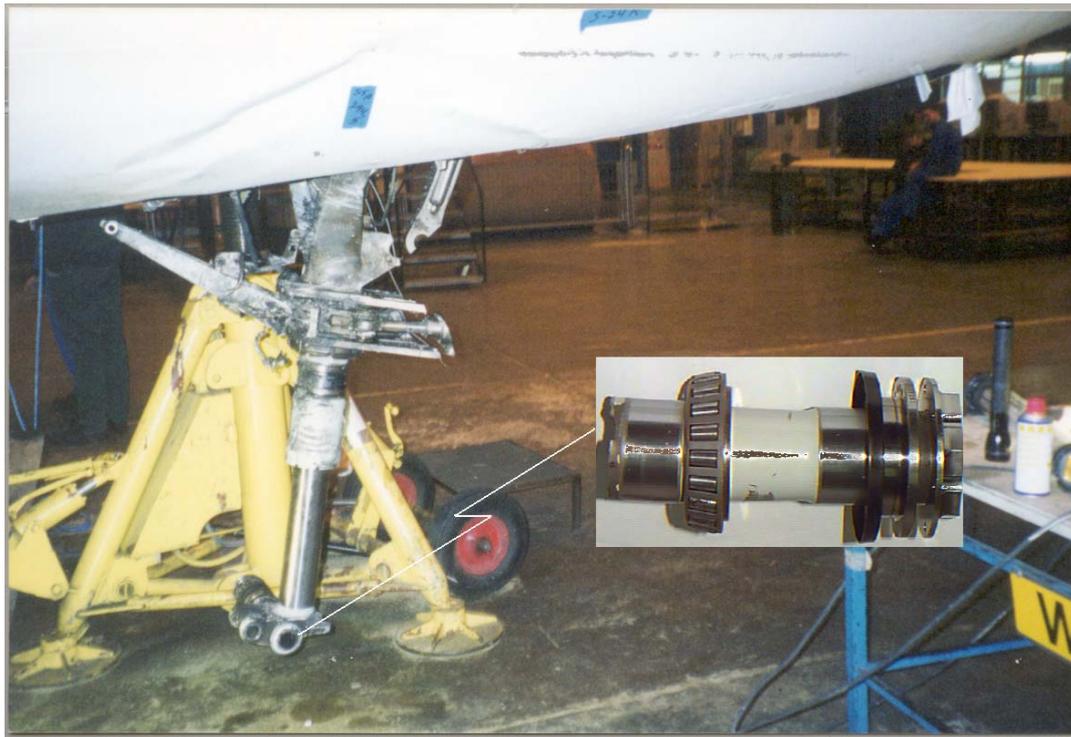
Skin panel located in cockpit area between Station 259.5 and 360 buckled. Nose wheel well doors, hinges, seals, seal retainers, upper and lower fuselage assemblies and bell cranks destroyed. *(Photo. 2)*

All associated nose wheel equipment such as steering cables, hydraulic pipelines destroyed. Nose landing gear destroyed including wheels, tyres and actuator. Lower drag strut fractured at lower bolt end. Half of the bolt plus one nut in place recovered from debris.

The initial force on the nose caused the right axle complete with right wheel and tyre to snap off. The weight on the remaining wheel caused it to disintegrate leaving the bearing cages on the left axle. The axle then impinged on the ground until the forces on the drag brace caused the pin to shear and the nose strut to rotate 90° rearwards. The nose gear broke within 1 second of the second touchdown. The aircraft pitch attitude then decayed to 4° nose down for the remainder of the “rollout”.

Therefore, it appears likely that the nose gear first contact caused the right nose wheel axle to snap off which subsequently led to the failure of the nose gear in the aft direction.

Photo 2. Damage to the drag strut, shock strut and axle of the nose undercarriage assembly and to the nose cone skin of the aircraft. This photo was taken following the removal of the aircraft to the hangar. The damaged nose strut is shown in the normal down position, without its wheels, having been rotated forward from the belly of the aircraft by engineers. Also shown (insert) is the right hand axle, ruptured from the strut, and found in the grass alongside the runway following the accident.

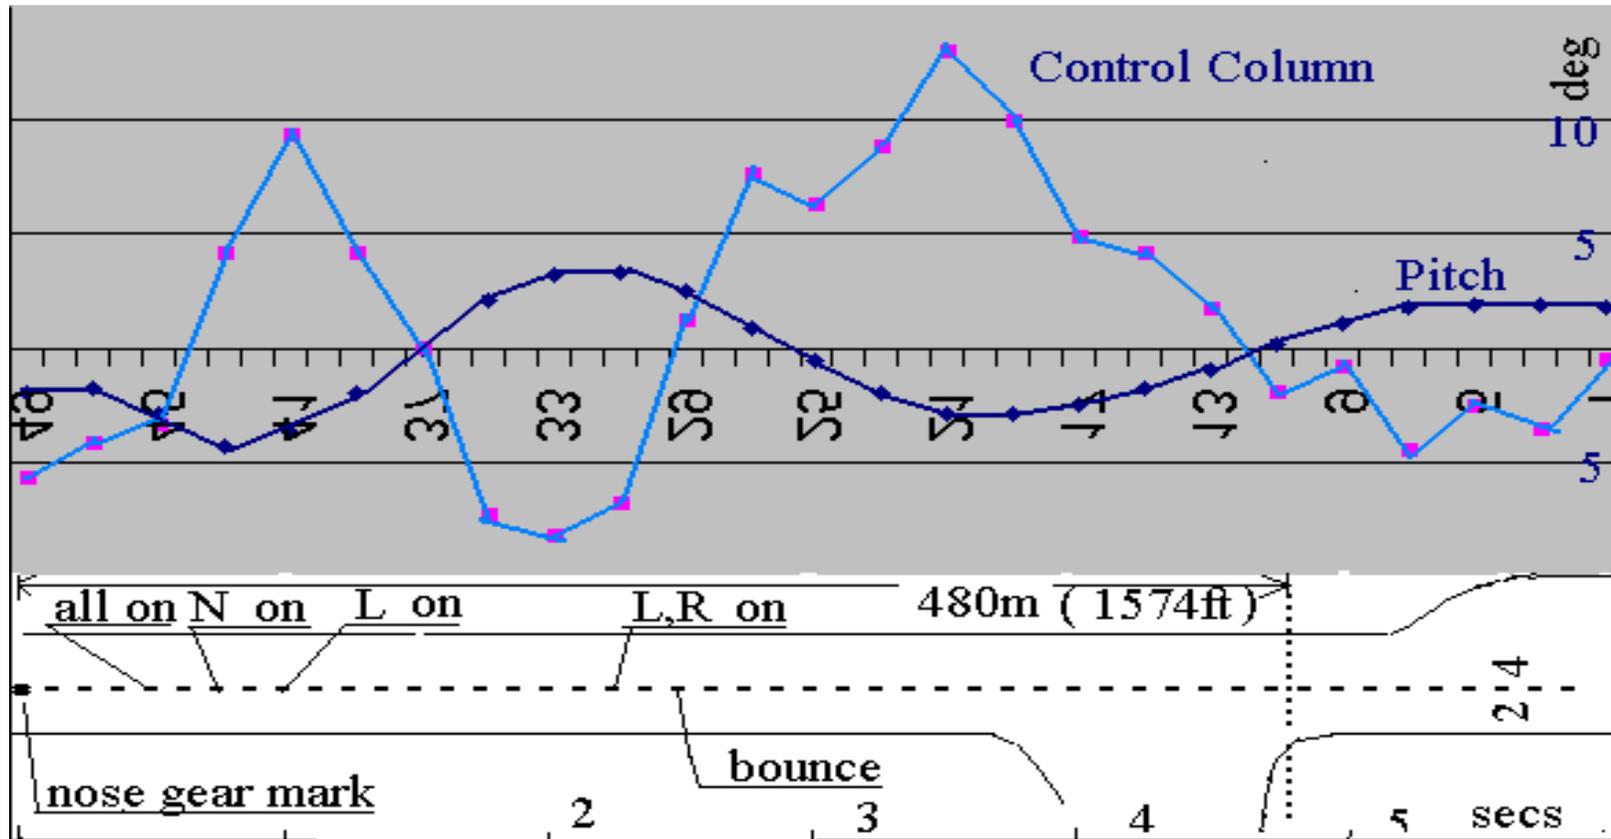
The gusts and turbulence contributed to over control of the pitch attitude during the flare resulting in a hard touchdown. The aircraft pitched down. This caused the aircraft to contact the ground nose gear first, with a longitudinal deceleration of 0.4 G. Shortly thereafter, the main gear contacted the ground coincident with a vertical load factor of 3.8 G.

Graph of fwd/aft position of First Officer's control column with pitch of the aircraft superimposed during flare and landing of EC-HMK.
