Serious Incident to MD-11 N803DE at Dublin Airport, 3 February 2002

FINAL REPORT

**MD 11
N803DE**

AAIU Report No: 2003/004
AAIU File No: 2002/005
Published: 11 April 2003

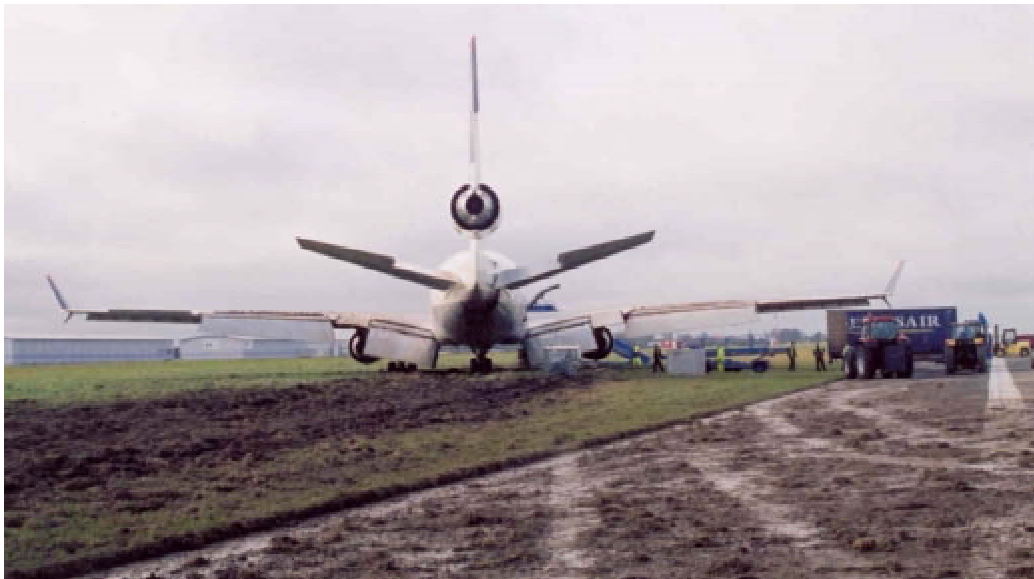
Fig 1

Approximately 3 seconds after touchdown, the FO confirmed “*Spoilers out*” and “*Three in reverse*” thereby indicating that the ground spoilers had fully deployed and that the three engines were providing reverse thrust. The Captain then called out that “*.....it’s slippery*”, as the aircraft started drifting initially to the right and then to the left. Inputs from the Captain, consisting of full right rudder and right tiller, failed to arrest the drift to the left and the aircraft departed the paved surface on an indicated heading of approximately 270°, at a point halfway abeam Taxiway E5 and E6³. The aircraft continued through the prepared graded ground, which was rain soaked, for a distance of approximately 250 metres before finally coming to a halt at approximately 08.05:13 hours (See Fig 1). The RFO immediately asked the Captain if he required “*Engines off/Auxiliary Power Unit (APU) on*”. The Captain replied, “*Affirmative, tell them to remain seated*” and this action was carried out by the RFO, with the FO calling out the shutdown checks. The subsequent emergency response and disembarkation is covered under **Section 1.15, Survival Aspects**.

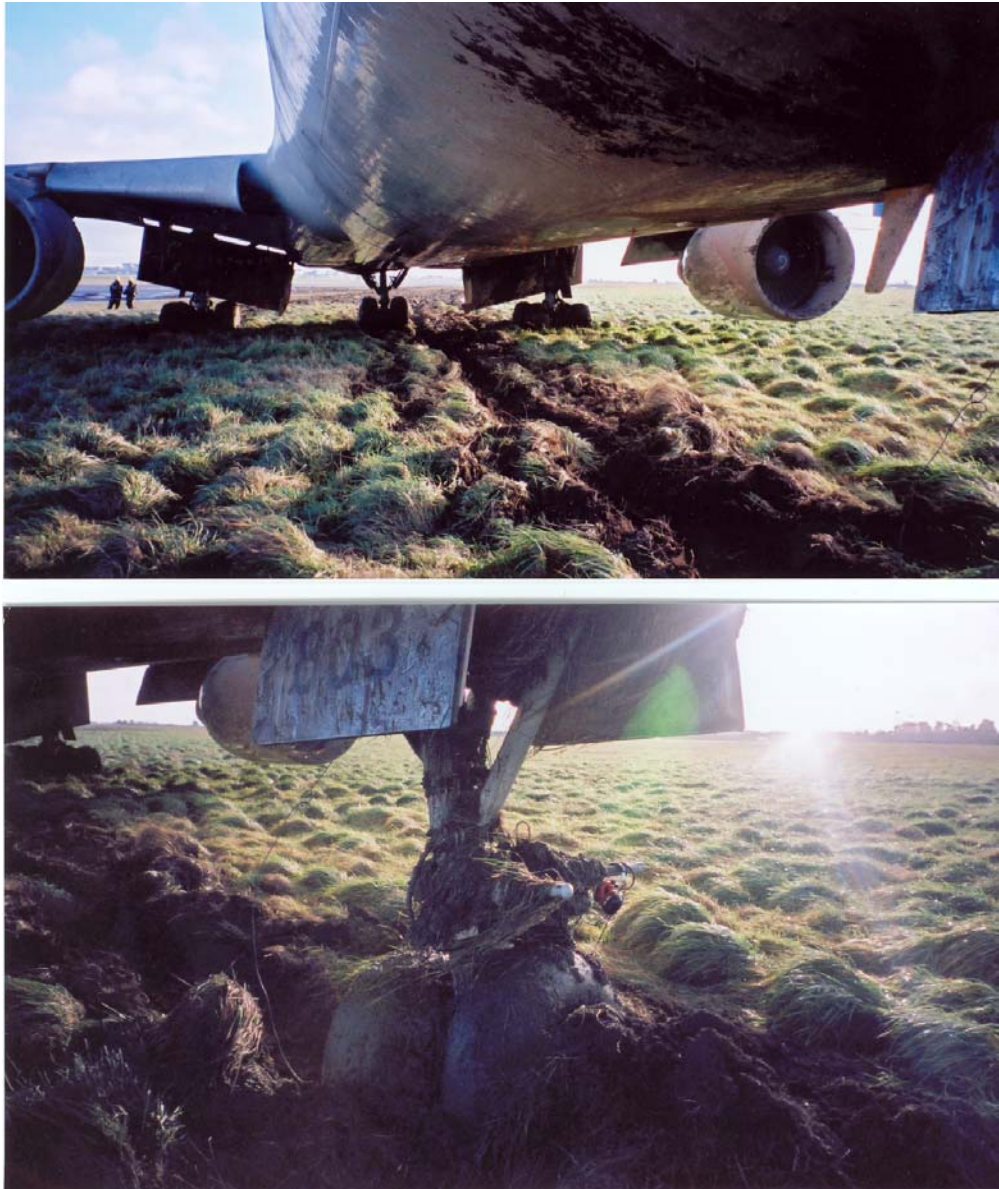
Fig 2

The initial damage inspection determined that the aircraft was covered in mud splash, in particular on the left side. The flaps and slats were deployed and the thrust reversers were stowed. The nose gear wheels were rotated at near 90° to the right of the aircraft centreline (See Fig 2). The brakes and wheels were embedded with mud. All wheels were still inflated and the brakes were intact.

No 1 and No 3 engine showed evidence of moderate Foreign Object Damage (FOD) ingestion in both the hot and cold sections, and damage was caused to the fan blades. The No 1 engine intake acoustic lining had a 3-inch hole in the (8) o’clock position. There was also evidence of mud around the No 2 engine intake. The left inboard flap fairing was damaged.

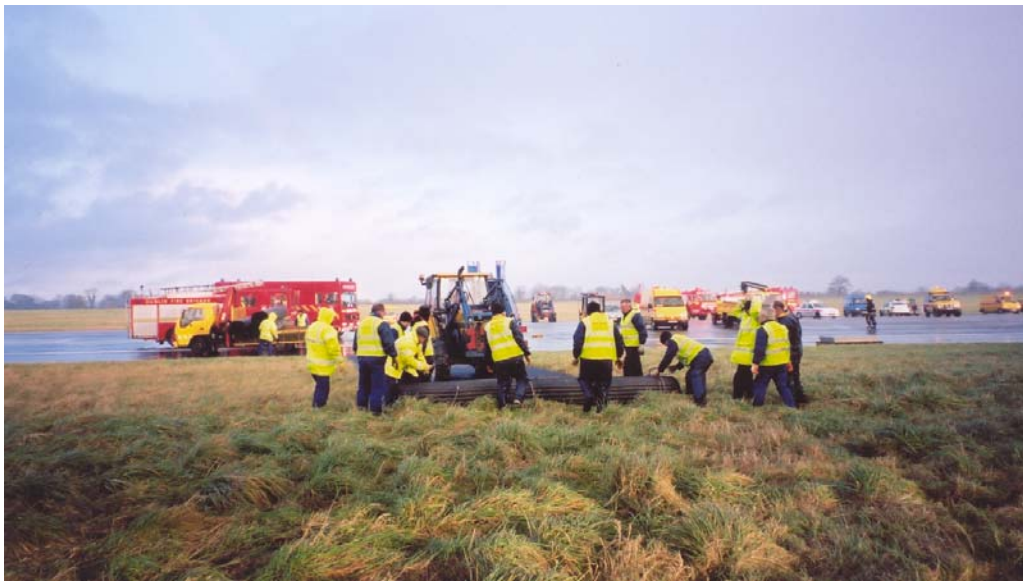
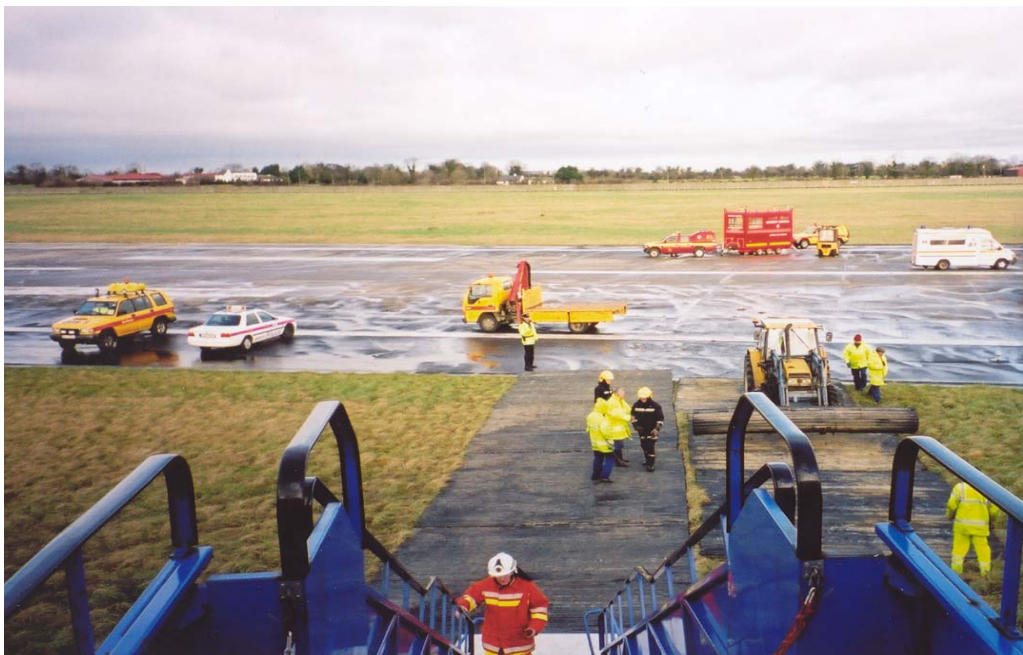
Fig 3

Disembarkation of the passengers and the crew commenced at approximately 10.05 hours through the R2 door and down the mobile stairs to the waiting buses. Both the Operator's Station Manager and one Company Agent were present for the passenger disembarkation and subsequent bus transfer. The passengers were bussed (about 10.29 hours) to Stand 34 (Gate B 26), where they were met by representatives from the Handling Agent and the Airport Authority.

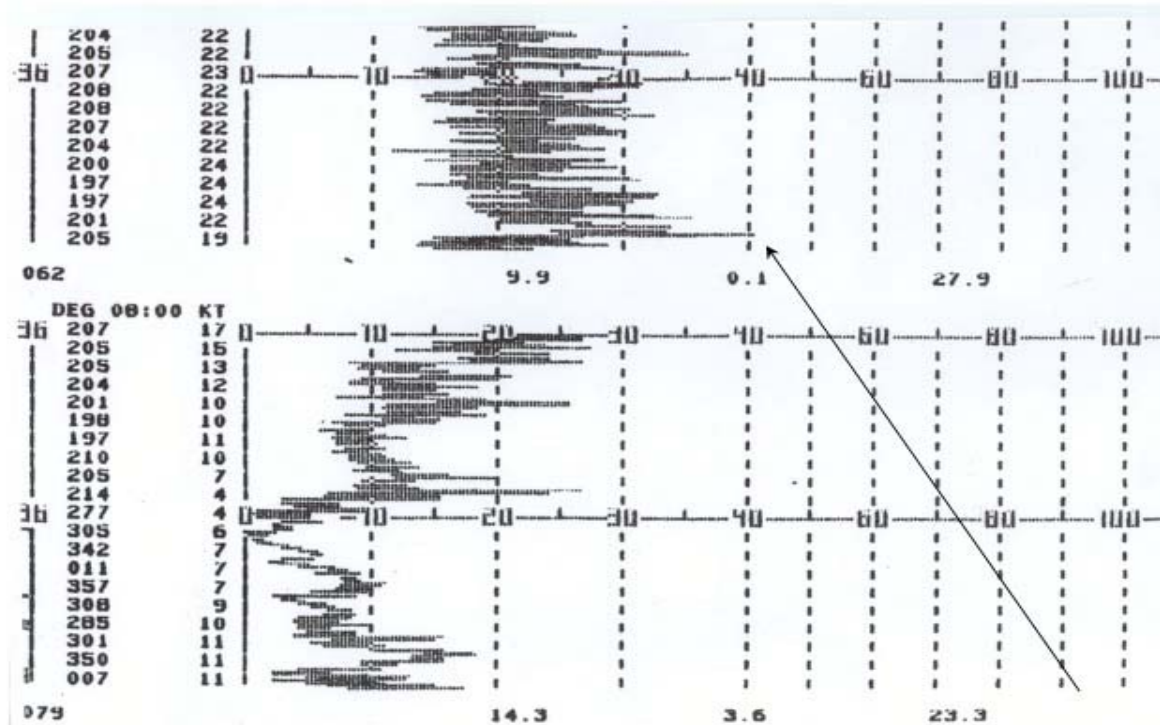
Main Anemometer Trace
Dublin Airport 3 February 2002

Gust 43 kts at about
08.04:45-50 hours
