Engine failure, Serious Incident to ATR 42 EI-CBK near Dublin 8 August 2003

FINAL REPORT

AAIU Formal Report No: 2005-014
AAIU File No: 2003/0043
Published: 11 August 2005

Operator: Aer Arann
Manufacturer: ATR
Model: ATR 42-300
Nationality: Ireland
Registration: EI-CBK
Location: Near Dublin
Date/Time (UTC): 8 August 2003 @ 23.07 hrs

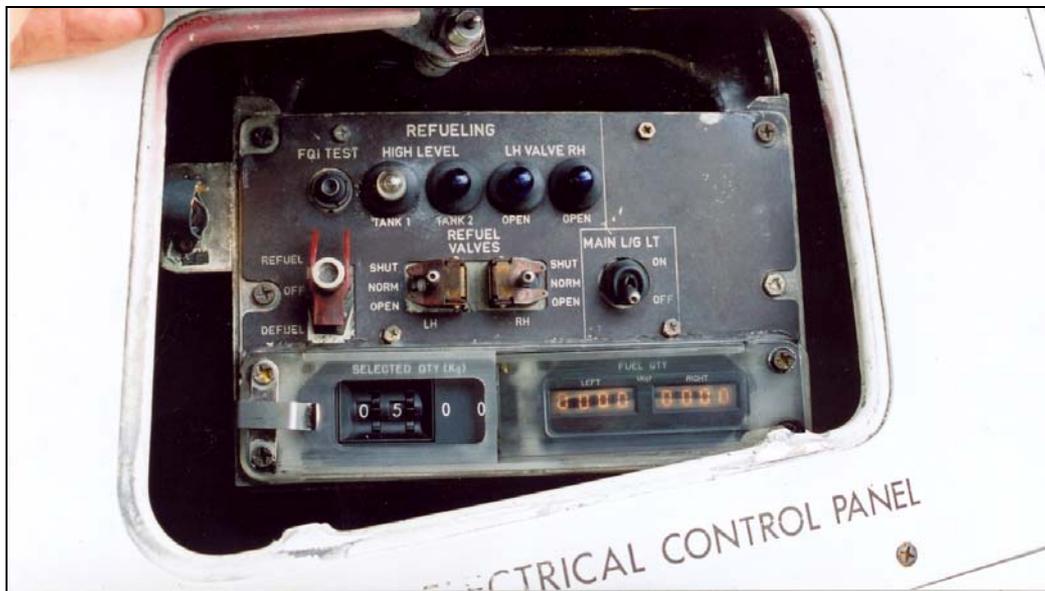
Photo 1

This shows the Electrical Refuelling Control Panel located in the RH Fairing when inspected at Shannon. The blue valve lights can be seen on top of the panel, just to the right of centre. Note the refuelling quantity pre-select at 500 kg in bottom right, and the LH and RH fuel gauges, indicating zero, at bottom right.²

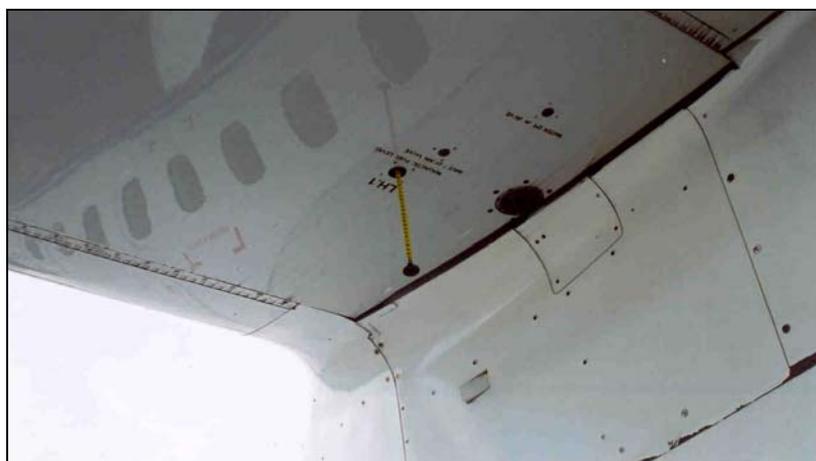
Photo 2

This shows the LH Inner Drip Stick deployed to read LH Fuel Tank contents at Shannon.

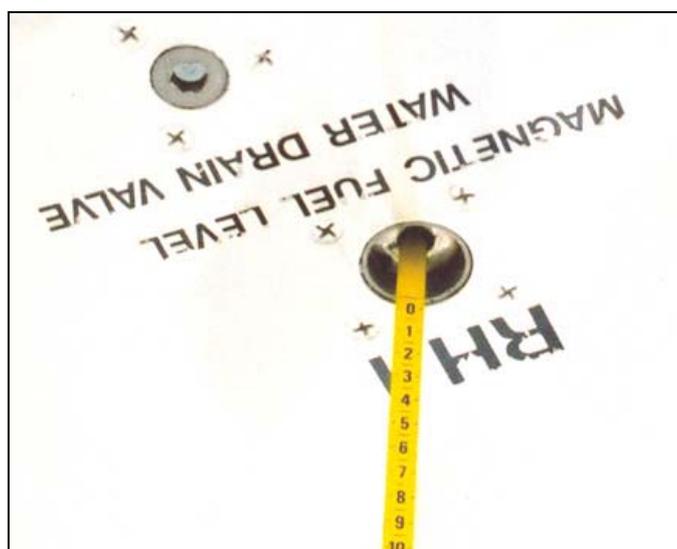
Photo 3

This shows the RH Inner Drip Stick indicating a reading of zero as recorded at Shannon after the incident.

The aircraft was inspected by the Investigation the day after the event. It was noted that the RH fuel tank was empty. This was measured by a dip check and confirmed by performing a physical drain of the tank. It was also determined that the LH tank contained 480 kg of fuel, by doing a drip check. Inspection of the Electrical Refuelling Control Panel in the fairing showed that the selected fuel quantity was 500 kg.

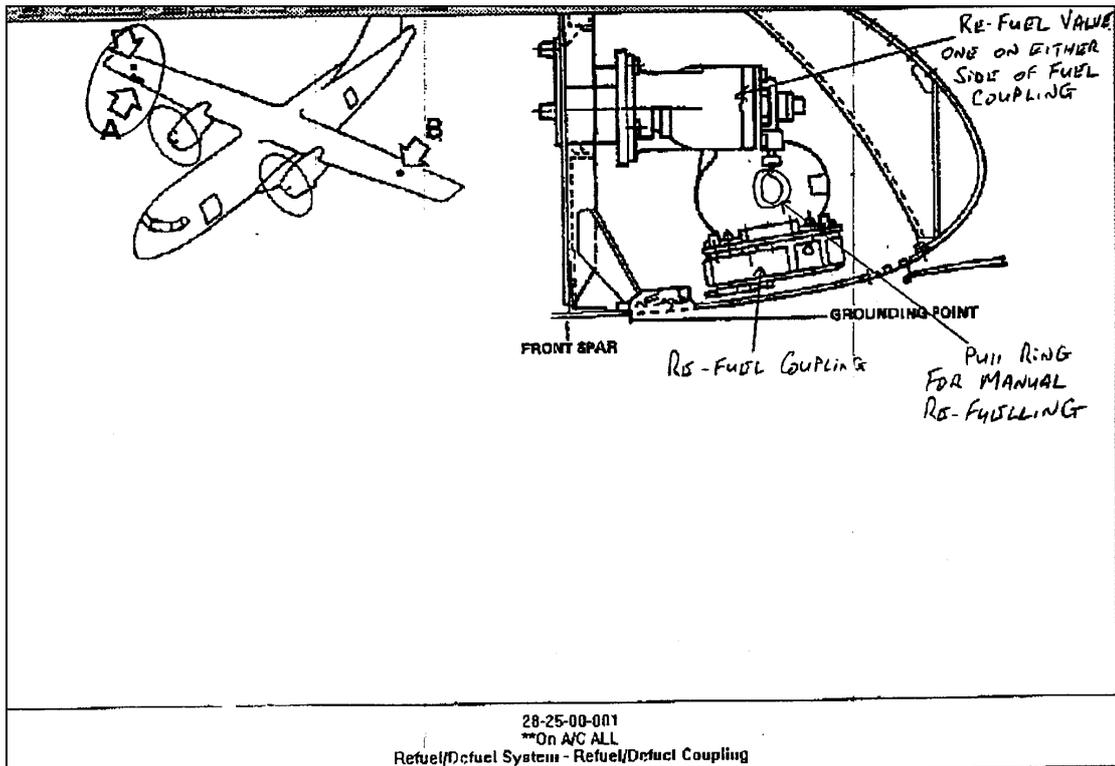
Annex D

The Investigation could not find, within the Operator's Flight Manuals or any other documentation, any diagrams which detail the location and operation of the manual Toggle Rings, located in the wing refuelling panel, which are used to manually open the refuelling valves. In Chapter 28 of the ATR 42 Maintenance Manual there is a diagram which shows the location of the refuelling point in the wing and also includes a section of the fuelling point and the pull triggers. A copy of this page, with hand written explanation notes, is reproduced in **Annex D**. It should be noted that the Maintenance Manual is not readily available to flight crews.

This is taken from Chapter 28 of the ATR 42 Maintenance Manual. Ref A on the left diagram shows the location of the pressure refuelling point which was used for refuelling of EI-CBK on the day of the incident. The gravity refuelling points (Ref B) were not used. The right diagram shows a section through the wing at the pressure refuelling point, and shows the triggers (pull ring) for opening the valve to the RH fuel tank.
