MLG failure, Boeing 737-500 EI-CDE, September 8, 2003

FINAL REPORT

AAIU Synoptic Report No:2005-006

SYNOPSIS

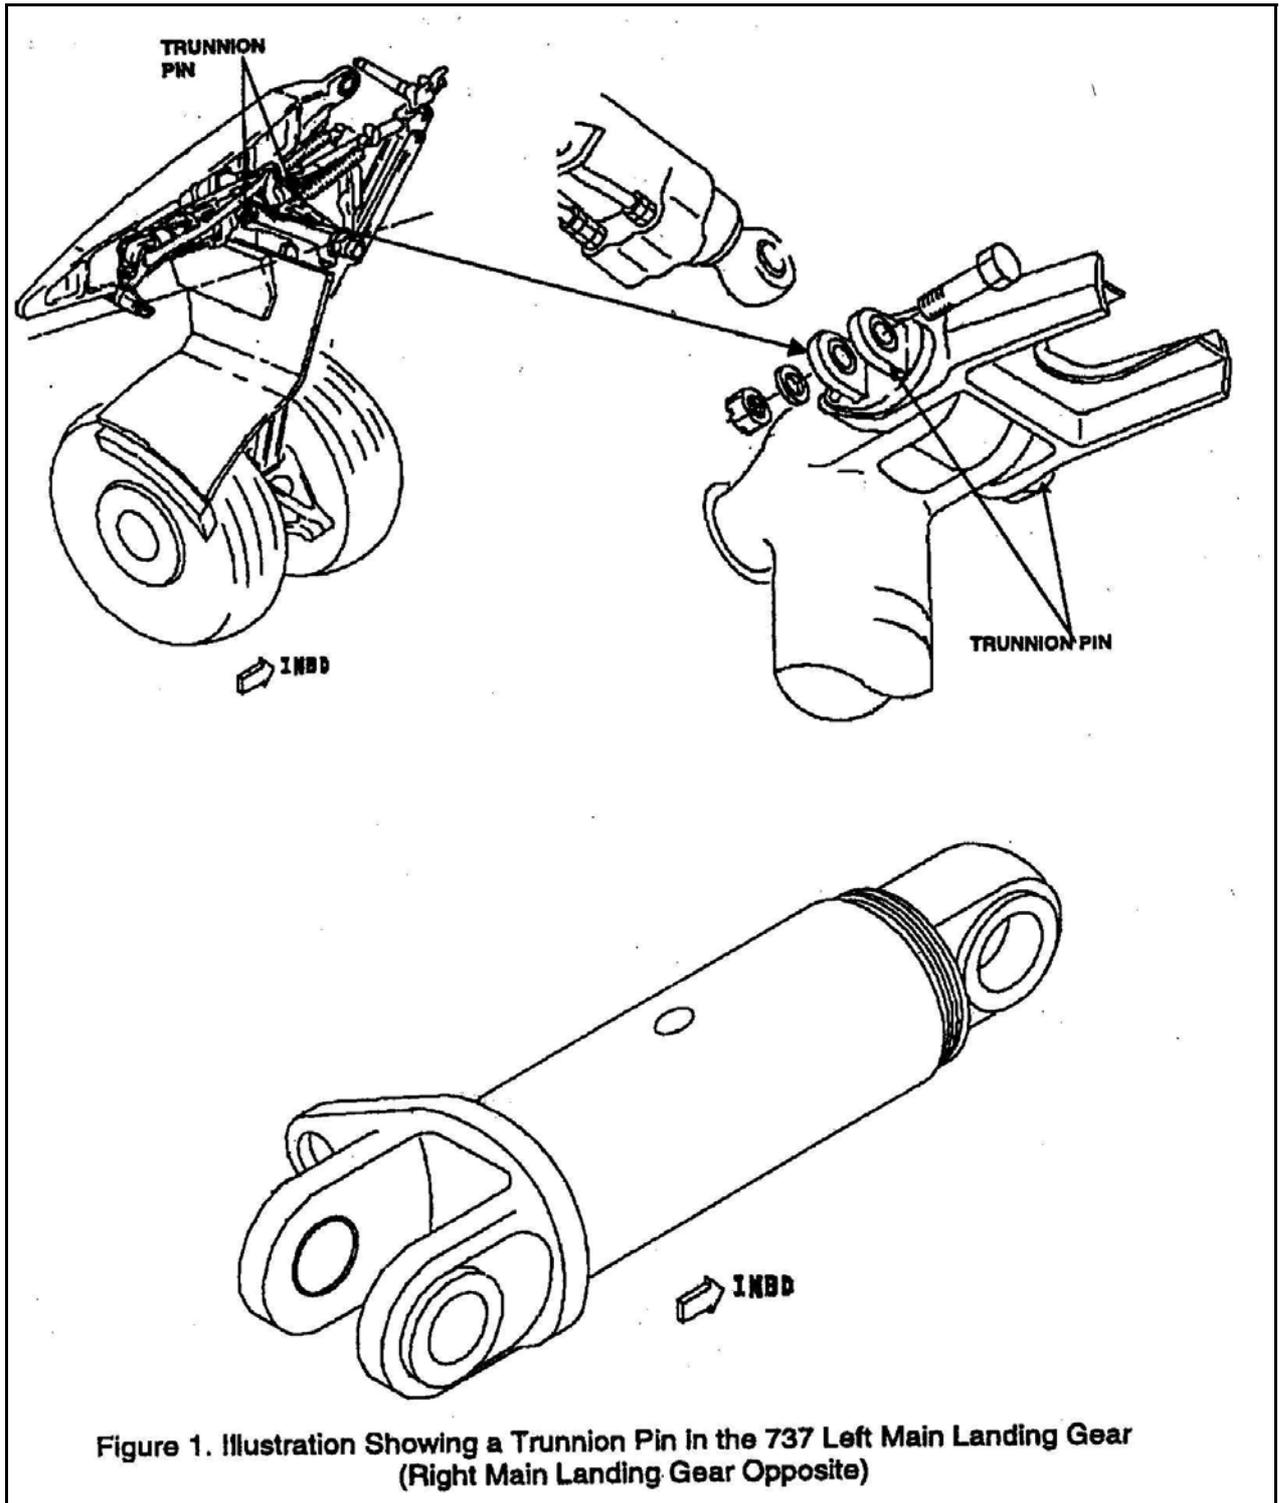
APPENDIX A

The LH MLG trunnion pin Part No. 65-46113-20, Serial No. AT067 failed at the outboard end at the MLG actuator attachment point (**APPENDIX A**).

The pin was fractured at the transition radius between the shaft and retract flange (APPENDIX A). The surfaces of the pin at and near the fracture were heavily oxidized and corroded and much of the chrome plating in these areas was missing. Due to experience with similar trunnion pin fractures in the past where the corrosion inhibiting compound JC5A has been implicated in accelerating the corrosion process, a chemical analysis was performed on deposits taken from the transition radius as well as nearby locations. There was no indication that JC5A was present.

Figure 1. Illustration Showing a Trunnion Pin in the 737 Left Main Landing Gear (Right Main Landing Gear Opposite)

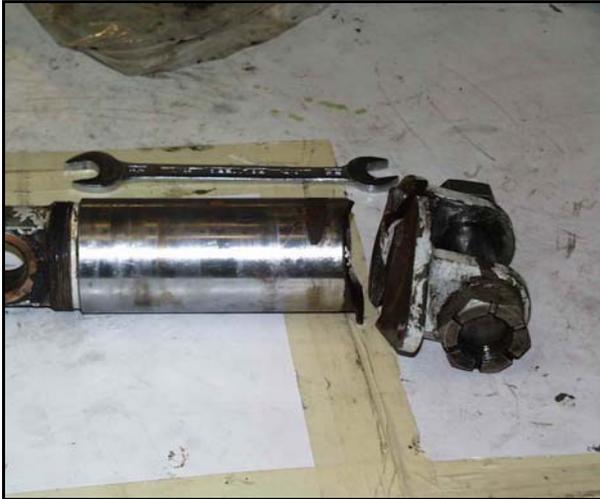
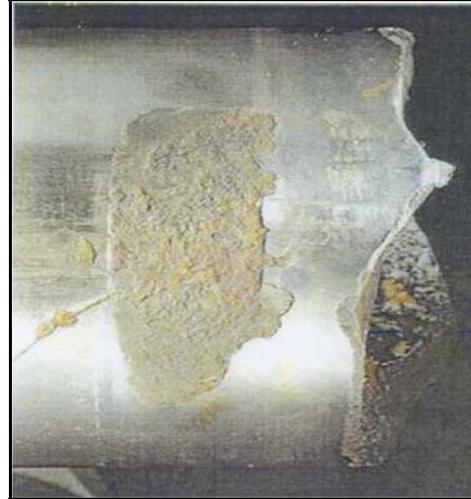
The above photos show the fractured pin shaft on the left with a detail view of the detached plating on the right.

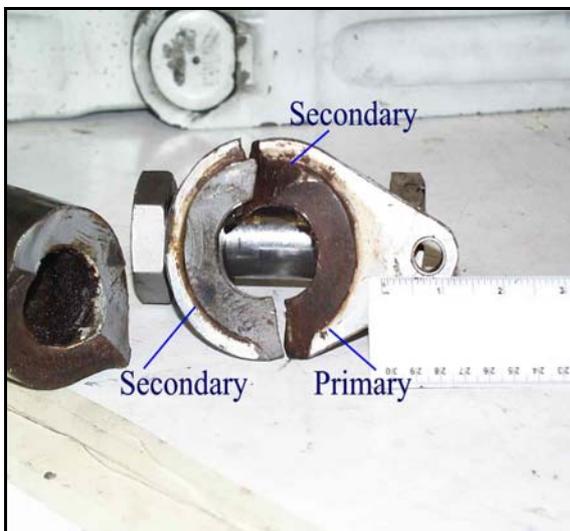
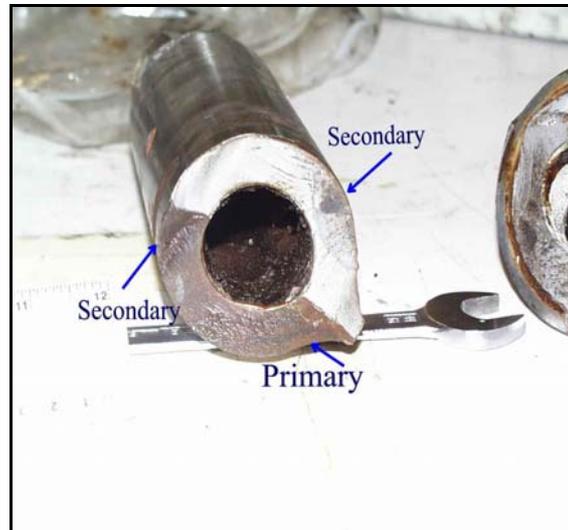
The fracture surfaces on the separated retract flange section can be seen in (APPENDIX B). The fracture surfaces were cleaned in the laboratory due to the heavy oxidation and corrosion products. The fracture surfaces exhibit three separate planes of fracture propagation, which indicates three separate initiation or origin sites. Each fracture plane exhibits a blocky, rough thumbnail shaped region on the fracture surface emanating from the outer surface of the pin.

This surface morphology is consistent with stress corrosion cracking (SCC). All three fracture planes exhibit the flat grainy surface appearance with directional flow lines that are typical of final fracture in high strength steel beyond the SCC regions.

The primary fracture origin as well as the two other secondary fracture origins are located in or adjacent to the transition radius where much of the chrome plating was missing. The severity and number of through-thickness cracks in the plating (APPENDIX C) indicates poor quality and adhesion characteristics. Additionally, the thickness of the plating is approximately 0.013 inches. Even though the design drawing specification allows for 0.003 inches minimum for the chrome plating, the 0.013 inch layer indicates that the pin might have been reworked or overhauled.

The photo on the left shows the fracture surfaces on the retract flange sections of the pin. There were three Stress Corrosion Crack (SCC) origins and fields of propagation, which are denoted by the arrows. The photo on the right shows the corresponding fracture surface of the shaft section of the pin.

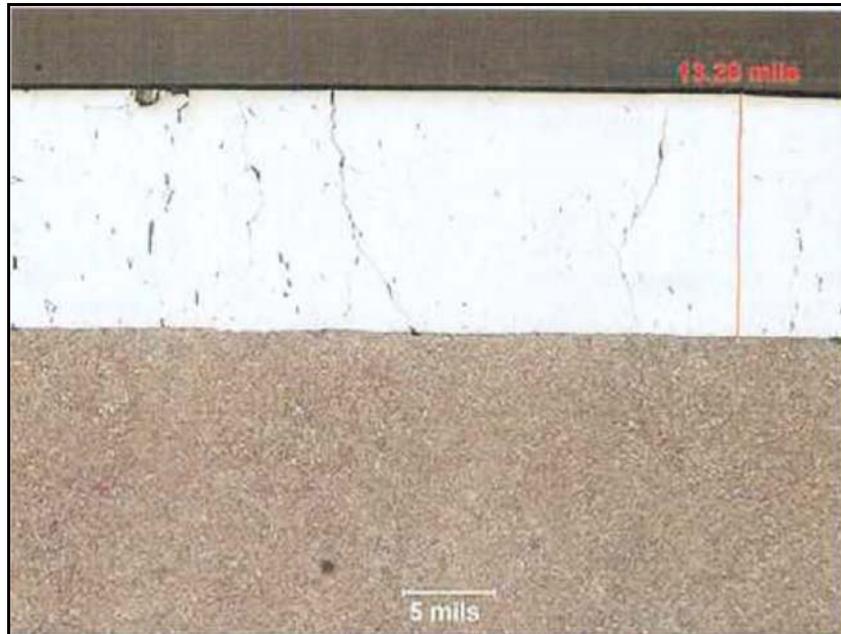
APPENDIX C

Cross section through the chrome plating showing the through-thickness cracks.
(Courtesy of The Boeing Company)
