Flight Management Concerns, Ryanair Boeing 737-800, EI-CSA, July 21, 2004

FINAL REPORT

AAIU Synoptic Report No: 2005-018

Aircraft Type and Registration:	B737-800, EI-CSA
No. and Type of Engines:	2 x CFM 56-7B
Aircraft Serial Number:	29916
Year of Manufacture:	1999
Date and Time (UTC):	21 July 2004 @ 13.40 hrs
Location:	Approach to Skavsta Airport, Sweden
Type of Flight:	Public Transport
Persons on Board:	Crew - 6 Passengers - 184
Injuries:	Crew - Nil Passengers - Nil
Nature of Damage:	None
Commander's Licence:	Airline Transport Pilot's Licence
Commander's Details:	Male, aged 38 years
Commander's Flying Experience:	5,000 hours approximately (of which 1,500 were on type)
First Officer's flying Experience:	700 hours (of which 400 were on type)
Information Source:	Reports received from the Operator and Pilots. AAIU Field Investigation.

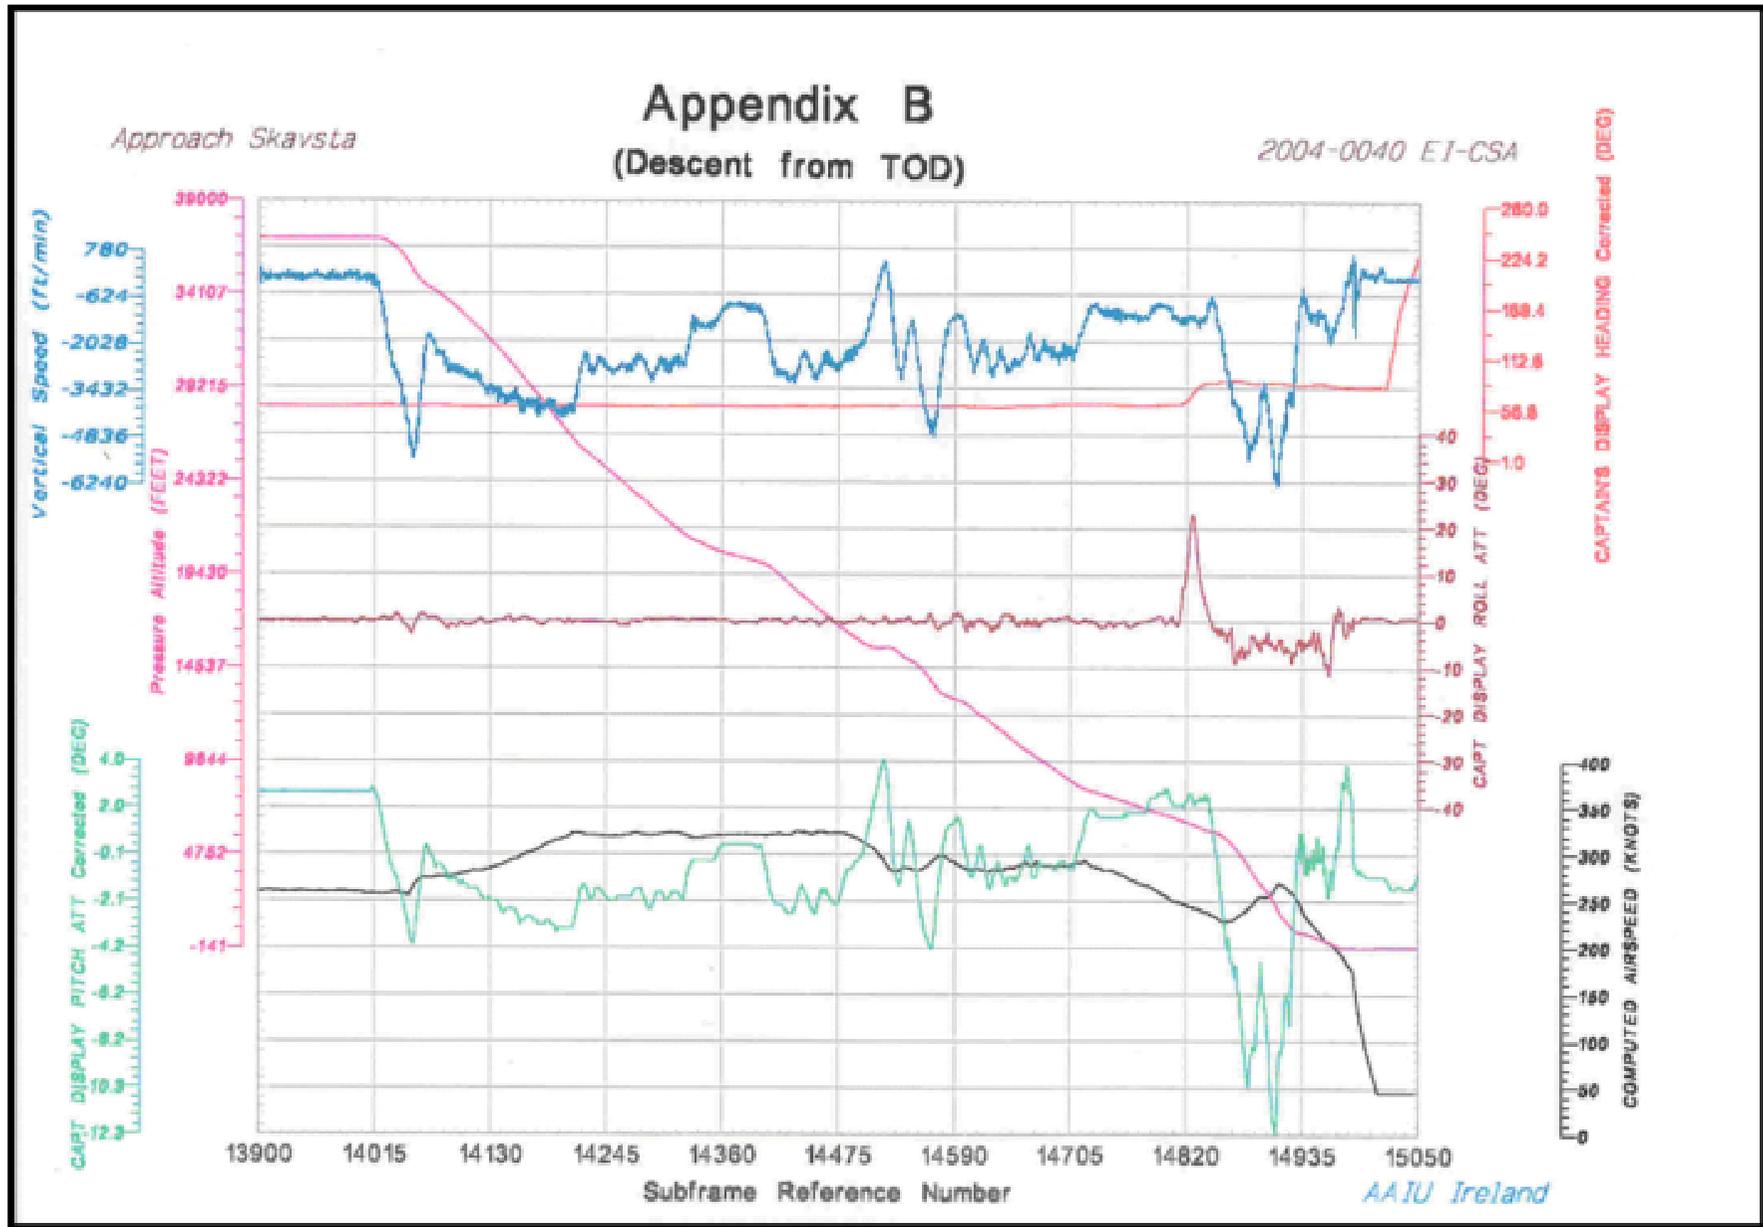
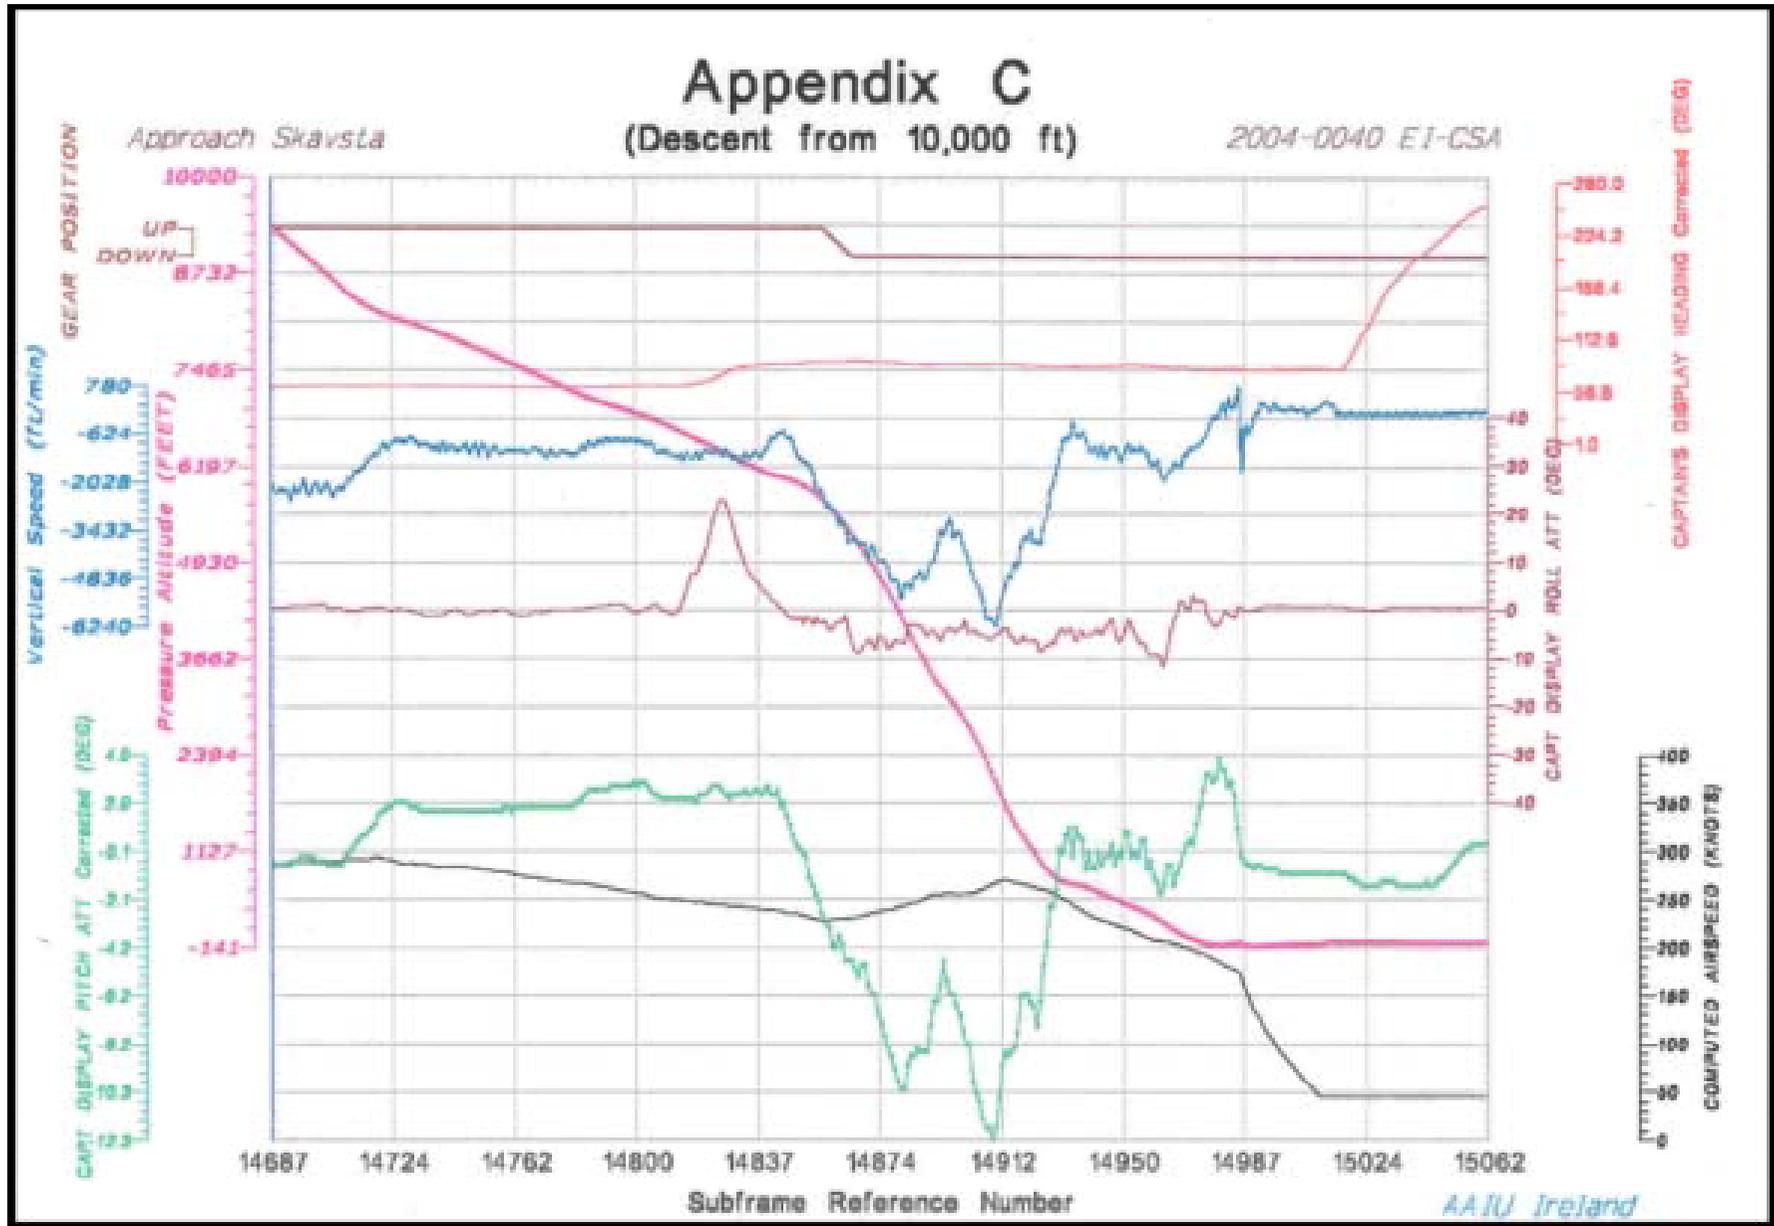
Nose down pitch reached 12.3° which, in turn, with the use of side slip contributed to excessive Rates of Descent (ROD), up to 6,200 fpm were recorded, and excessive speeds for flap deployment (**Appendix B and Appendix C**). These, in turn, led to GPWS alarms sounding which were ignored by the PF, as were the speed and height warning inputs from the PNF. All of the foregoing led to an unnecessarily high speed landing. In his written statement the PF attempted to address his behaviour over that fifteen minute period. He stated, inter alia *"I cannot understand what possessed me to continue the approach, I have replayed these events in my mind hundreds of times and, at no instance, do I arrive at the decision I took. I became fixated and lost sight of the big picture. It was only at such a late stage that the events taking place around me actually penetrated my mind; but by then I found myself in the landing roll"* and *"I cannot understand myself how it was possible for me to show such poor judgement. I can only imagine that certain personal stresses and tiredness affected my ability to think rationally. I do not offer this as an excuse but merely an insight into my deficiency for logical thought"*.
