## Failure of flap deflection control track, Boeing 767-319 ZK-NCH, approach to Auckland International Aerodrome, 19 May 2001

**Report 01-004**

**Boeing 767-319**

**failure of flap deflection control track**

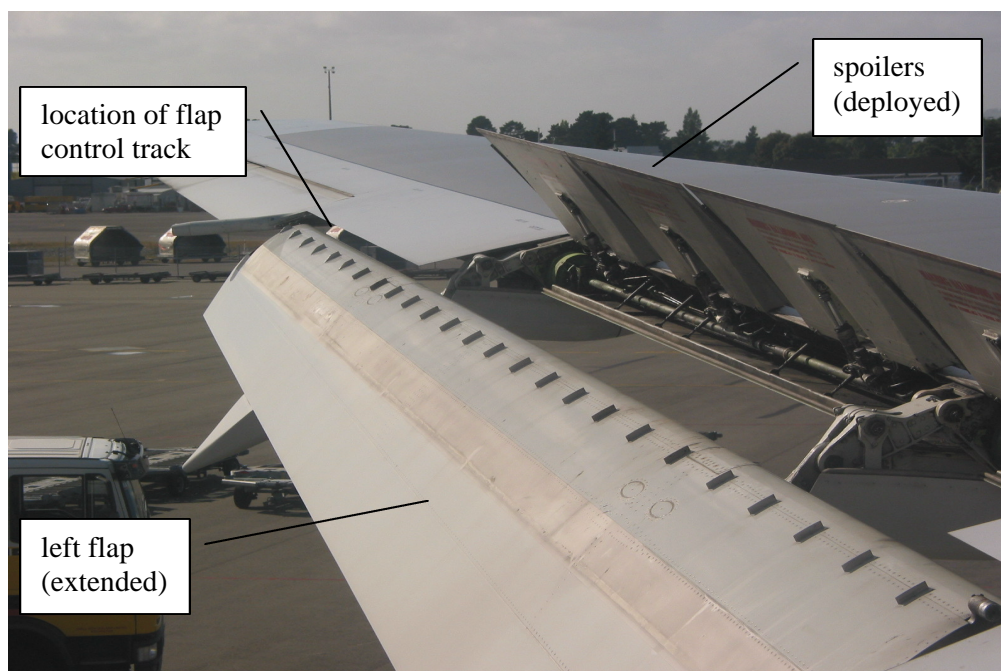
**Figure 2**  
**Left wing with flap fully extended and spoilers deployed**

- 1.1.5 With 2 engineers positioned near the left wing, the flaps were fully lowered and the spoilers deployed (see Figure 2). A set of steps was used in the inspection of the spoilers and flap, concentrating on the upper surfaces and the flap area adjacent to the spoilers. The engineers checked for damage and loose items – none was found. The spoilers and ailerons were cycled several times and both appeared to function normally. The flaps were retracted and no abnormalities were noted. The certifying engineer reported to the captain that he was satisfied there were no defects and completed the maintenance log entry. The aircraft was cleared for the return flight to Auckland<sup>2</sup>.

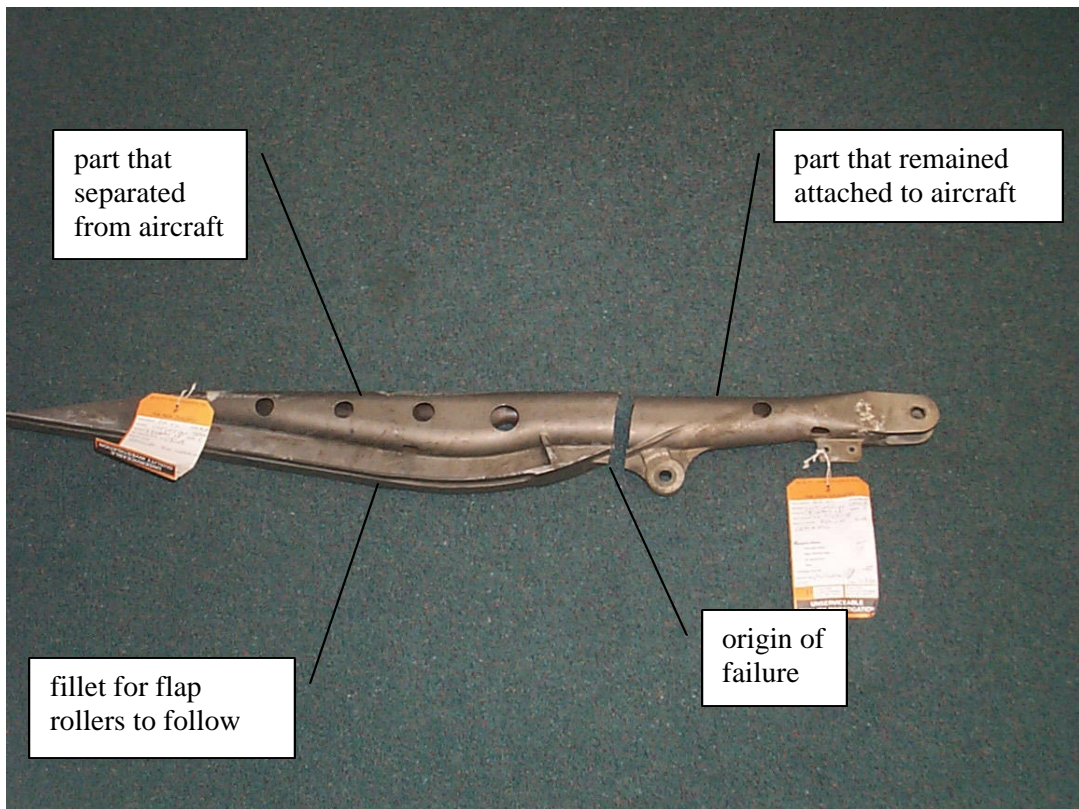
**Figure 3**  
**Flap deflection control track from ZK-NCH**

- 1.1.6 The return flight to Auckland, then operating as NZ 102 but with the same crew, proceeded uneventfully. At 1450 while on final approach to land at Auckland International Aerodrome, and at about the time full flap was selected, a section of the left outboard flap deflection control track assembly (the flap control track) separated from the aircraft and fell to the ground. The section of flap control track, weighing about 3 kg, struck the roof of a warehouse in Manukau, about 2 km from the aerodrome and in line with the runway centreline. The broken section penetrated the warehouse roof and bounced off an aisle stand before coming to rest on the floor. The warehouse was occupied but there were no injuries (see Figure 3).

1.3.1 There was minor deformation to the wing skin of the aircraft, around the position where the flap control track would be located.

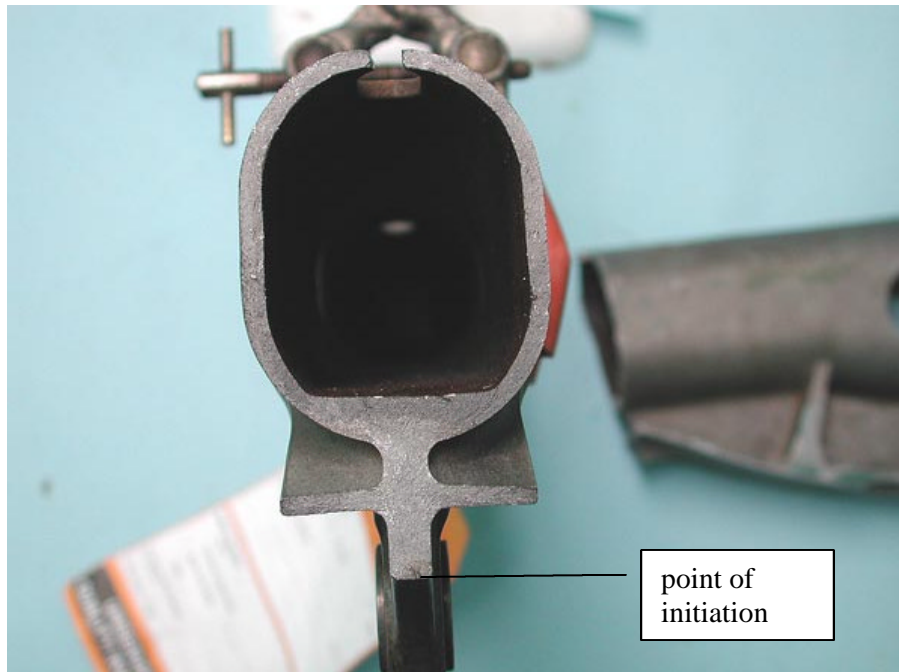
**Figure 4**  
**Fracture surface of flap control track**

- 1.8.1 The 2 sections of the flap control track were subjected to independent metallurgy testing (see Figures 4 and 5). The report on the testing is summarised as follows:

The fracture resulted from fatigue initiated at a casting defect (slag inclusion) at the surface of the tension face of the guide fillet, which had subsequently developed fatigue cracking. The fatigue crack had grown to a size (approximately 4 mm wide by 2.7 mm

deep) such that, at the applied stress level at the instant of failure, the part had fractured by a cleavage (fast, brittle) mechanism initiating at the fatigue cracking.

The casting defect was of the nature of an extrinsic (chance) defect resulting from the incorporation of a small amount of manganese-silicate slag into the liquid metal stream when the part was being poured, which had become trapped near the surface of the casting in this critical area of the structure.

- 1.8.2 Inspection of the 2 sections revealed paint contamination on the fracture face of the section that separated from the aircraft. There was also similar coloured paint scraped onto several other surfaces of the same part. The 2 fracture surfaces did not display any evidence of having met and rubbed together after failure.

- 3.1 As a result of the incident, the operator notified both the manufacturer and a number of other Boeing 767 operators to alert them to the incident. The manufacturer in turn ensured that all Boeing 767 operators were aware of the potential for the flap control track to fail and depart the aircraft.
- 3.2 The manufacturer undertook to develop an inspection procedure with repeat intervals that will minimise the possibility of future track failures. The procedure was to be released as a service bulletin with the following requirements:

- 3.4 The operator advised that it was replacing all Boeing 767 model 113T833-1, -3 or -5 flap track guides with the Boeing 767-400 model -7 series of flap track guide.
