Runway excursion during landing, Aerospatiale-Alenia ATR 72-212A, ZK-MCJ, Queenstown Aerodrome, 5 October 2005

AVIATION OCCURRENCE REPORT

05-010

Aerospatale-Alenia ATR 72-212A, ZK-MCJ, runway excursion
during landing, Queenstown Aerodrome

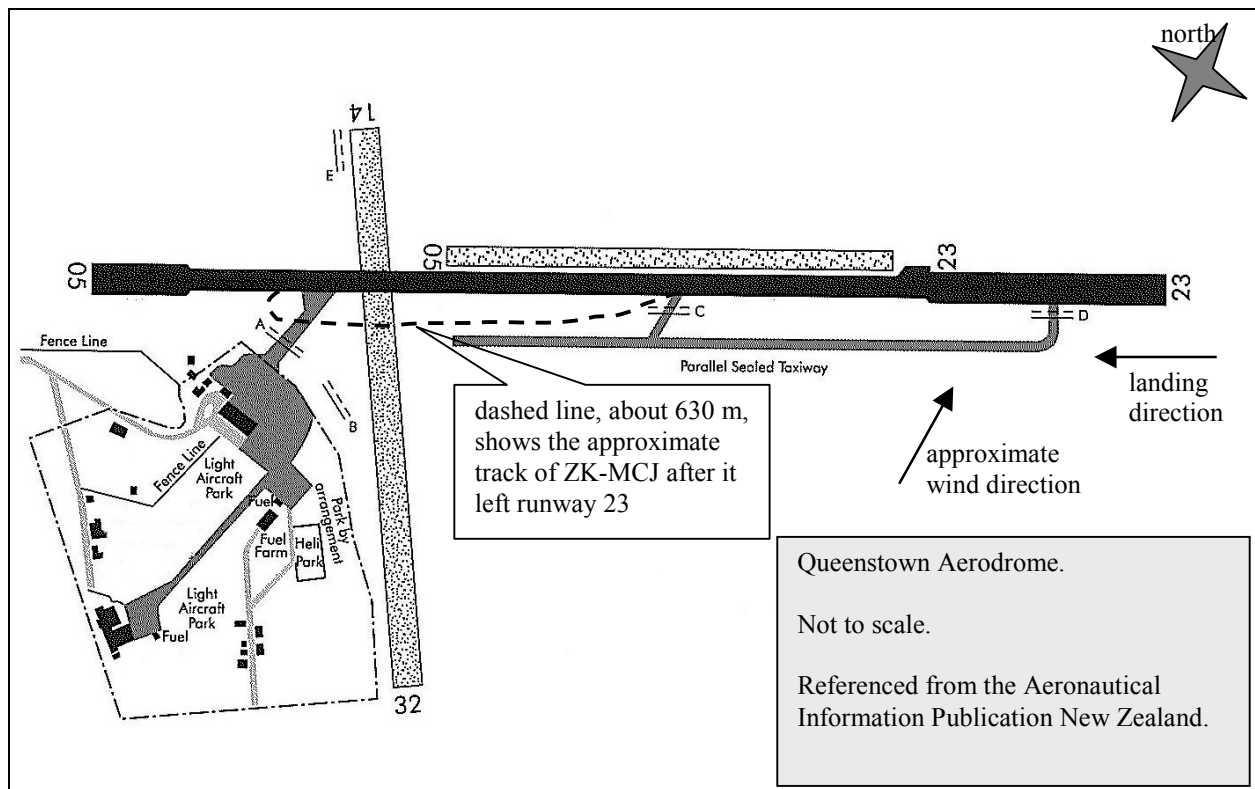
Figure 1
Queenstown Aerodrome showing approximate landing track of ZK-MCJ

- 1.1.15 After the aeroplane had left the runway it paralleled it, crossed grass runway 14 and continued to the main terminal taxiway, by which time it had slowed to normal taxi speed. The captain taxied the aeroplane across the taxiway, applied power and taxied back onto the runway abeam the control tower. He stopped the aeroplane on the runway for about 30 seconds, and using the intercom spoke to the cabin crewmember at the rear of the aeroplane, before taxiing to the terminal. Using the public address system during the taxi, the cabin crewmember reassured the passengers and advised them what had happened.

- 1.1.19 The air traffic controllers later commented that it seemed to them the nose wheels were off the runway longer than normal during the flare and landing, and that there appeared to be little weight on them after they contacted the runway. They said the aeroplane slewed in the mud alongside the runway, and that the nose wheels appeared to be pointed toward the runway. They said there was a lot of mud thrown up, and that the aeroplane had straightened and slowed by the time it crossed grass runway 14.
