Runway overrun, Incident involving Aircraft N-263US, 12 November 1996 at Örebro Airport, T county, Sweden

Investigative Body: Swedish Accident Investigation Board (AIB), Sweden

Report C 1997:36

**Incident involving Aircraft N-263US
12 November 1996 at Örebro Airport,
T county, Sweden**

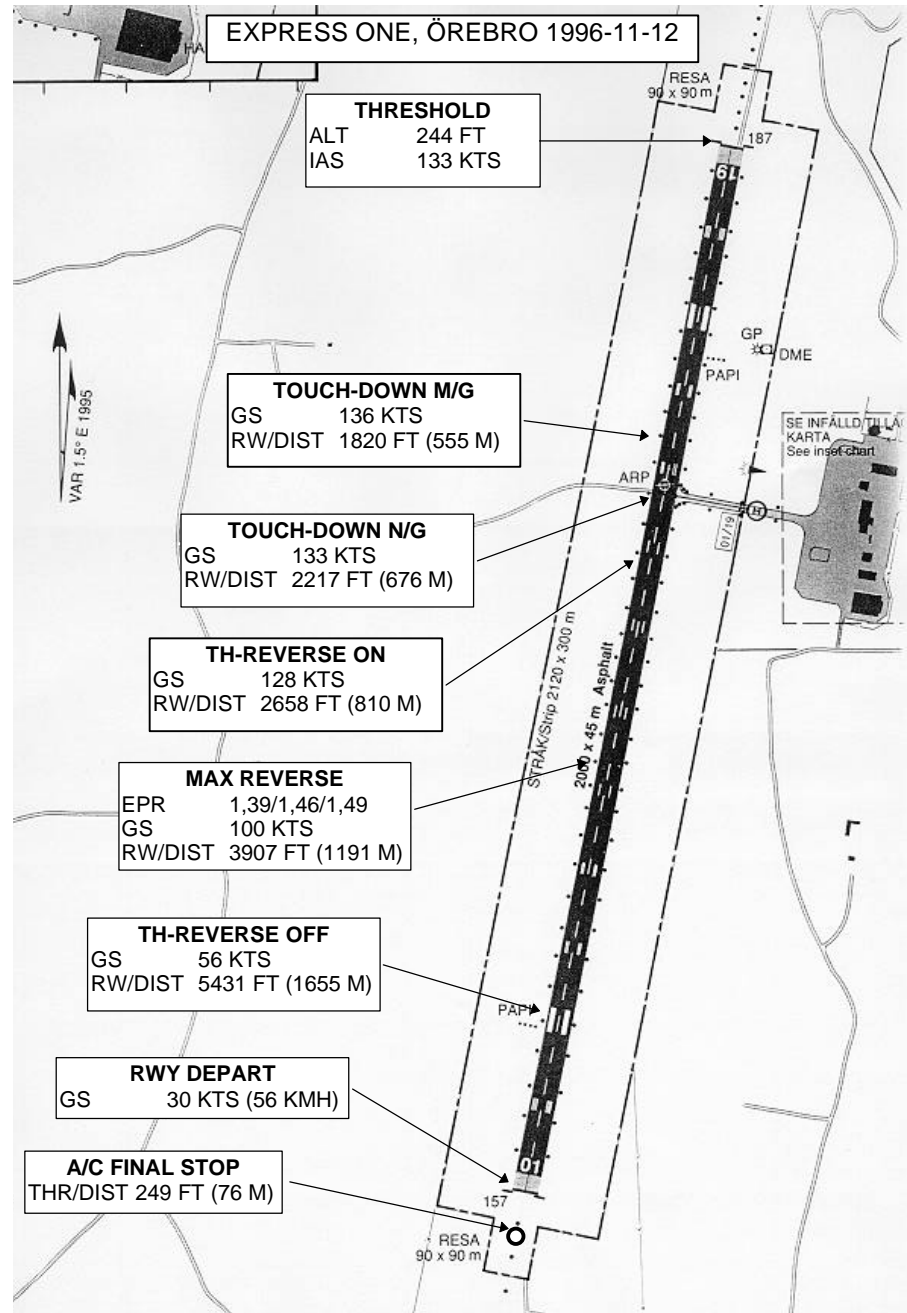
In drawing below essential positions along the runway have been pointed out.

The captain used reversing and wheel braking normally down to a ground speed of 56 kts (103 km/h) at which speed he unreversed only 345 m remained of the runway length. The captain has stated that braking was normal until the speed had been reduced to taxiing speed and that he thereafter intended to continue to the runway end to turn around there. The ground speed when the aircraft skidded off the runway was 30 kts (56 km/h), however, which indicates that the captain underestimated the ground speed and unreversed the engines and released the brakes too early. Contributing to this misjudgement may have been a visual perception of low ground speed due to the snowflakes moving in the same direction due to the tailwind.

When the captain was to perform the final braking before the 180° turn at the end of the runway, the ground speed was thus too high in relation to the actual runway friction. The main wheels lost their grip and the aircraft skidded uncontrollably over the runway and additionally 76 m into the overrun area.

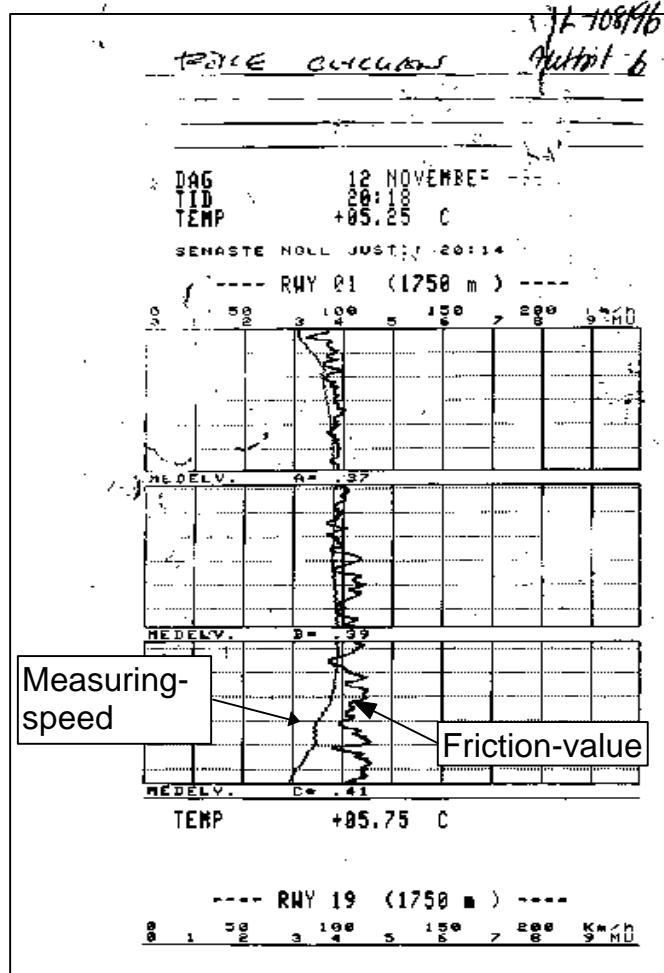
Recording slip of test before the incident (one direction)

The following friction values were reported to the tower: 0.37, 0.39, 0.41 corresponding to braking action "good to medium", "good to medium" and "good". The test equipment computer was wrongly programmed and gave the result as being obtained on runway 01.

The friction report given to the aircraft was based on a test performed 21 minutes before the landing, near the centreline and along a section that had just been swept. As the heavy snowfall persisted during the continued cleaning, which was terminated just before the landing, the real friction values must have been lower than those reported. This was also confirmed 8 minutes after the landing when it was found that the friction values had deteriorated by 0.01 on the first third and by 0.05 on the last two thirds of the active runway.

Also, the test before the landing was performed only in one direction and at an average speed below the recommended 95 km/h, which rendered the test result less reliable.
