Accident involving aircraft SE-DMX, 9 March 1997, Kiruna airport, BD county, Sweden

Report C 1998:03e
Accident involving aircraft SE-DMX,
9 March 1997,
Kiruna airport, BD county, Sweden

Report C 1998:03E

The Swedish Board of Accident Investigation has investigated an accident which occurred on March 9:th 1997 at Kiruna airport, BD county, Sweden, involving an aircraft with registry SE-DMX.

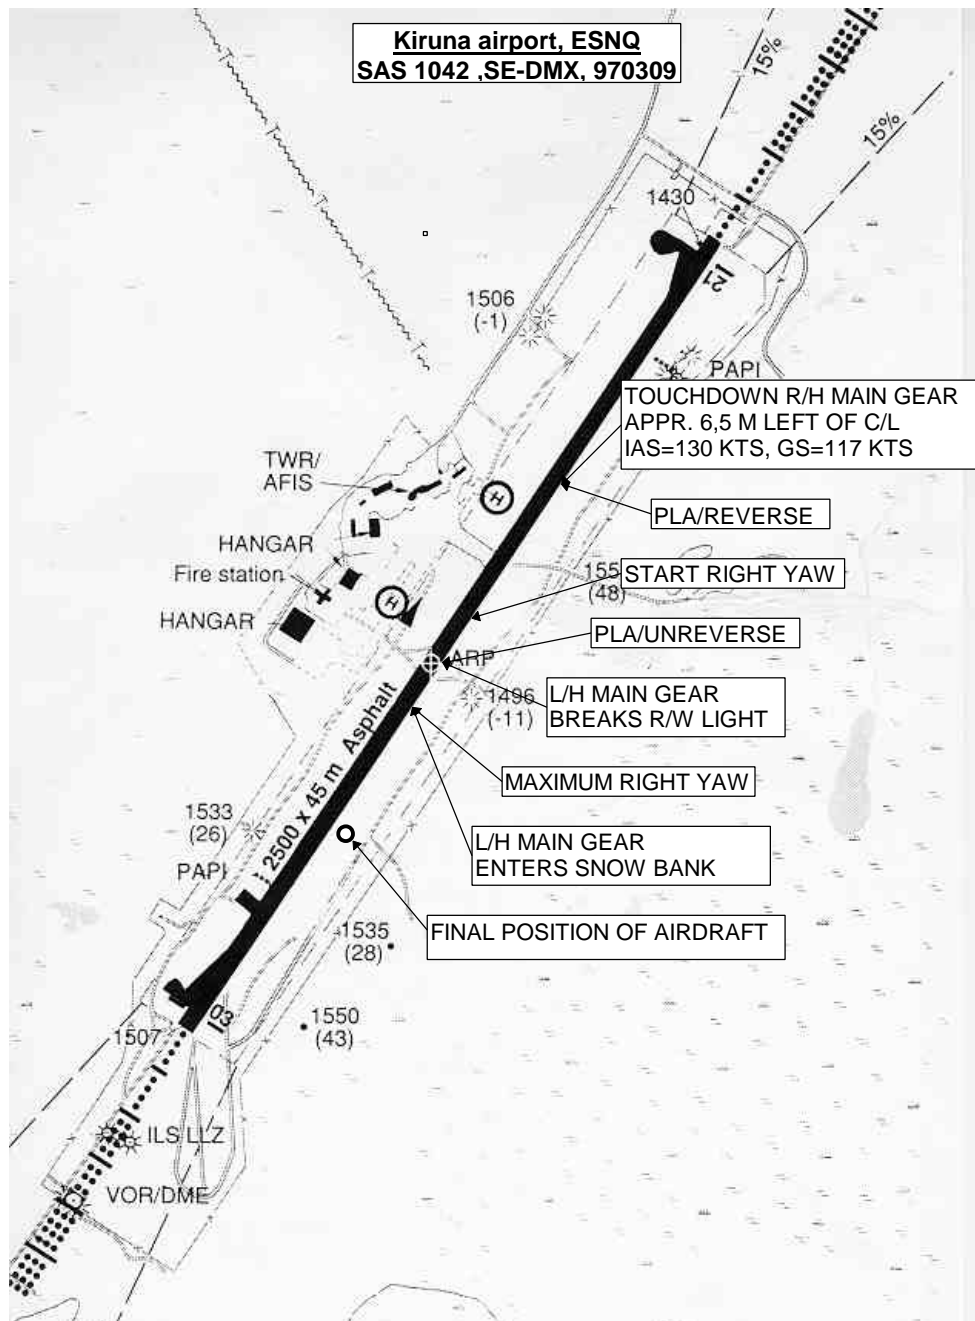
The measurements of the runway and the essential positions and occurrences along it are depicted on the airport map below.

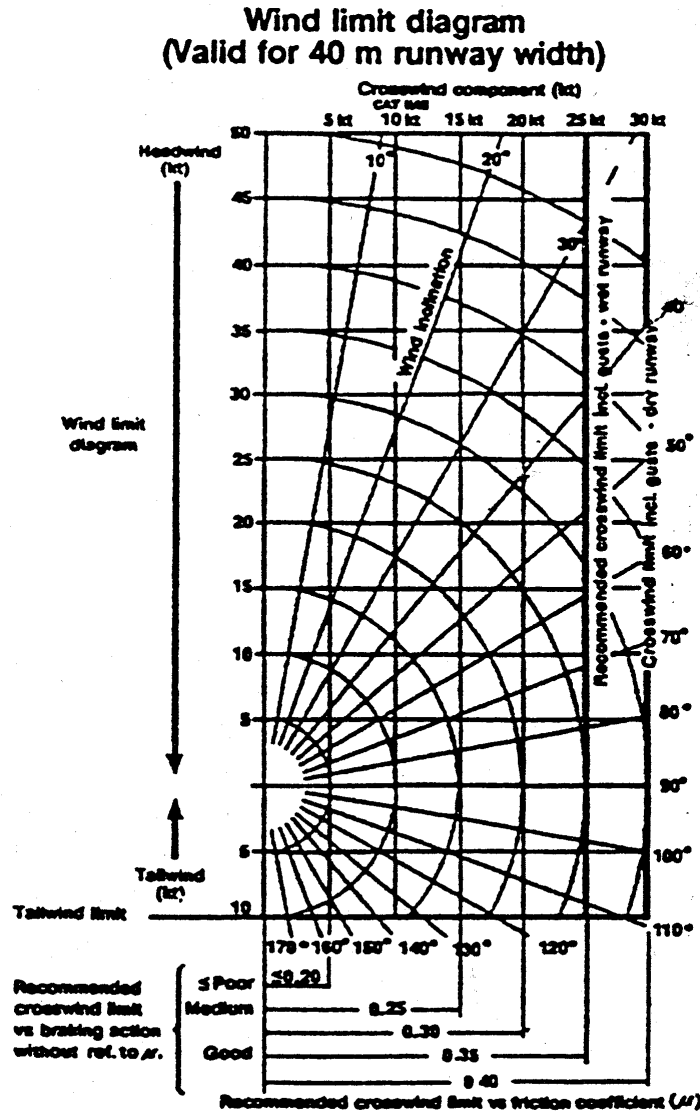
Wind limit diagram (actual size 33 x 66 mm)

From the diagram, the maximum allowed crosswind component¹⁰ can be found for landing on a runway with a reported friction coefficient of 0.32. It is 22 knots, which on runway 21 at Kiruna corresponds to an actual wind of 250°/42 knots or 270°/25 knots.

If the pilots had understood the change in the wind direction and had had the possibility of checking the new direction on the wind limit diagram, they would have found that the crosswind component now exceeded the recommended value for landing with the prevailing runway braking coefficient. But even if the pilots had perceived the message, it would hardly have been possible for them to accomplish that check at this late phase of the landing. With the thought in mind that the pilots were aware that the landing conditions were difficult, they should have requested

When faced with marginal landing conditions, generally pilots should well prior to the approach, when necessary, request complementary weather and runway information, determine and mentally prepare themselves for the valid limiting values. By doing so, a decision to abandon an approach shortly before landing in the event of the deterioration of one or more landing parameters could be accomplished quicker and safer. SHK is furthermore of the opinion that the wind limit diagram in use should be able to be made clearer and easier to use.
