Contaminated air, Incident onboard aircraft SE-DRE during flight between Stockholm and Malmö, M county, Sweden, on 12 November 1999

Report RL 2001:41e

***Incident onboard aircraft SE-DRE
during flight between Stockholm and Malmö,
M county, Sweden, on 12 November 1999***

Case L-102/99

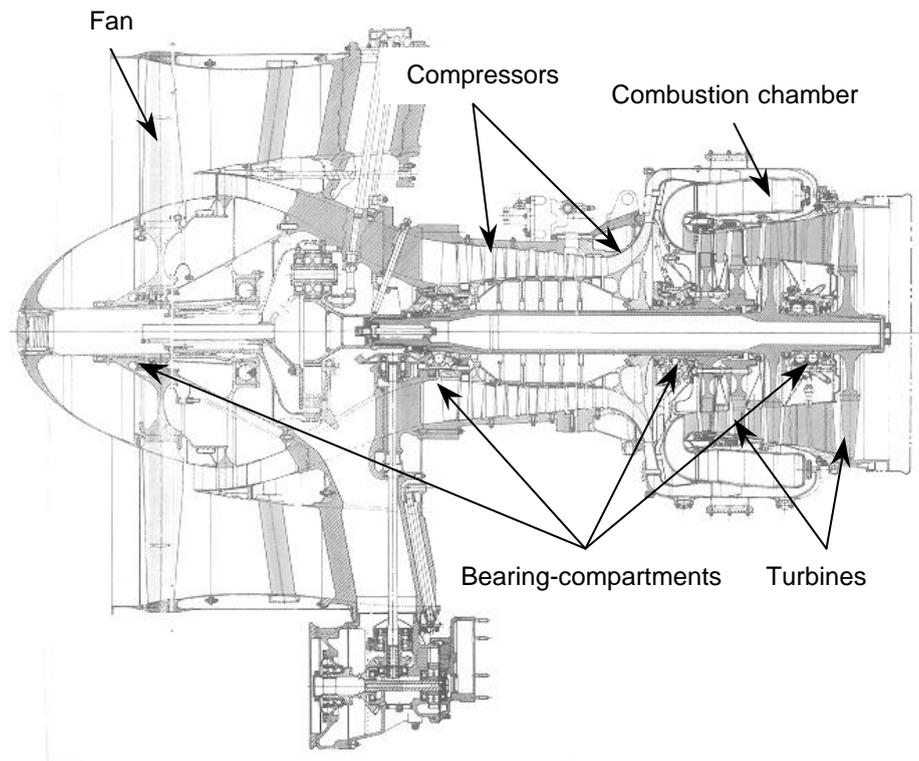
Engine schematic

This engine type does not have so-called knife-edge seals to back up the carbon seals at the number one bearing compartment (inlet to high-pressure axial compressor). Knife edge seals are found in many engine types and are a non contact method of maintaining the desired pressure distribution within an engine, one function of which is to reduce oil and oil mist entering the gas flow.

- The air extraction takes place unusually far back on the engine. The drawing off takes place directly from the combustion case shroud that is mounted aft of the compressors. As depicted in the figures in section 1.6.2 the combustion chamber is situated in the combustion case. Inside the combustion chamber the temperature can reach up to approximately 850 °C.
- The seals for the engine bearing compartments do not all have knife-edge seals that are supposed to take care of the possible oil that normally can leak out in small amounts from oil lubricated carbon-seals after a certain time of operation.

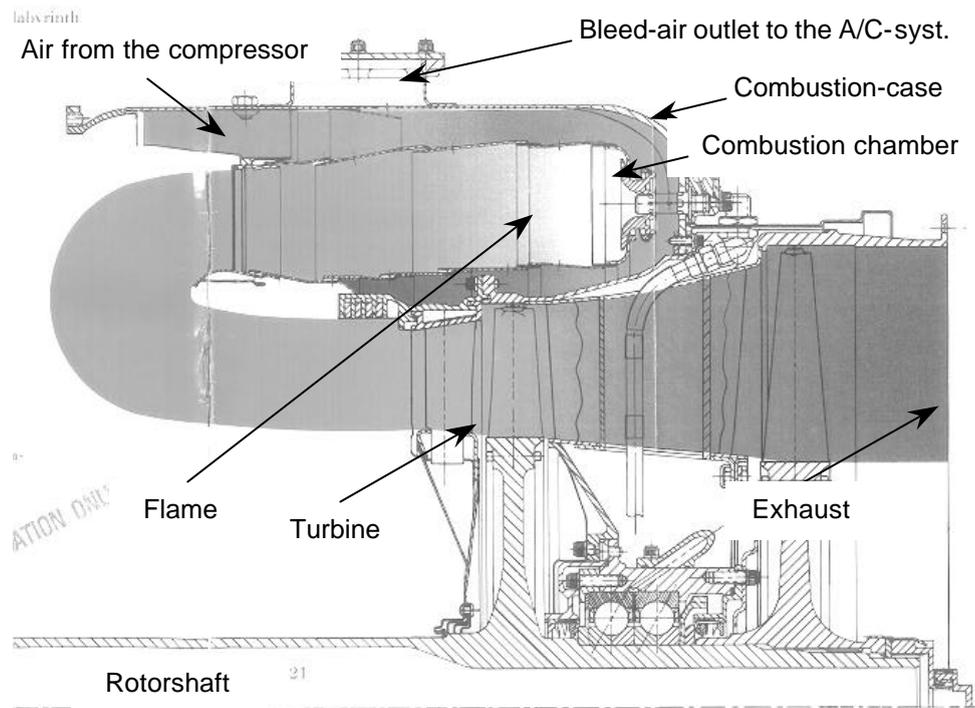
Burner section

The engine has bleed air valves partly for deicing, partly for the aircraft's air-conditioning system. The bleed air for the air-conditioning system takes place via a ring-formed duct in the outer shroud of the combustion case abreast of the engine's combustion chamber. The outlet is placed on the upper portion of the combustion case shroud. Depending upon the thrust setting of the engine, the temperature of the engine bleed air varies between 100 °C and 400 °C. On most modern jet engines, the bleed air outlet is located farther forward on the engine, i.e. somewhere on the compressor section of the gas generator.

The combustion case and the combustion chamber are designed so that air that is bled off to the air-conditioning system shall not be able to contain any combustion gases or air that has been in contact with hot surfaces in the combustion case. In the engine that the SHK has investigated no physical fault was found in the combustion case that could indicate that this had taken place.

Even if such a fault was not found in the engine, SHK nevertheless considers that a momentary ingestion of oil-mist or overheated oil-product into the aircraft's air-conditioning system might have been a contributing factor to the problem. This because oil-leak is possible and the bleed-air outlet is located very close to the combustion chamber.

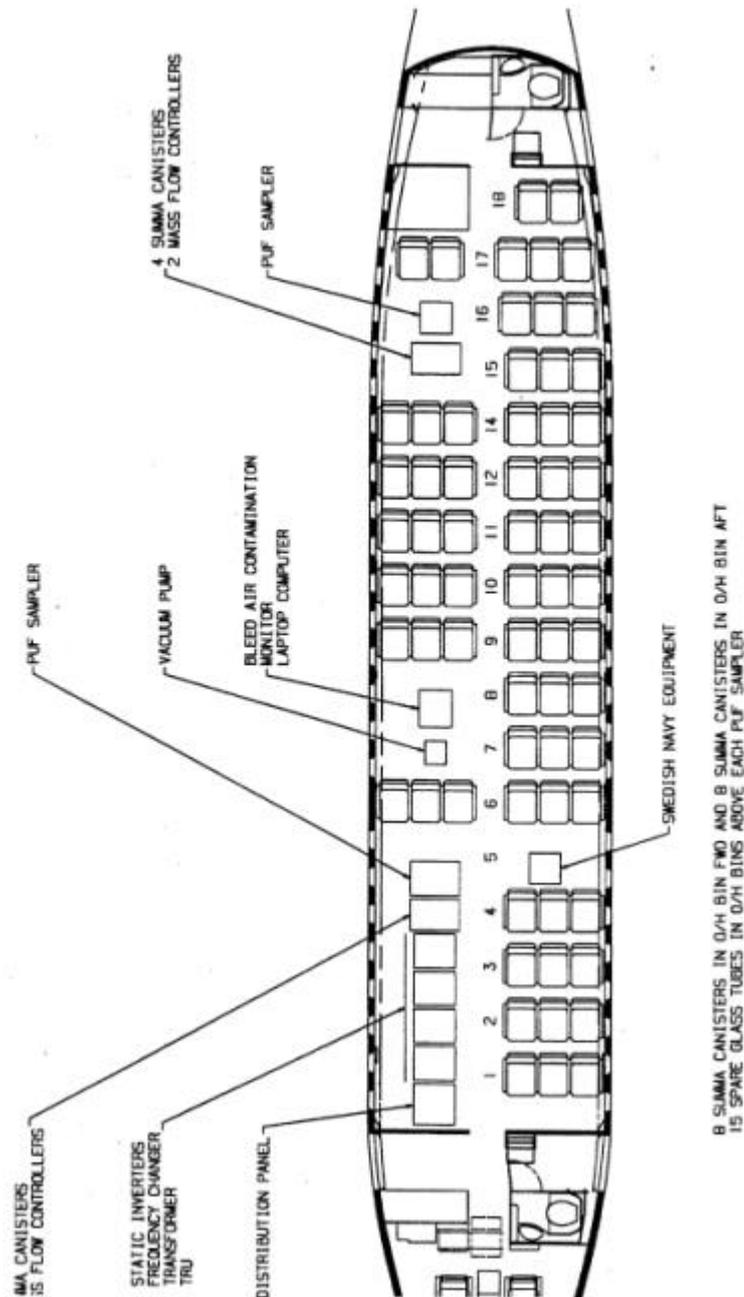
Installation of measuring equipment in the aircraft

The results showed that the concentrations of carbon dioxide, carbon monoxide, hydrocarbons, oil degradation products (such as formaldehyde) and ozone were within the stipulated and generally accepted limits respectively. The concentrations of aldehydes, semi-volatile gaseous substances, and volatile organic substances were consistently low. There are no limits established by the FAA or the JAA⁹ for these substances. A review of "the ventilation equipment's various settings" did not show any noticeable changes in the results of the cabin air analysis whether it was ventilated with fresh air or if the cabin air was re-circulated.
