Accident with aircraft SE-LIR at the Gällivare airport, BD County, Sweden, on 10 November 2000

Report RL 2001: 18e

***Accident with aircraft SE-LIR
at the Gällivare airport, BD County,
Sweden, on 10 November 2000***

Case L-113/00

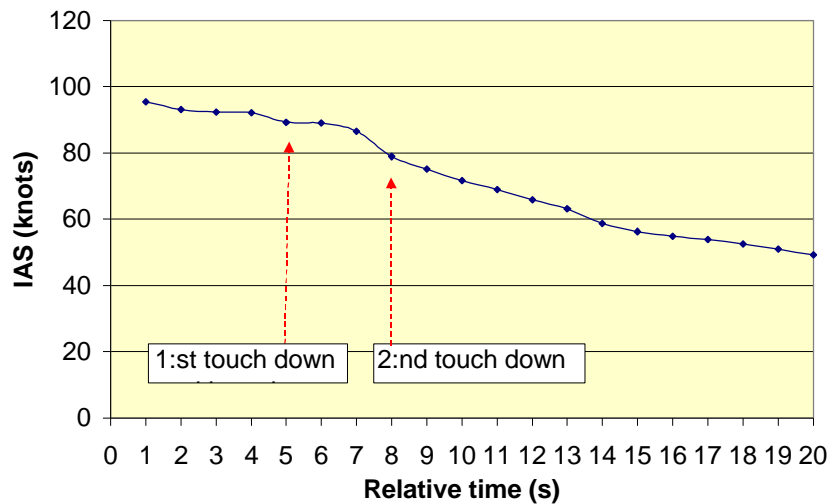
In the diagram below the relationship between indicated air speed (IAS) during the landing and the time in seconds from the first recorded data can be seen.
