## Incident involving aircraft SE-LIP in the airspace between Jönköping and Linköping, Sweden on the 22nd of December 2000

## **Report RL 2001: 22e**

***Incident involving aircraft SE-LIP  
in the airspace between Jönköping  
and Linköping, Sweden on the 22<sup>nd</sup> of  
December 2000***

**Case L-001/01**

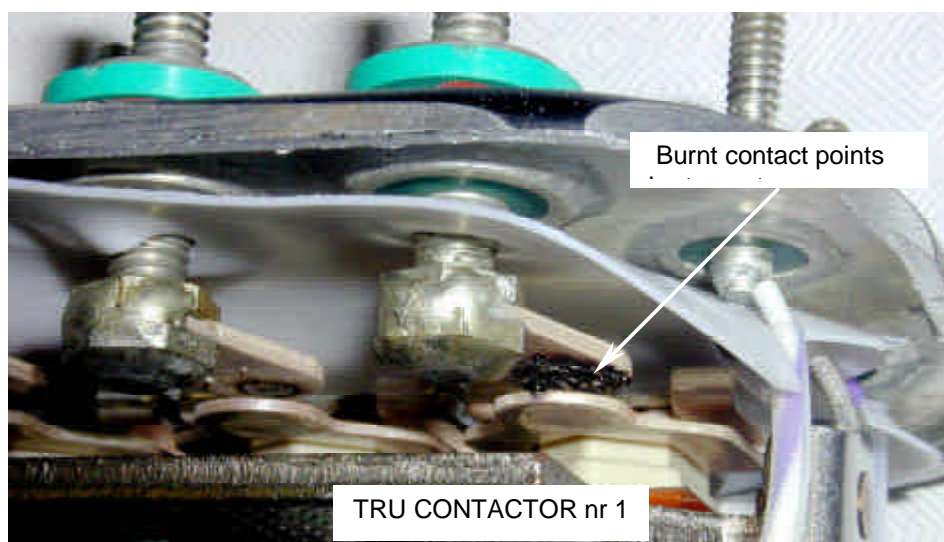
At the time of the functional test of TRU-CONTACTOR no. 1, the contact for one of the phases in the closed position was found to be sporadic. The unit was opened and it was found that the breaker points of the actual phase were substantially burnt. The consequences of this malfunction was that the subsequent component in the system, TRU no. 1, periodically was fed with only two-phase current (2 x 115/200V, 400Hz).

Tests have been performed by feeding a TRU with only two phases to ascertain what the effects of this are on the TRU's downstream direct current. During the investigation it was found that the voltage decreased and the direct current's so called ripple<sup>5</sup> increased with a factor of ten in relation to approved limits.

With the exception of breaker point malfunction, which was located in the left low-voltage system's TRU CONTACTOR, no malfunction has been found in the components that have been examined. The breaker point malfunction can not have caused the smoke or the burnt odor that the pilots experienced since the failure was isolated in a sealed box.

As is evident from section 1.16.2, the malfunction did however possibly cause the output DC-power from the system's TRU to temporarily become too low and instable. The DC-power system provides electrical power to a

Subsequent to these two identical malfunctions, the airline has introduced an operational time limit of 5,000 flight hours for TRU CONTACTORs in these locations. (The same type of relay is also placed at other locations in the aircraft's electrical system, but these have a lesser electrical load.)
