Fire and smoke, Incident involving aircraft SE-DUP in the airspace above Jönköping, F county, Sweden, on 2 February 2001

Report RL 2001:42e

***Incident involving aircraft SE-DUP in
the airspace above Jönköping, F county,
Sweden, on 2 February 2001***

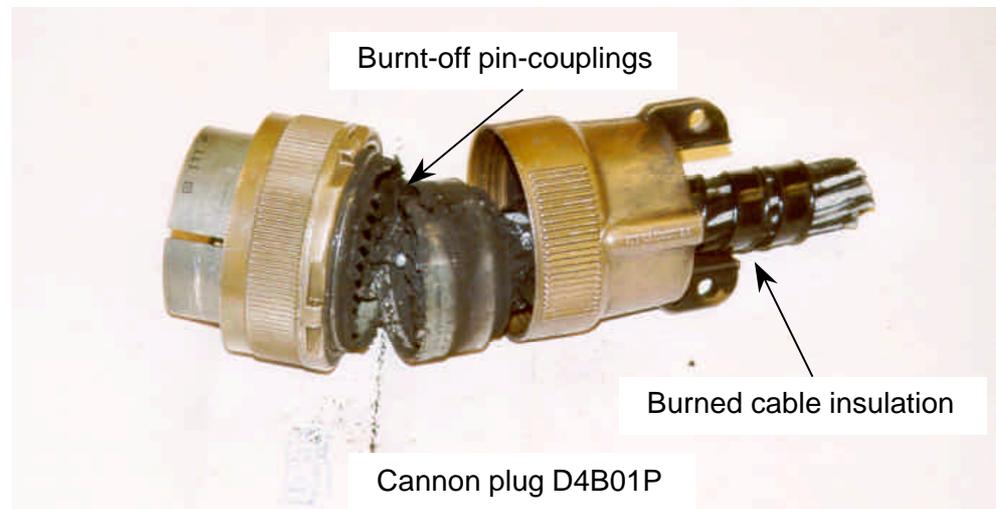
The burned cannon plug has been examined at a technical materials laboratory. The investigation showed that all but one of the electrical conductors within the connector were burned-off adjacent to the pin-clamp couplings. The internal area was completely burned-out and the heat generation had been so high that the copper in the electrical cables had melted.

No manufacturing defect of the cannon plug that could explain the flash-over has been identified. The technical investigation of the cannon plug showed however that internal overheating had taken place in the connector over an extended period of time. The rubber material between the contact pins in the male portion had “aged” so that its insulating ability had been impaired.

All the evidence therefore indicates that the electrical short was initiated by a flash-over between two contact pins. The electrical arc and heat that was hereby generated caused further shorting between other contact pins in the cannon plug. Finally an electrical arc was produced that short circuited all the electrified pins simultaneously, thereby creating an explosion and local fire within the cannon plug, resulting in the smoke generation.

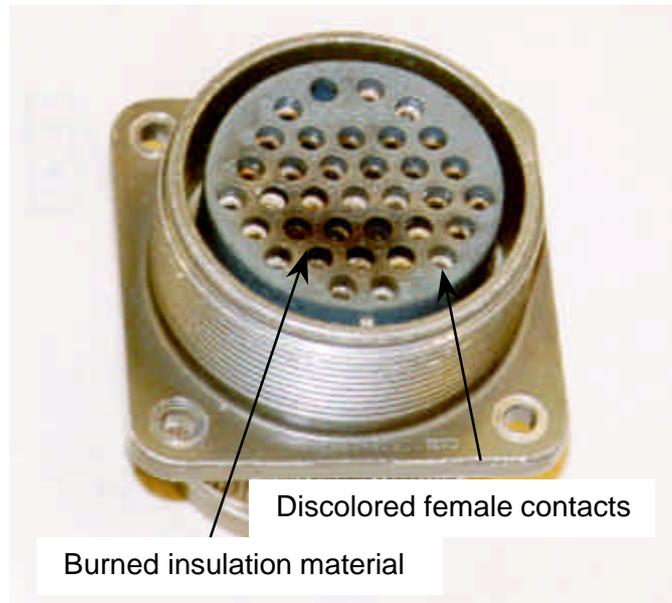
The investigation also showed that several of the contact pins were discolored due to the overheating and that the insulating material between the pins in the cannon plug had been affected by high temperature and had also been discolored. This all points to the fact that the source of heat generation was not external in connection with the fire but took place within the electrical pin couplings during an extended period of time.

This occurrence and the previous incidents that took place involving the overheating and fire in the same type cannon plug indicate that the cannon plug was under dimensioned. The design of the cannon plug was such that the cooling ability of the surrounding air was not sufficient to dissipate the heat that was generated on the surface of the conductor pins when all ovens and water boilers were turned on to full rated effect.

The final modification that the manufacturer has introduced with regards to the cannon plug, and that has obviously solved the problem, entails larger contact surfaces and better cooling. As this modification is obligatory, SHK finds no reason to issue any recommendation.

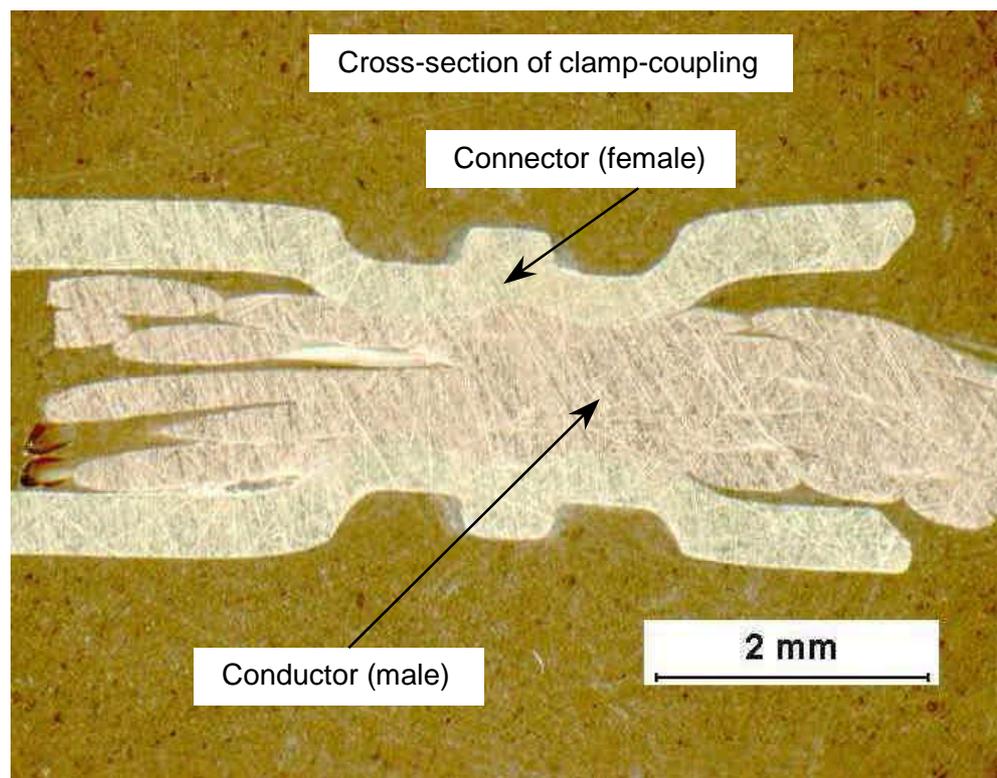
Metallurgical examination of the burned pin-clamp couplings indicates that they were manufactured correctly and that there was no presence of contamination on the contact surfaces.
