## **Smell of burning plastic, Incident involving aircraft SE-KUT in the airspace above Umeå, AC County, Sweden, on the 6th of March 2001**

## **Report RL 2002:05e**

***Incident involving aircraft SE-KUT  
in the airspace above Umeå, AC County,  
Sweden, on the 6<sup>th</sup> of March 2001***

**Case L-009/01**

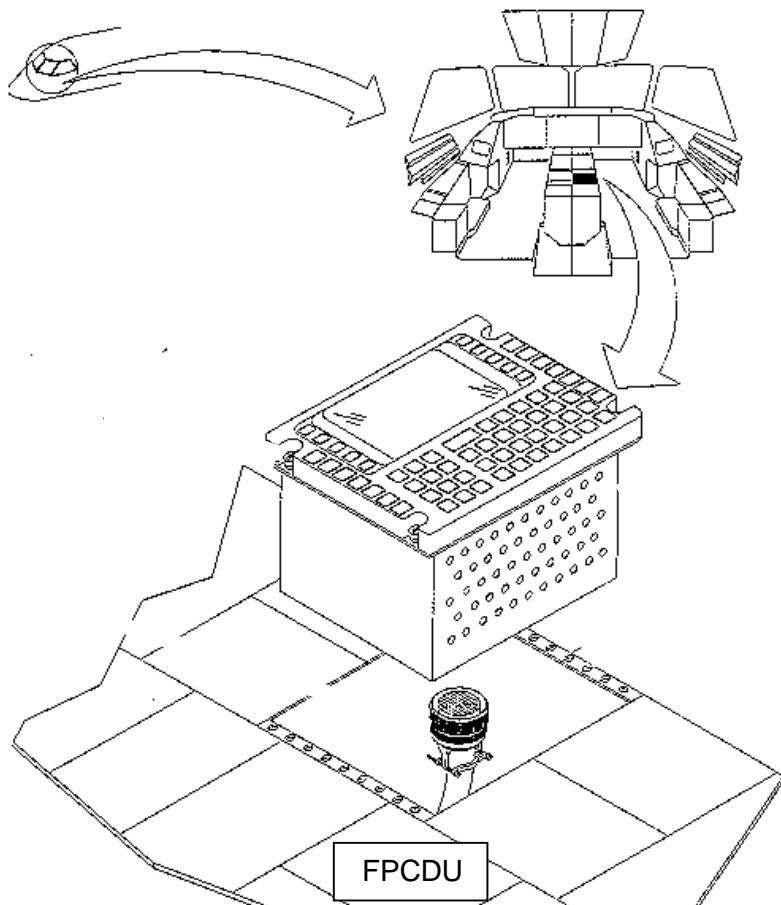
However, later the burnt smell was localized to a control unit called the FPCDU<sup>4</sup>, which is installed in the center console placed between the pilot seats. The FPCDU is an electronic control unit for a number of the aircraft systems. The unit was replaced and sent to the manufacturer, Universal Avionics, for trouble shooting. Subsequent to this replacement no burnt odor was experienced and the aircraft was returned to service.

As is evident from section 1.16, a type-related fault existed within the control unit (FPCDU) at the time of the incident, which could cause the odor of a fire. After this unit was exchanged no smell of fire has been evident in the aircraft. This therefore confirms that the odor of fire was caused by a failure within the FPCDU in the aircraft. In view of the fact that the problem has been attended by the manufacturer and measures have been taken in order to overcome the problem, SHK sees no occasion to issue any recommendation.

The incident was caused by overheated electronics in the control unit FPCDU.

On the 11th of June 2001 Universal Avionics issued a non-compulsory Service Bulletin on the FPCDU (SB No 1117.XX-34-2698) that recommends retrofit of the unit with a latter version (Model 8). The stated intention with this is to diminish the risk of a component failure within the unit.

On the 29th of June 2001 Universal Avionics issued a compulsory ("Alert") Service Bulletin on the FPCDU (SB No 1117.XX-34-2699) that prescribes specified periodical functional testing of the unit. The stated intention is preemptive identification of a possible component failure in the unit which can result in the ("--- odor characteristic of hot electrical equipment").

The measure is also prescribed in the aircraft manufacturer's SAAB 340 Service Newsletter No SN 340-0112, issued on the 31 st of December 2001.
