Near-miss, Infraction of minimum separation between the aircraft SE-KOL and SE-ISV at Stockholm/Arlanda airport, AB County, Sweden, on 28 November 2001

Report RL 2002:11e

*Infraction of minimum separation
between the aircraft SE-KOL and SE-ISV
at Stockholm/Arlanda airport, AB County,
Sweden, on 28 November 2001*

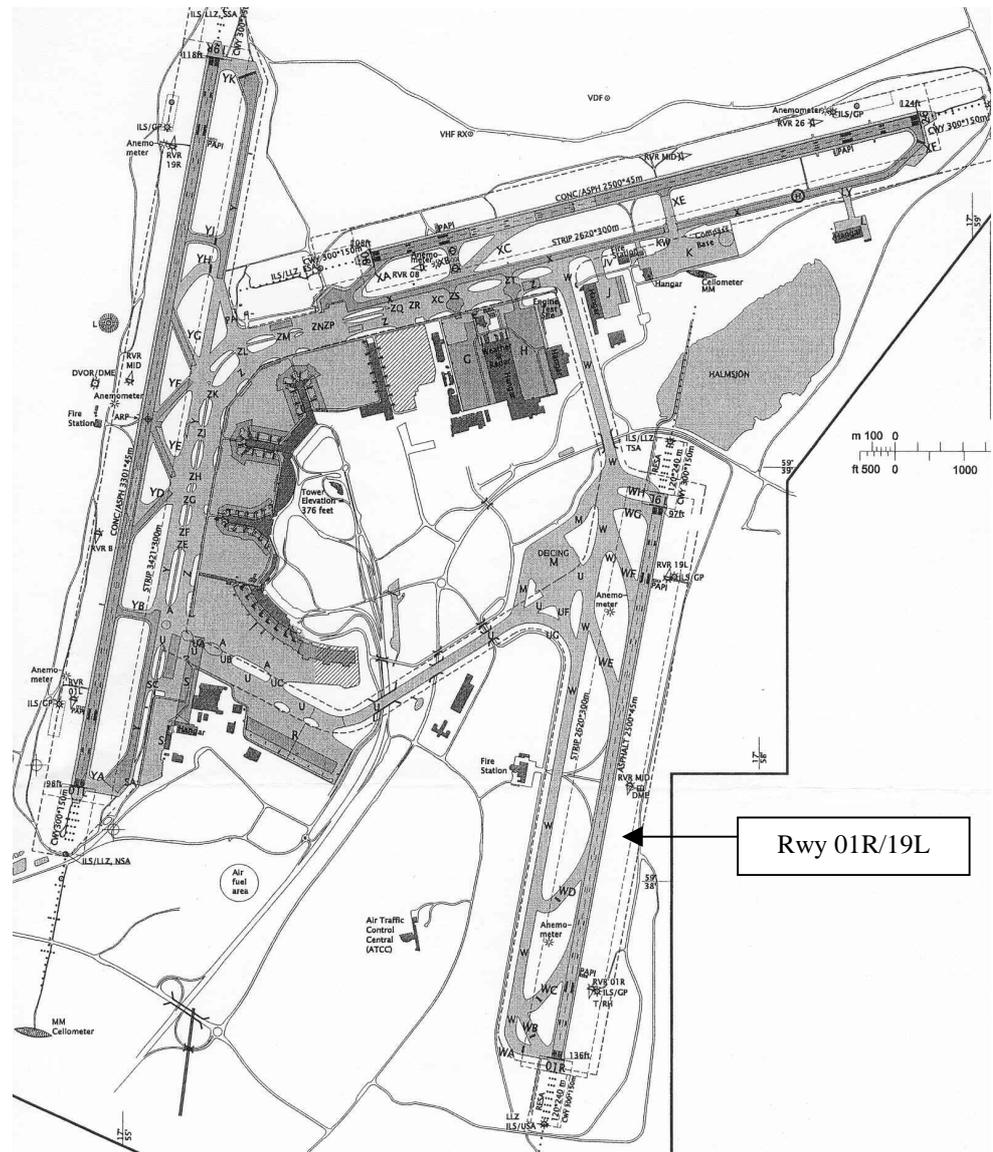
1.10 Aerodrome information

At the time of the occurrence Stockholm/Arlanda airport was for scheduled traffic using runway 08 for departures and runway 19R for arrivals. Air traffic was then still controlled from the old low tower.

On and around the new third runway construction work was still in progress and therefore the runway and its taxiways were not within the airport's maneuvering area. At a controlled airport the maneuvering area normally consists of runways and taxiways. However aircraft parking stands and similar surfaces normally are not included in the maneuvering area.

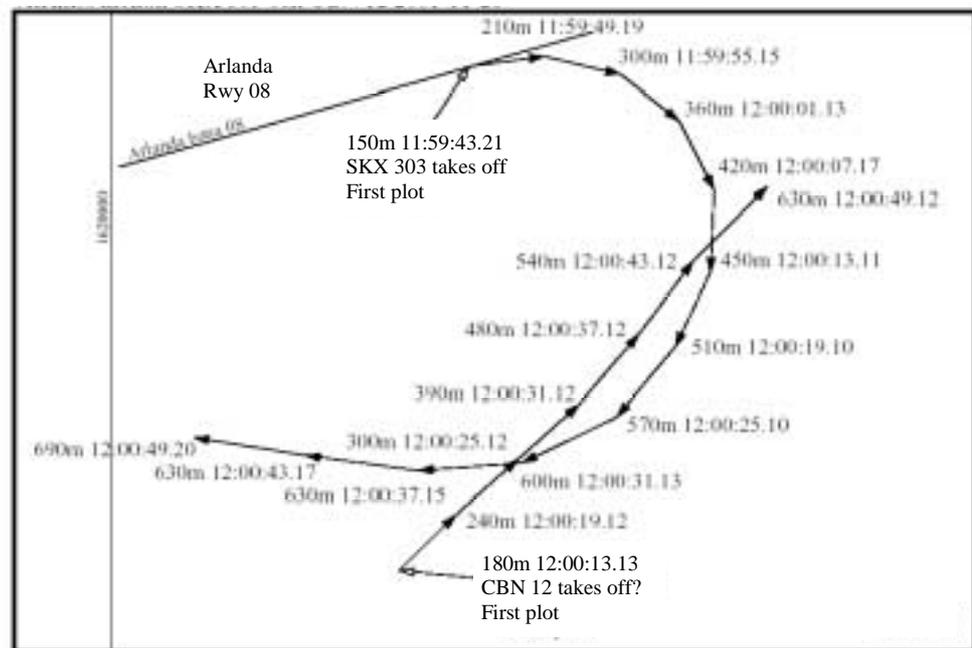
Airmiss between SKX 303 and CBN 12, 2001-11-28

Through analysis of the radar data from Arlanda's MSSR⁸ radar, the following relative positions/correlations have been ascertained.

<i>Time</i>	<i>Event</i>	<i>Alt. SKX303</i>	<i>Alt. CBN12</i>	<i>relative range</i>
11.59.45	SKX303 is initially observed on radar	500 feet	–	–
11.59.56	SKX303 is observed to initiate right turn	1,000 feet	–	–
12.00.14	CBN12 is initially observed on radar	1,500 feet	600 feet	1.28 nm
12.00.19		1,700 feet	800 feet	0.83 nm
12.00.26		1,900 feet	1,000 feet	0.33 nm
12.00.32	The aircraft have passed each other	2,000 feet	1,300 feet	0.23 nm
12.00.38		2,100 feet	1,600 feet	0.77 nm

According to the radar information that exists and the fact that the pilots in CBN had visual contact with the on-coming aircraft, there was no risk of a collision. The aircraft were closest to each other at time 12:00:32, horizontally at a distance of 0.23 nm (425 meters) and with a vertical separation of 700 feet (213 meters). Nevertheless it was a very unpleasant experience for the air traffic controller, who did not have visual contact with the aircraft from the position she was in, but only observed the radar echoes overlap on the radar screen.

- i) A violation of minimum separation ensued between aircraft CBN and SKX 303. The closest they came to each other was 0.23 nm (425 meters) with a vertical separation of 700 feet (213 meters).
