Runway overrun, Incident involving aircraft G-FLTA at Arvidsjaur airport, BD County, Sweden, on the 22nd of February 2002

Micro-summary: Following touchdown in poor weather, this BAe 146 ran off the end of the runway.

Report RL 2003:08e

***Incident involving aircraft G-FLTA at
Arvidsjaur airport, BD County, Sweden,
on the 22nd of February 2002***

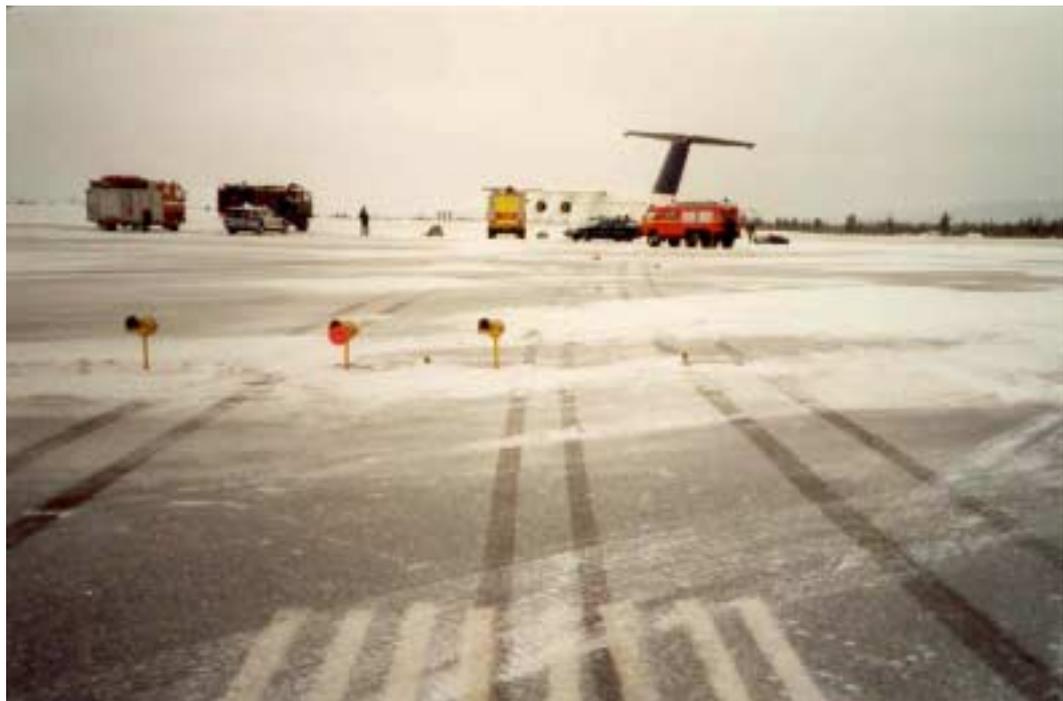
During the test runs, the presence of ice patches on the runway was noted. The majority of these were located near the runway centerline in section A. The picture below was taken from the runway end shortly after the incident.

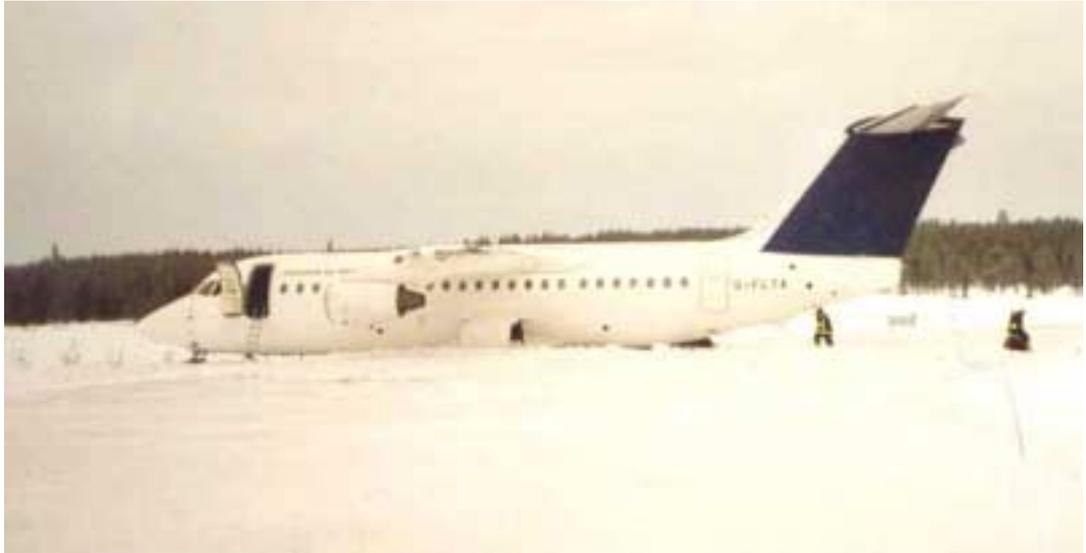
The touchdown point of the aircraft, determined by the ground personnel, was 475 meters down runway 30 from the runway threshold. The aircraft collided with a runway 12 threshold light and thereafter continued out onto a level snow-covered surface along the extended centerline of the runway, where it came to a stop in an approximately 50 centimeter deep snow bank, 83 meters from the runway (12) threshold, measured from the main landing gear.

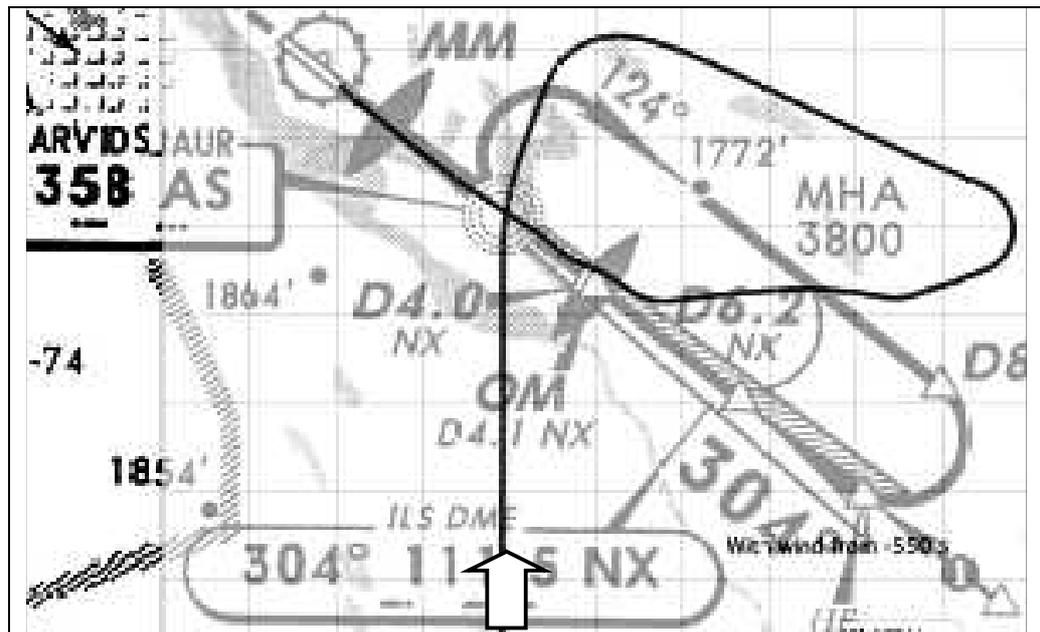
Based on FDR data and estimated winds in the area, an approximate approach path has been compiled and superimposed on the actual instrument approach chart shown below.

Instead of as he had planned, turning east and subsequently joining the ILS straight-in to runway 30 after a left turn, he was now suddenly forced to rethink and instead perform a full procedure turn approach via the initial approach beacon "AS". This caused the later portion of the approach to become forced, which possibly contributed to the fact that the pilot did not correct sufficiently for the strong crosswind, with the result that the approach path deviated considerably from the prescribed procedure.
