Near-miss with tractor, Incident involving aircraft LN-RPL and a tow tractor at Stockholm/Arlanda airport, AB County, Sweden, on the 27th of October 2002

Report RL 2003:47e

***Incident involving aircraft LN-RPL
and a tow tractor at Stockholm/
Arlanda airport, AB County, Sweden,
on the 27th of October 2002***

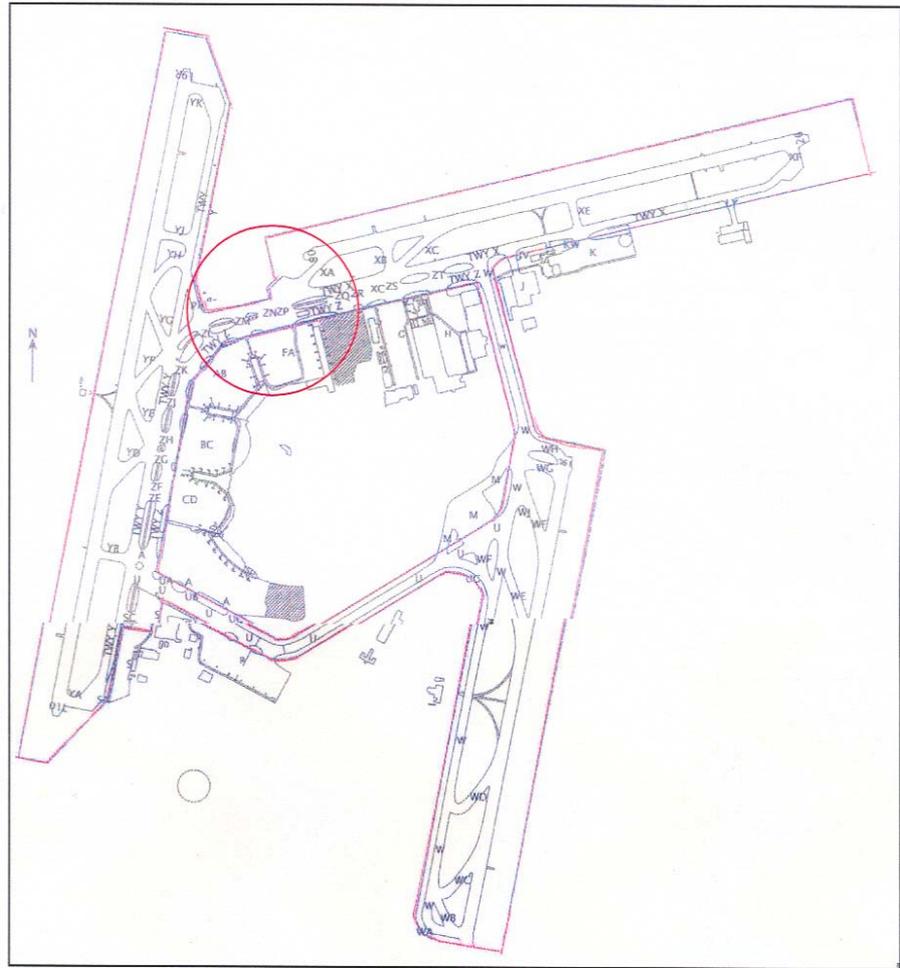
The layout and equipment of the airport is depicted in the AIP Sweden. Below (next page) is a survey map of the entire airport with the area of the incident circled.

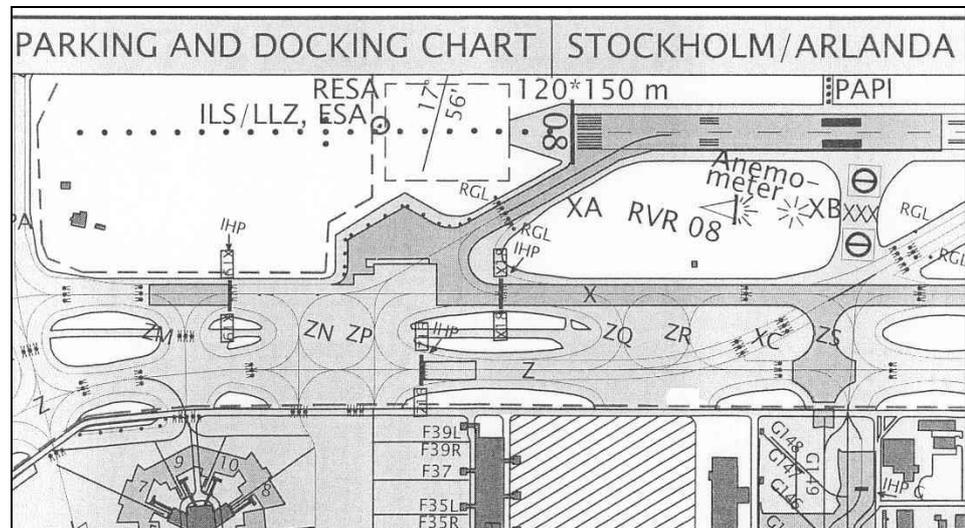
1.12.1 AIP Sweden

Shown below is the area of the airport in question according to the AIP Sweden dated 15 July 2002, which was applicable at the time. All depicted taxiways have centerline lighting. The areas between taxiways X and Z that are depicted on the chart as white fields consist of grass surfaces.

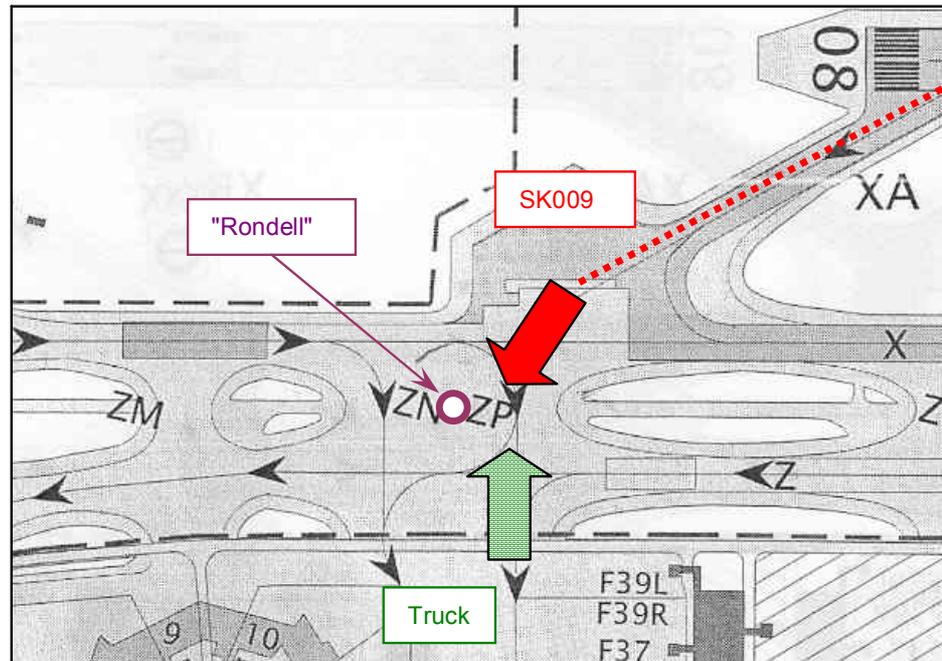
1.12.2 Location of the incident

The incident occurred at ZP. Between ZP and ZN there is a "roundabout", which was marked with colored stakes at the time. The "roundabout" was not depicted in the AIP. The taxiways around the roundabout" have concentrated centerline lighting. According to the airport personnel, the lighting was on at the time on all of the taxiways in the area. On the chart depicted below from the AIP/ARRIVAL, the "roundabout" has been drawn in as a circle. The approximate positions of the aircraft and the tow tractor at the time of the incident have been marked with arrows.

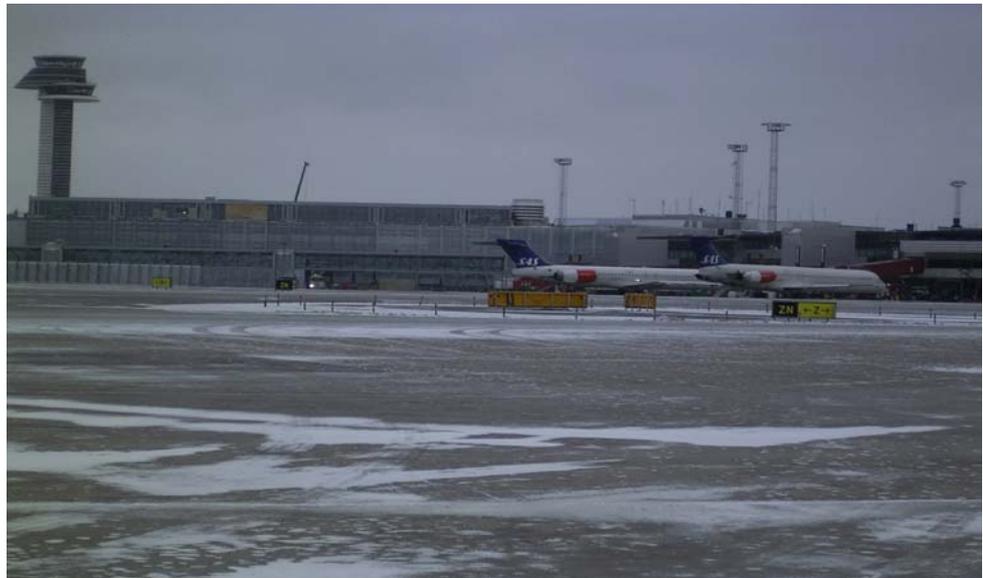
The "roundabout" consists of a circle with a diameter of approximately 20 meters that is painted onto the asphalt surface between ZN and ZP. There are three illuminated information signs within the circle. One of these, with the appearance depicted below, is facing north and is readable from XA. This is a combination type sign, where the letters "ZN" are supposed to show that the aircraft is on a specific taxiway as viewed from the left-hand pilot position (pilot in command) and the symbol "<- Z ->" is intended to show directions to taxiway Z, behind the sign.

The photo below shows the "roundabout", as seen from XA, a few months after the incident.

Taking into consideration how the "roundabout" appeared from the viewpoint of the pilots (see chart and picture in 1.13.2-3), it is understandable that they mistook it for the grass area that is situated immediately to the right of ZN in the direction of travel.

Even the combination sign that the pilots observed within the "roundabout" lends itself to misinterpretation.

It is true that the sign is situated to the left of ZN, according to the instructions in BCL-F 2.2. However, because the letters "ZN" on the sign itself are placed to the left of the symbol " $\leftarrow Z \rightarrow$ ", it may be very likely to interpret the sign as indicating that ZN lies to the left of the sign and also on the left side of the "roundabout", which in this case is erroneous. Even the symbol " $\leftarrow Z \rightarrow$ " can be considered to be ambiguous, as taxi way Z, which lies behind the sign is a "one-way" taxiway to the right from the viewpoint of the observer.

The Swedish Civil Aviation Administration is recommended to revise the present regulations concerning the design of taxi charts in the Swedish AIP and that of information signs, with respect to the risk of misinterpretation (*RL 2003:47e R1*).

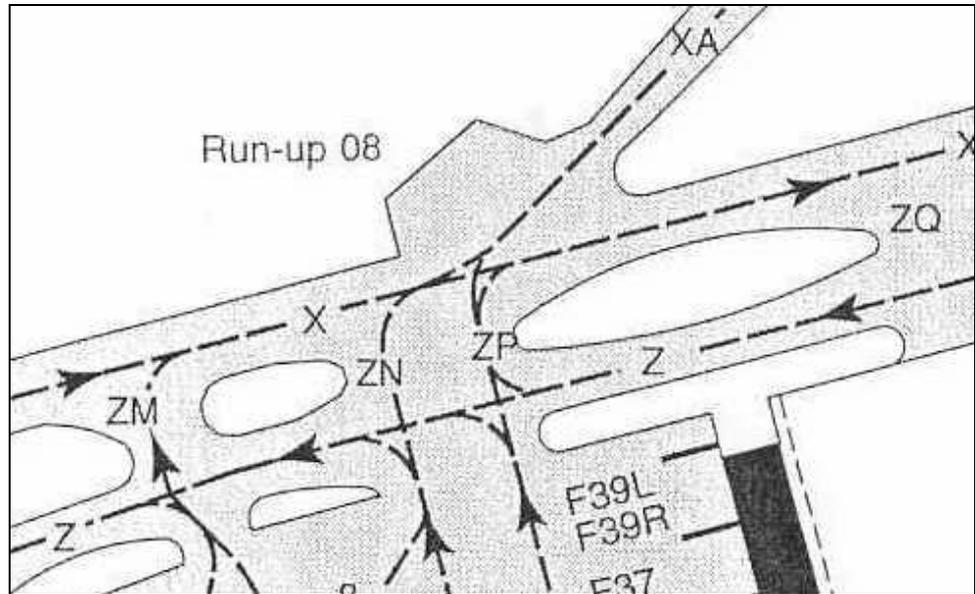
SAS Route Manual

On the taxi chart in the SAS Route Manual, which the pilots used during the taxiing, the "roundabout" between ZN and ZP was not depicted (see below). The chart was based on the AIP dated 15 July 2002. According to re-

ports from the Swedish Civil Aviation Administration, the AIP chart had been unchanged since the 23rd of December 2001.

The pilots have stated that they believed that the area between ZN and ZP consisted of an open surface without any "island" in between. Subsequent to the incident the "roundabout" (island) has been drawn-in in both the AIP and the SAS Route Manual.
