## Near ground collision, Incident involving aircraft HB-JAY and SE-ISR at Stockholm/Arlanda airport, AB County, Sweden, on the 16th of December 2002

## **Report RL 2003:32e**

***Incident involving aircraft HB-JAY  
and SE-ISR at Stockholm/Arlanda  
airport, AB County, Sweden, on the  
16<sup>th</sup> of December 2002***

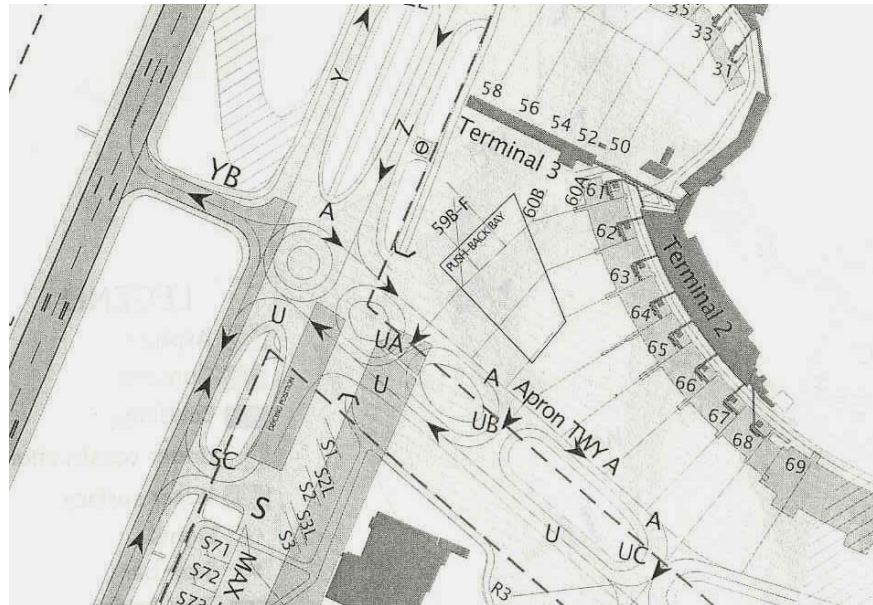
During this time the aircraft SE-ISR, with flight number SKX 300, landed on runway 01L. After landing the aircraft left the runway via exit YD. When the pilots contacted GND for taxi directions they received the instructions "*Express 300, morning, taxi to Sierra 75 hold before Alfa*". This clearance was acknowledged. They continued taxiing via taxiway ZH and Z southbound towards the S 75 parking stand. While taxiing the pilot in command requested that the first officer shutdown the left-hand engine. As the aircraft approached terminal 3, initially the pilot in command did not observe LX 1223, due to an aircraft, which was parked on stand 59. However he did see an aircraft that taxied out from the ramp situated behind the terminal. He also observed that a so-called marshaling vehicle had been pre-positioned and was waiting for them beyond taxiway A, according to the normal routine (See depiction below).

Out-taxiing from Terminal 2 shall, according to the AIP<sup>3</sup>, take place via taxiway U (see below). In order to shorten the taxi distance for departures from the northern portion of the airport, it is customary that crews request to taxi out via taxiway A, which is often accepted by the air traffic control. The aircraft taxiing out ahead of LX 1223 was cleared to taxi out via taxiway A without having requested this.
