Uncommanded rotation, Incident involving aircraft LN-RPL at Gothenburg/Landvetter Airport, O county, Sweden, on 7 December 2003

Report RL 2005:20e

Incident involving aircraft LN-RPL at Gothenburg/Landvetter Airport, O county, Sweden, on 7 December 2003

Case L-59/03

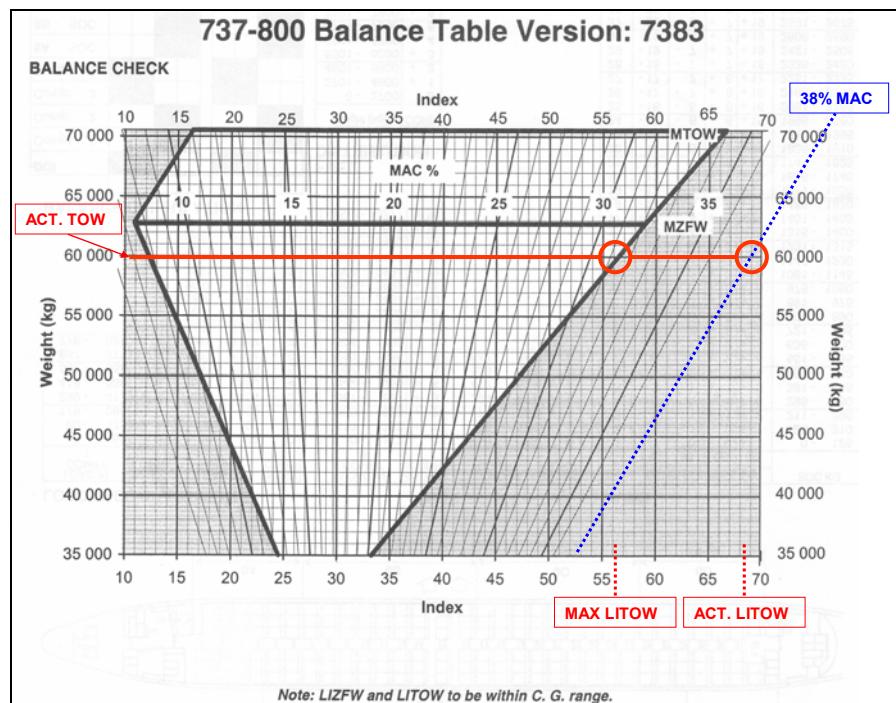
Actual start mass and centre-of-gravity position prior to takeoff from Göteborg/Landvetter Airport (LITOW⁵) is marked on the diagram below.

It can be seen from the diagram that the aircraft's centre-of-gravity-position was approx. 38 % MAC, which is approx 6.6 % MAC aft of the aft certified CG limit for the actual takeoff mass, 59 285 kg. The deviation represents more than 1/4 of the certified CG span. (See also 1.18.1.)
