Airplane exploded at gate, Aircraft Accident Report, Thai Airways International Company Limited, Boeing Company 737-400, HS-TDC

AIRCRAFT ACCIDENT REPORT

**THAI AIRWAYS INTERNATIONAL COMPANY LIMITED
BOEING COMPANY 737-400, HS-TDC**

3 MARCH B.E. 2544 (A.D. 2001)

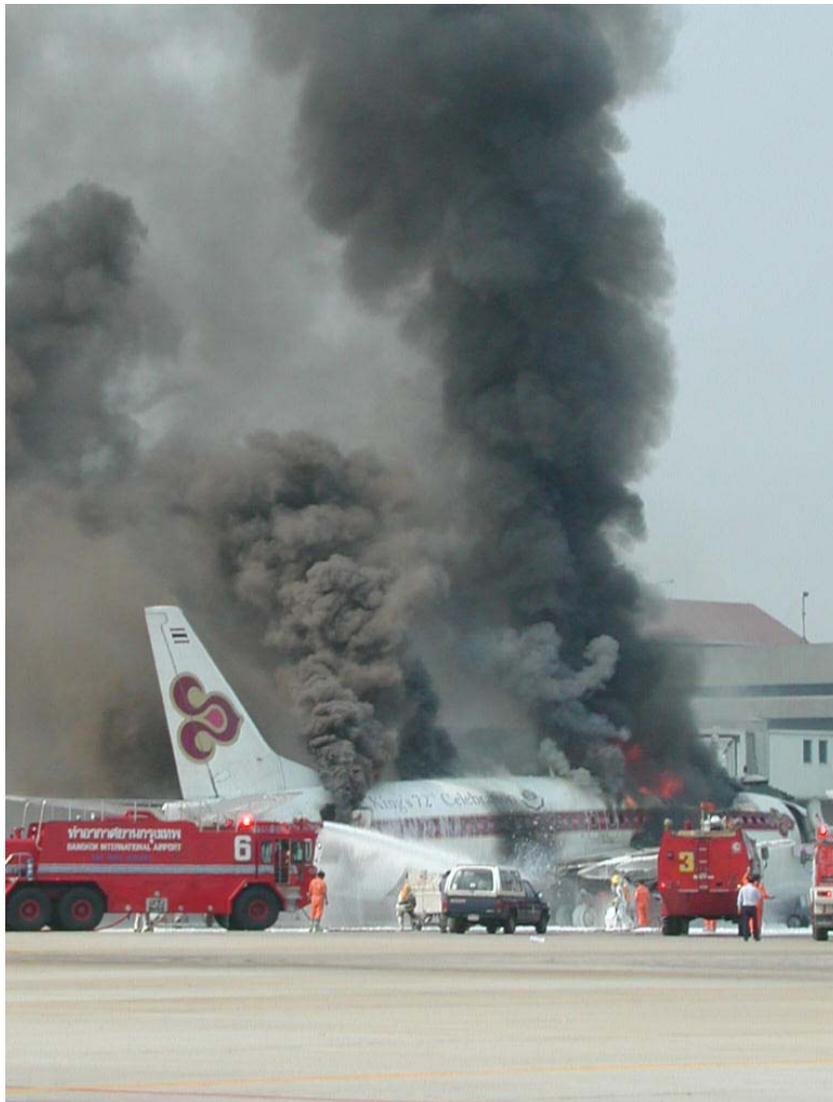
Figure 1. A Photograph taken Shortly after the Explosion

Immediately after the explosion, witnesses reported smoke in the center cabin and a fire underneath the Center Wing Tank (CWT) area. Photographs taken shortly after the explosion show a large fire beneath the airplane CWT and black and tan smoke coming from the left side forward and aft passenger doors (**See Figure 1**). Approximately 18 minutes after the initial explosion, a second explosion occurred in the right wing fuel tank.

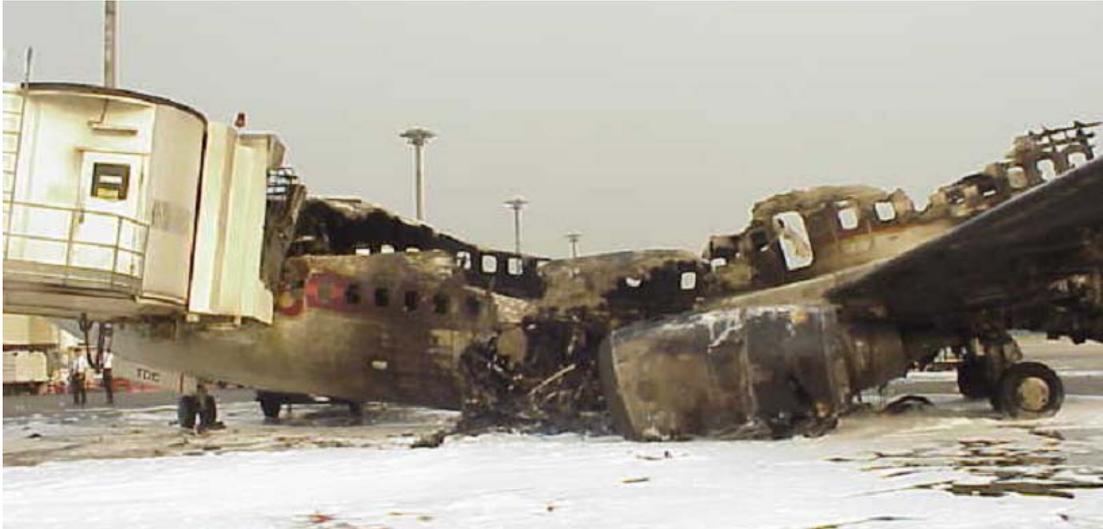
The upper fuselage crown was consumed by fire from the cockpit to aft of the wing (**See Figure 2**). The fuselage had failed both forward and aft of the wing as a result of the explosion and fire. Most of the floor structure, cabin seats, and airplane systems were consumed in the area above and several rows forward of the CWT. The majority of the right wing upper surface was missing and found essentially intact on the left side of the airplane.

Figure 2. Aircraft Wreckage

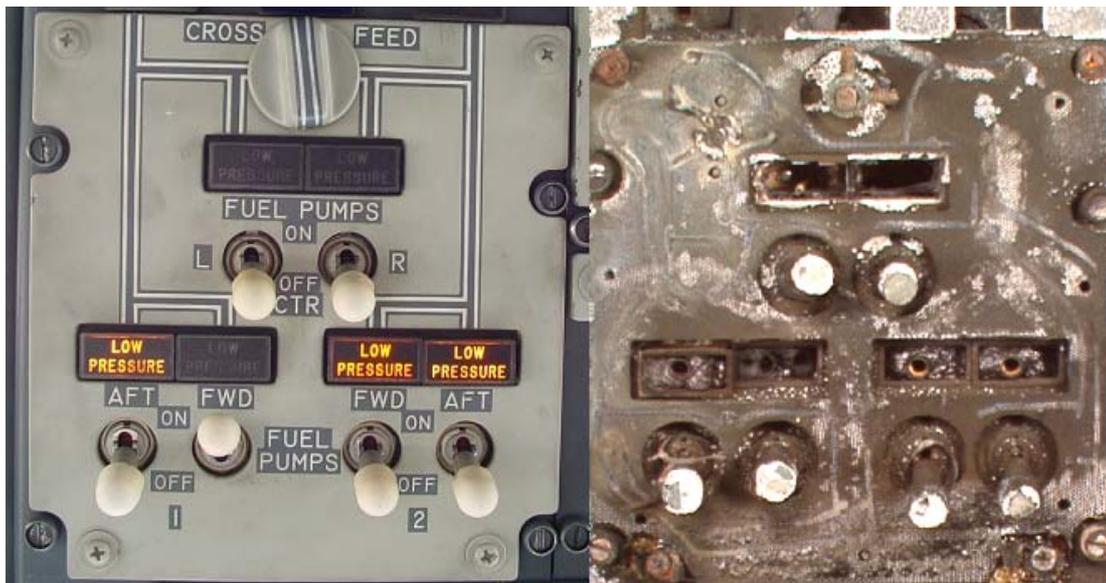
Figure 3. Cockpit Fuel Control Panel Comparison

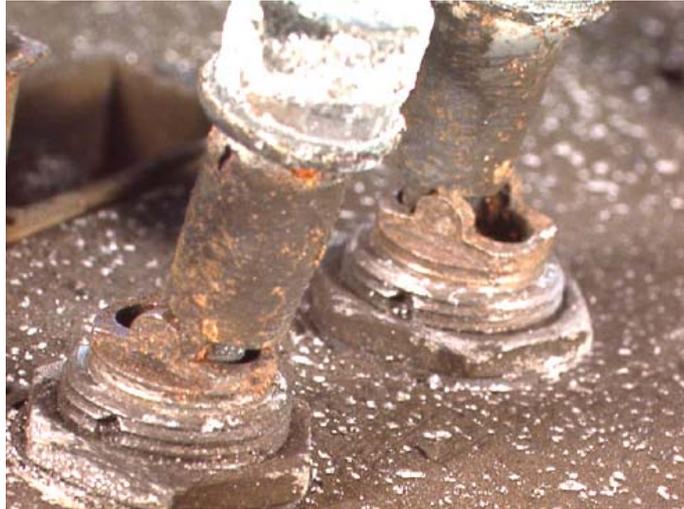
Figure 4. The Position of Toggle Switches Located on the Left of the Fuel Control Panel

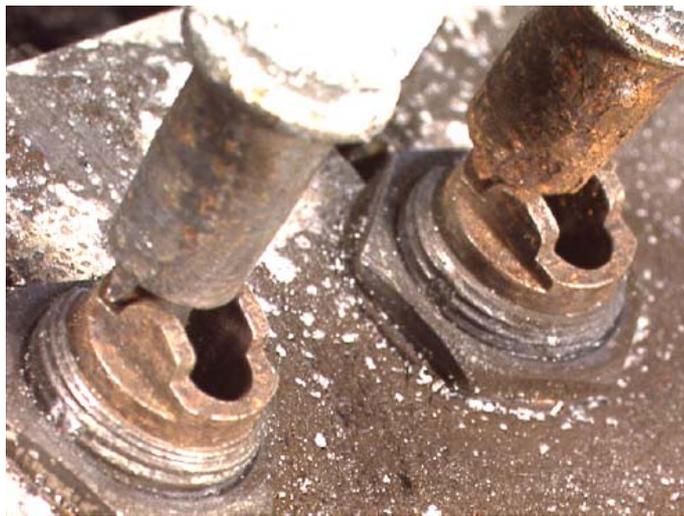
Figure 5. The Position of Toggle Switches Located at the Center of the Fuel Control Panel

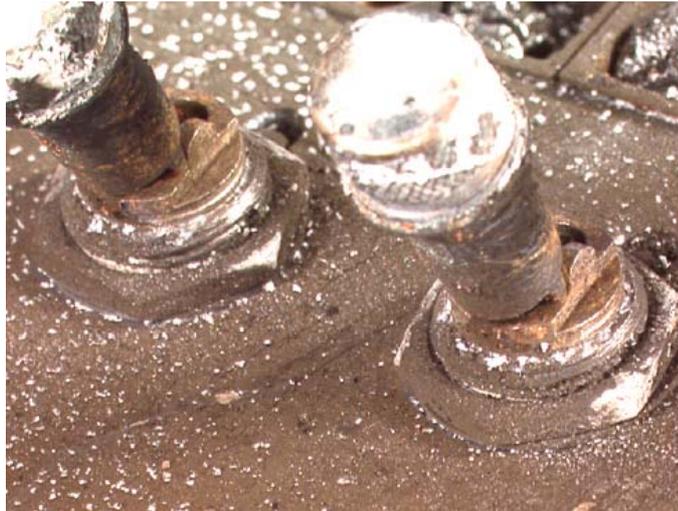
Figure 6. The Position of Toggle Switches Located on the Right of the Fuel Control Panel

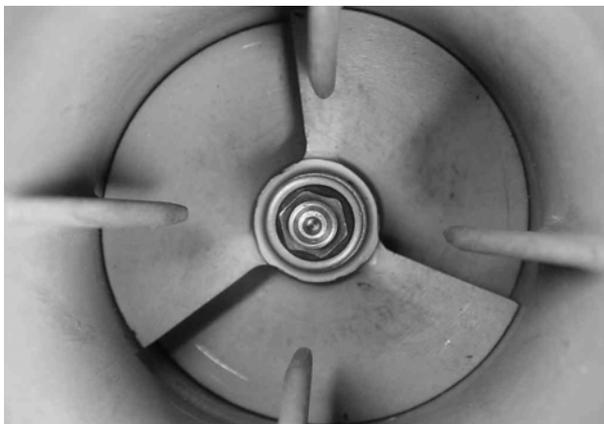
Figure 7. Scratches on Inducer Blades of the Left CWT Pump

The left CWT pump inducer had circumferential scratches on all three blades and moderate scoring was observed on the inducer-housing bore (See **Figure 7**). The impeller was galled and scratched along the entire periphery, and the bore of the housing was found scored along the area that aligned with the inducer (See **Figure 8**). The interior of the housing contained numerous metal shavings. The outer diameter of the impeller had numerous foreign metallic-like particles smeared along the circumference (See **Figure 9**).

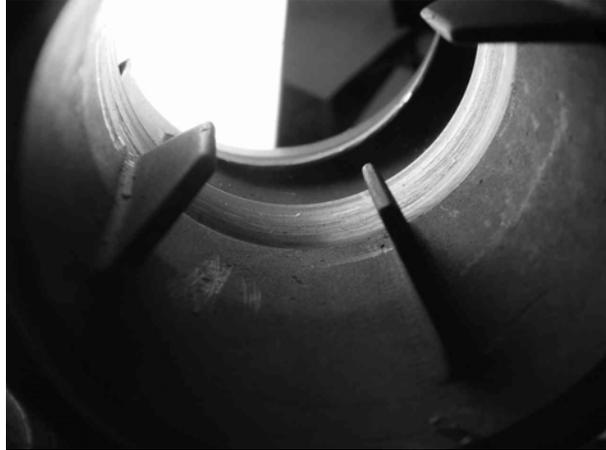
Figure 8. Galling in Aluminum Housing around Inducer and Impeller of the Left CWT Pump

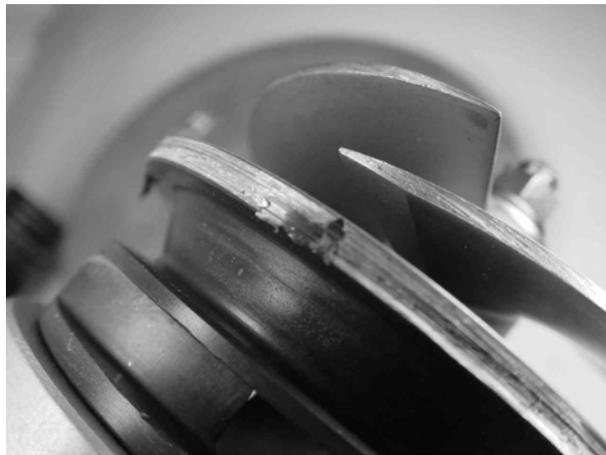
Figure 9. Scoring and Metal Adhered to Outer Diameter of the Impeller of the CWT Left Pump

Rotational scoring on the face of the CWT left pump impeller shows that at least some debris was held against the spinning impeller for an extended period. Further, the ground out condition of the housing at the impeller face suggests that the debris was captured in the impeller/housing gap until the debris was ground small enough to pass through the edge gap. As the U.S. Naval Ordnance Laboratory documented in 1957, it is possible to create an ignition by striking even non-ferrous metals. Therefore, a sparking

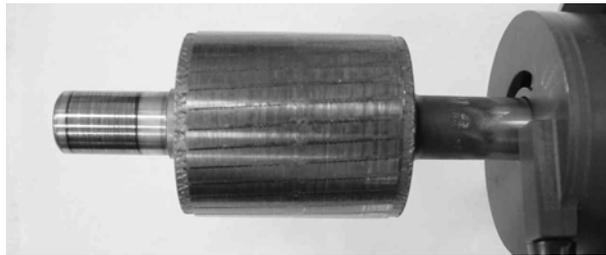
Carbon bearing material was found transferred to the rotor shaft (See **Figure 10**). The face of the aluminum housing where the impeller was contained was recessed, and a 0.054-inch gap existed between the housing and the impeller face (the normal gap between the housing and impeller face is 0.02 to 0.03 inches) (See **Figure 11**). The housing at the gap had been further opened by up to an additional 0.08 inch at the periphery of the impeller. Microscopic examination found numerous grinding and impact marks in the housing and the face of the impeller.

Figure 10. Carbon Bearing Material on Shaft

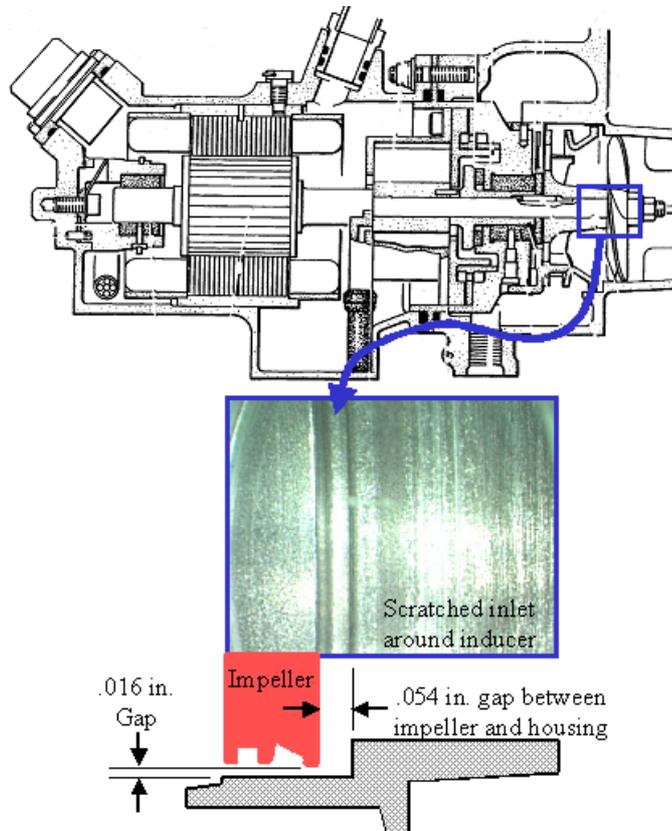
Figure 11. A Gap between Impeller and Housing

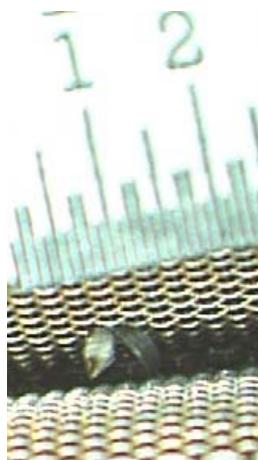
Metallic and non-metallic debris was recovered from both wing fuel tanks. The debris included loose particles of tank sealant, aluminum rivet heads, and portions of steel fasteners. Depending on the size, some of this debris would have been able to pass through the fuel pump inlet screens.

Figure 12. Steel & Aluminum Shavings Found in Engine Fuel Filter

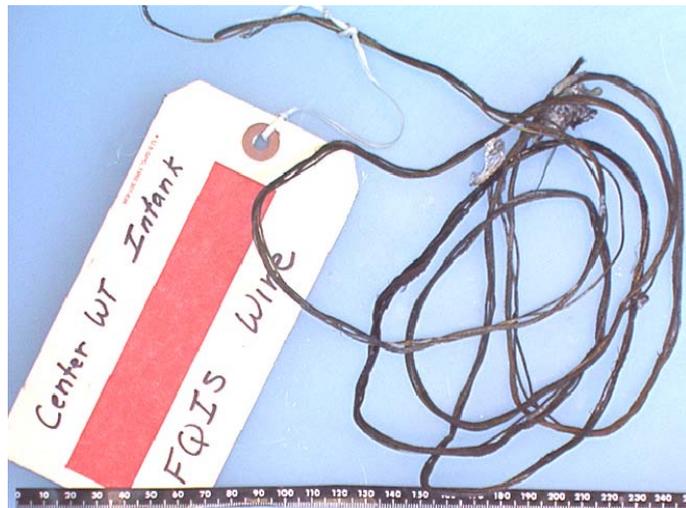
Figure 13. The Condition of the Center Wing Tank in-tank FQIS Wire

insulation and strands of uninsulated wire were found (See **Figure 13**). In addition, contaminates of aluminum shavings, grease, and dirt were found in the bundles.

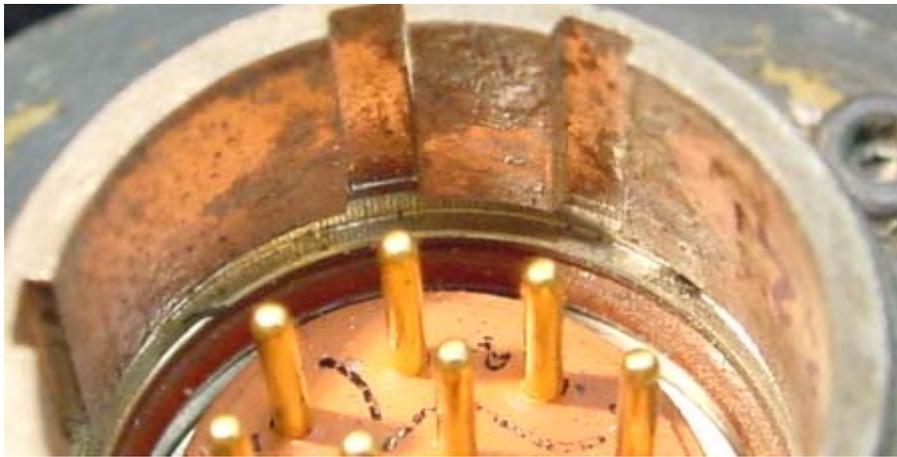
Figure 14. Fluid Tracks and Corrosion in Left Cockpit Gauge

After replacement of fire-damaged parts, the three cockpit indicators functioned normally and allowed for the readout of the solid-state memory. The gauge design includes an internal 1-kilohm (1k Ω) resistor that, if failed, would render the gauge inoperative. None of the gauges recorded an error code that would have indicated an internal error in the respective gauges, and each respective resistor was found intact. Maintenance codes for all three gauges indicated that before losing power, short circuits had developed between the compensator plates or the wires leading to each tank. In addition, the left gauge indicated leakage resistance between the two-compensator lines, the center gauge indicated that plates of a tank unit had shorted, and the right gauge indicated tank probe leakage resistance (See **Figures 14, 15 and 16**).

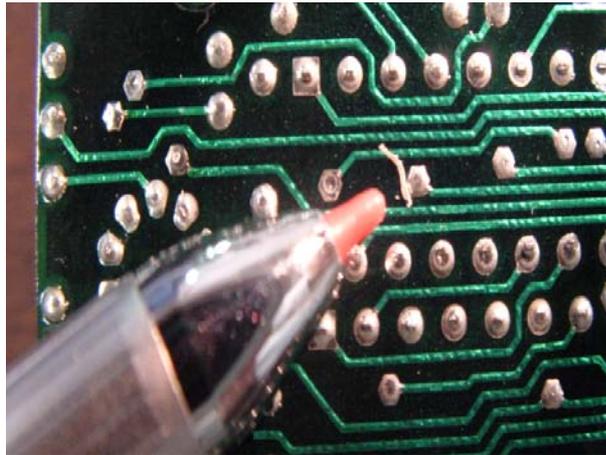
Figure 15. Conductive Debris between Tracks in CWT Gauge

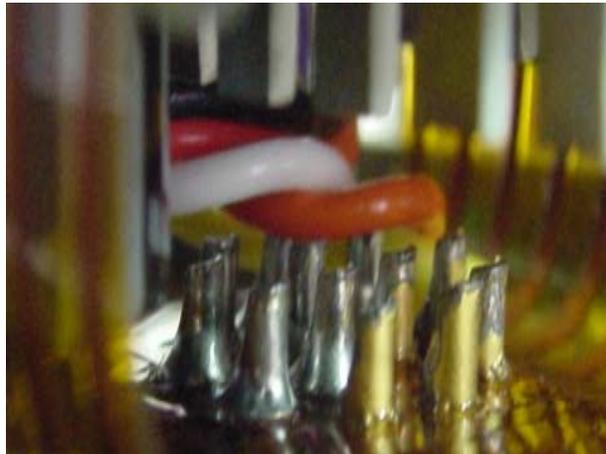
Figure 16. Wires Resting on Sharp Solder Cups in Right Gage

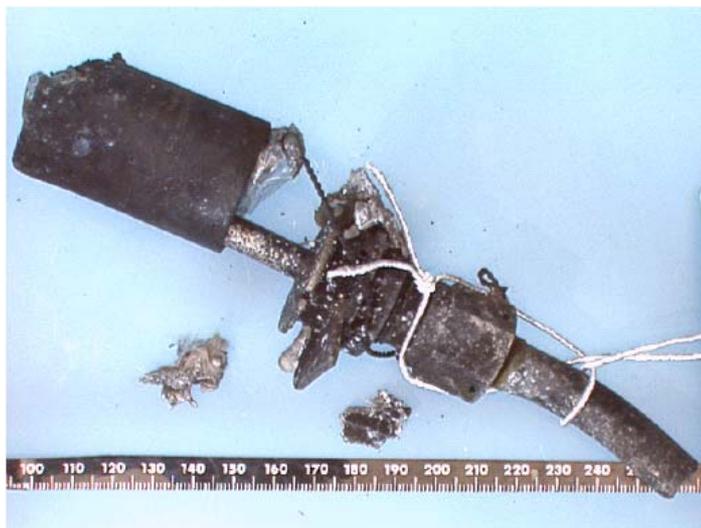
Most of the CWT float switch was recovered and examined at the laboratory facilities of the Air Force Research Laboratory in Dayton, Ohio, by personnel from the NTSB, FAA, and the Boeing company. The switch was found broken and extensively fire-damaged (See **Figure 17**). The glass from the reed switch enclosure was found shattered and resolidified globules of metal were found adhering to the reed (See **Figure 18**). Molten aluminum was also found in the tubular switch enclosure.

Figure 17. The Condition of the Float Switch

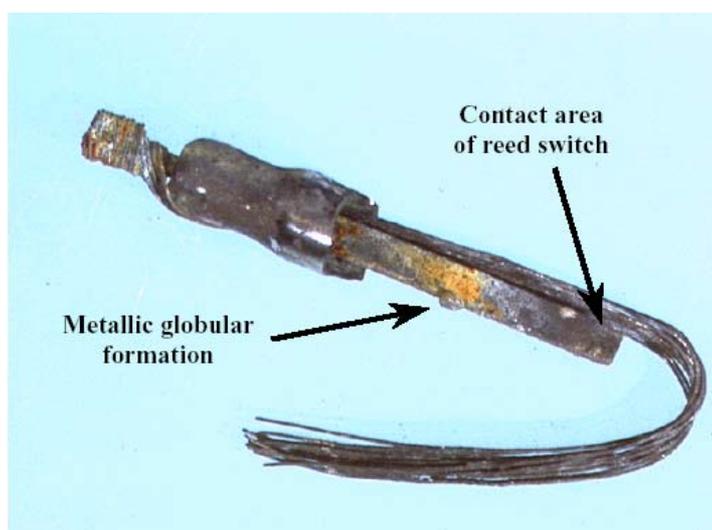
Figure 18. Remaining Section of the Glass Encapsulated Reed Switch

Analysis of the CWT refueling float switch found metal splatter inside the reed switch that could be an indication of an arcing event. However, since the material was contained within the wall of the aluminum conduit material and the refueling door was closed before the explosion, any arcing probably would have occurred as a result of wires short circuiting while being destroyed by the explosion and subsequent fire and was most likely not the ignition source.
