In-flight structural breakup, Boeing 747-200 B18255, May 25, 2002 in the Taiwan Straits approximately 23 nm northwest of Makung

CI611 Accident Investigation

Factual Data Report

ASC-AFR-03-06-001

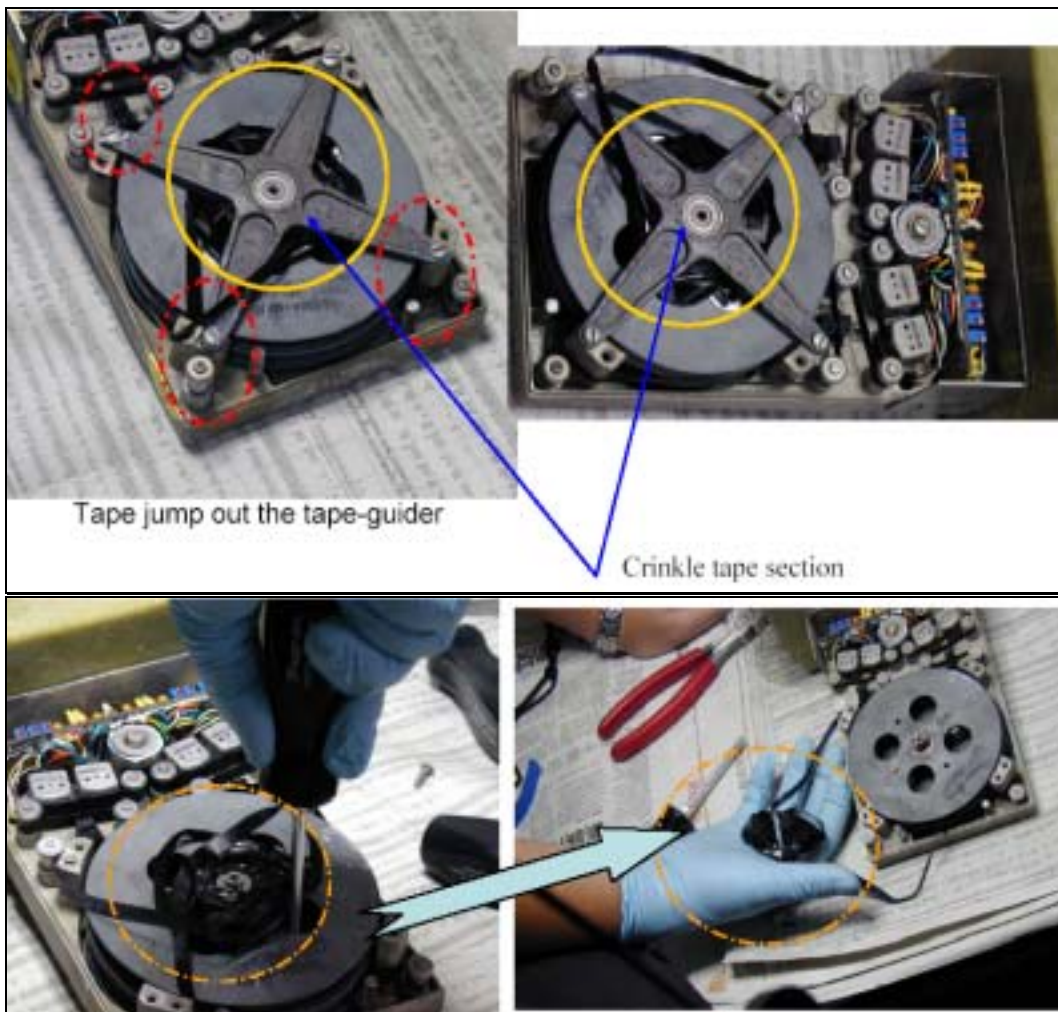
Figure 1.11-3 Photographs of damaged magnetic tape

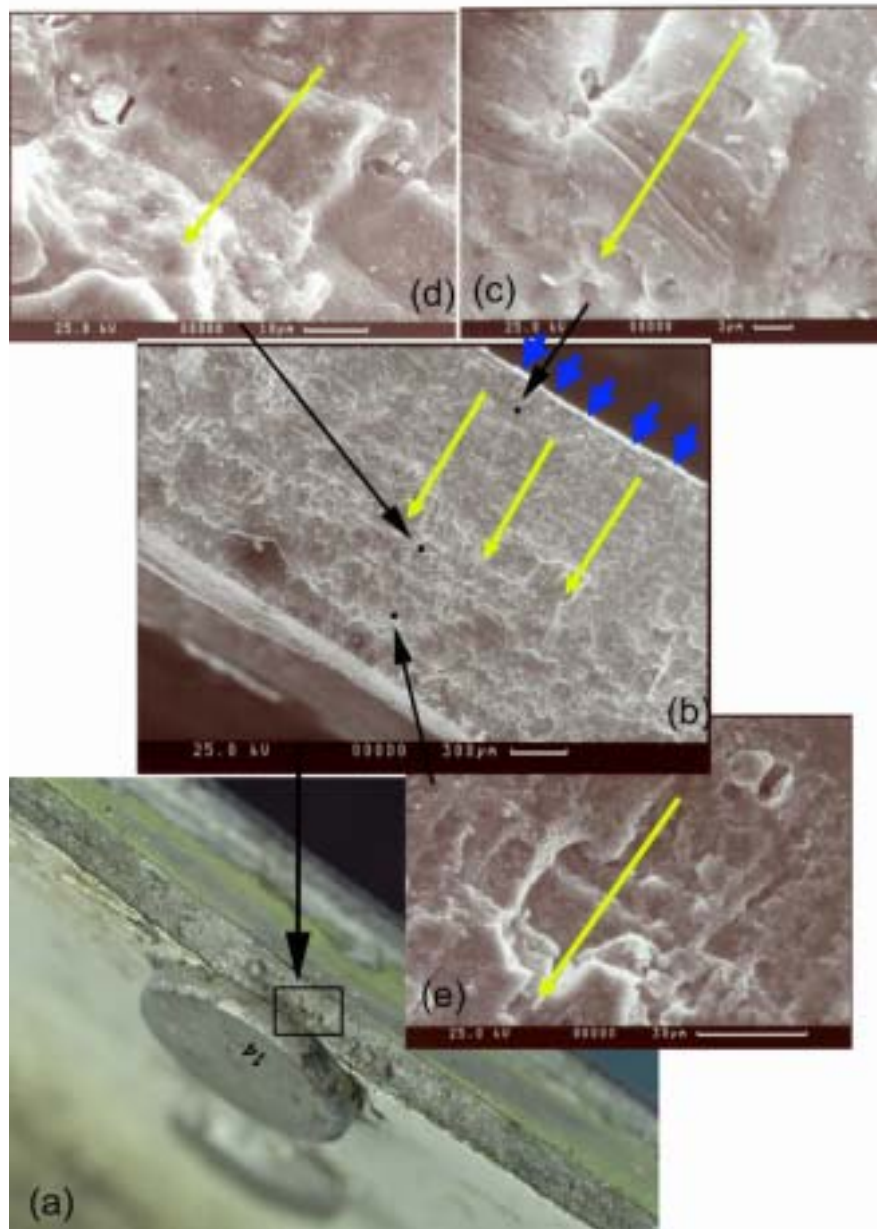
1.16-26 (d) and 1.16-26 (e), denoted by three small black squares, are high magnification photographs for various locations in Figure 1.16-26 (b), showing different spacing of fatigue striations at distances of 250 μm , 1020 μm , and 1480 μm , respectively, away from the skin edge next to doubler. These photographs can be used to measure the striation density at various locations along the crack front. Further, the cycles of loading can be estimated using fracture mechanics.

Figure 1.16-26 The fracture morphology of fatigue for the area near rivet 14

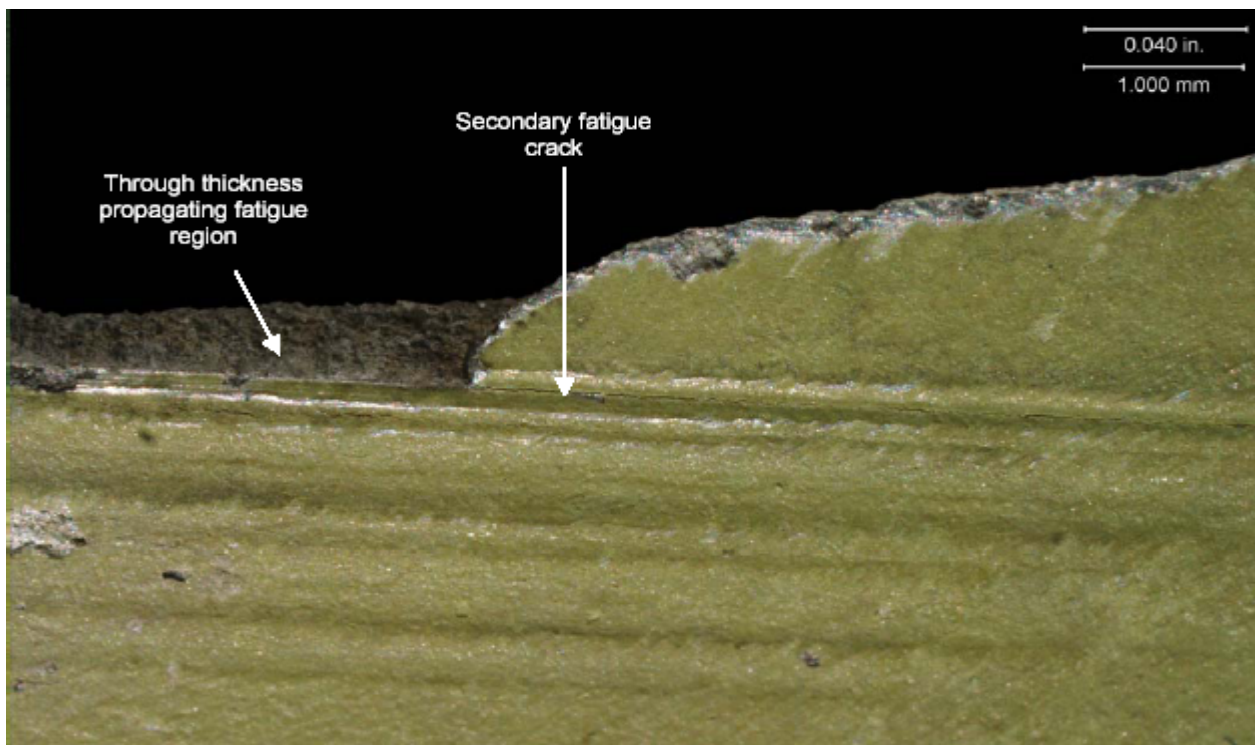
Figure 1.16-42 Surface of skin faying with repair doubler between hole 29 and hole 30 showing the longitudinal scratches in relationship to this fatigue crack. Note the secondary crack extending out of this common scratch.

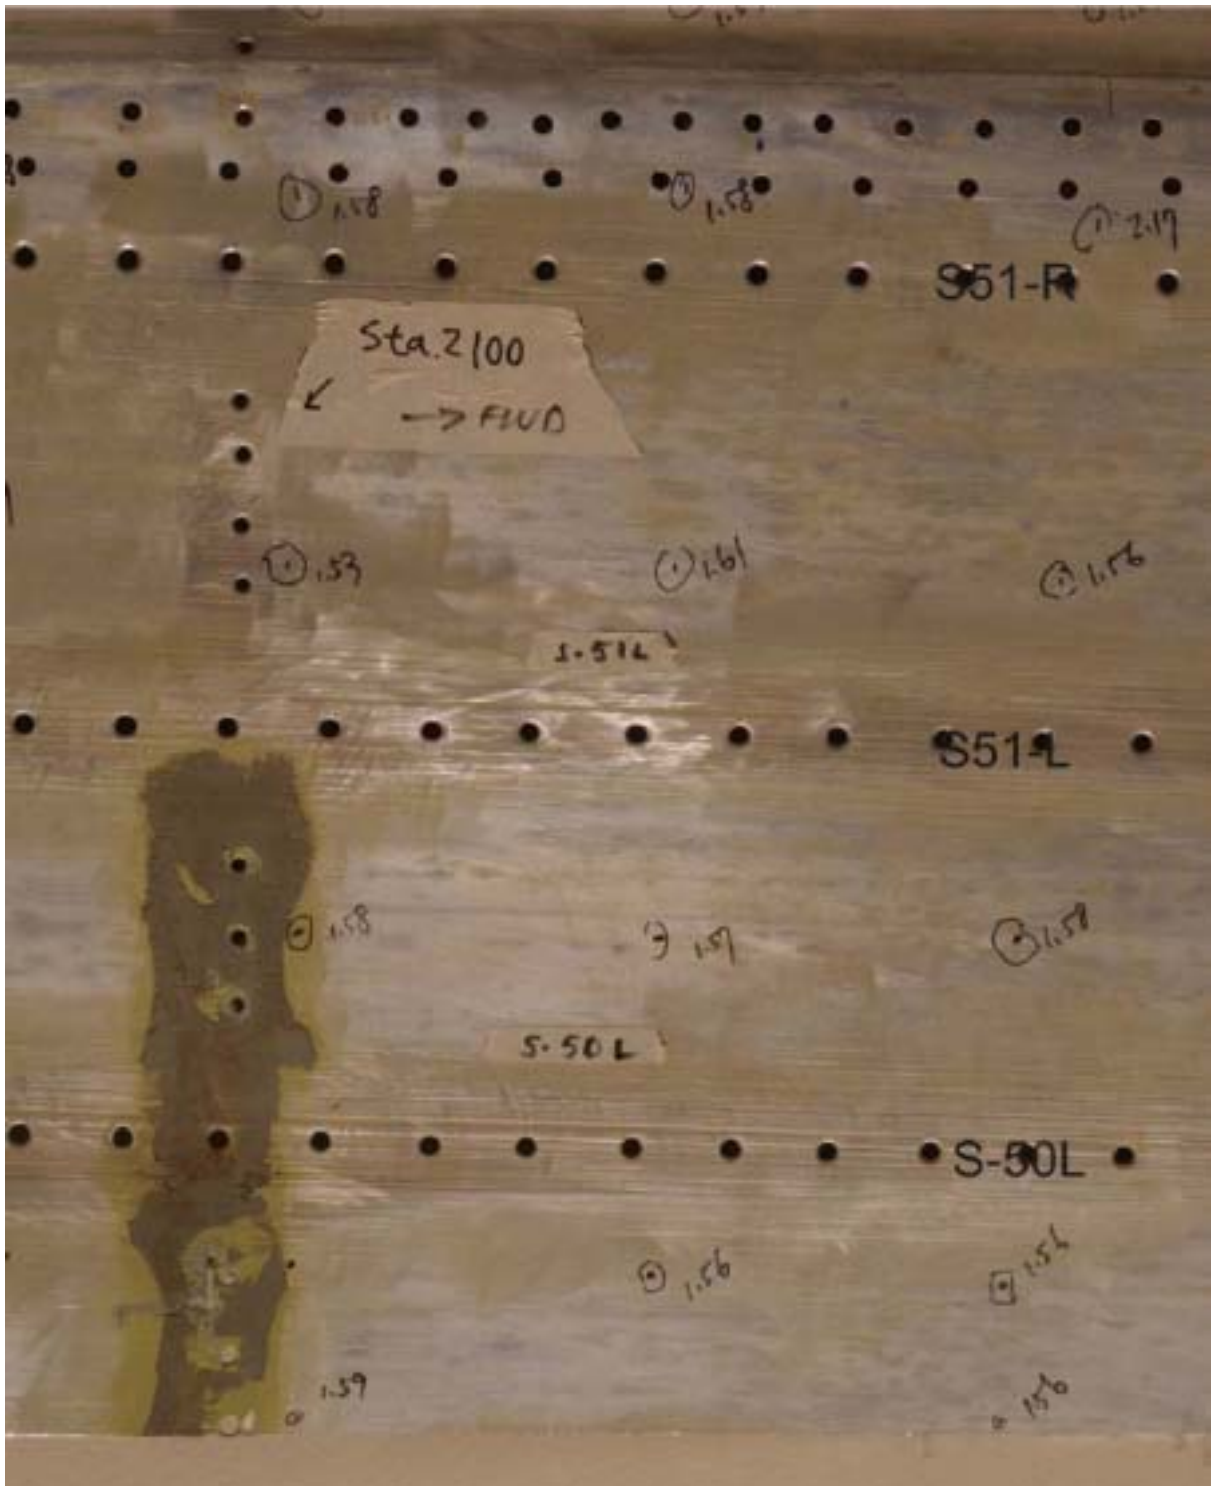
Figure 1.16-68 Extent of damage consistent with a tail strike
