Uncontained engine failure, Japan Air Lines, Ltd., Douglas DC-8-33, JA-8006, San Francisco, California, December 25, 1965

AIRCRAFT ACCIDENT REPORT

**JAPAN AIR LINES, LTD.,
DOUGLAS DC-8-33, JA-8006
San Francisco, California
December 25, 1965**

Adopted: June 26, 1967

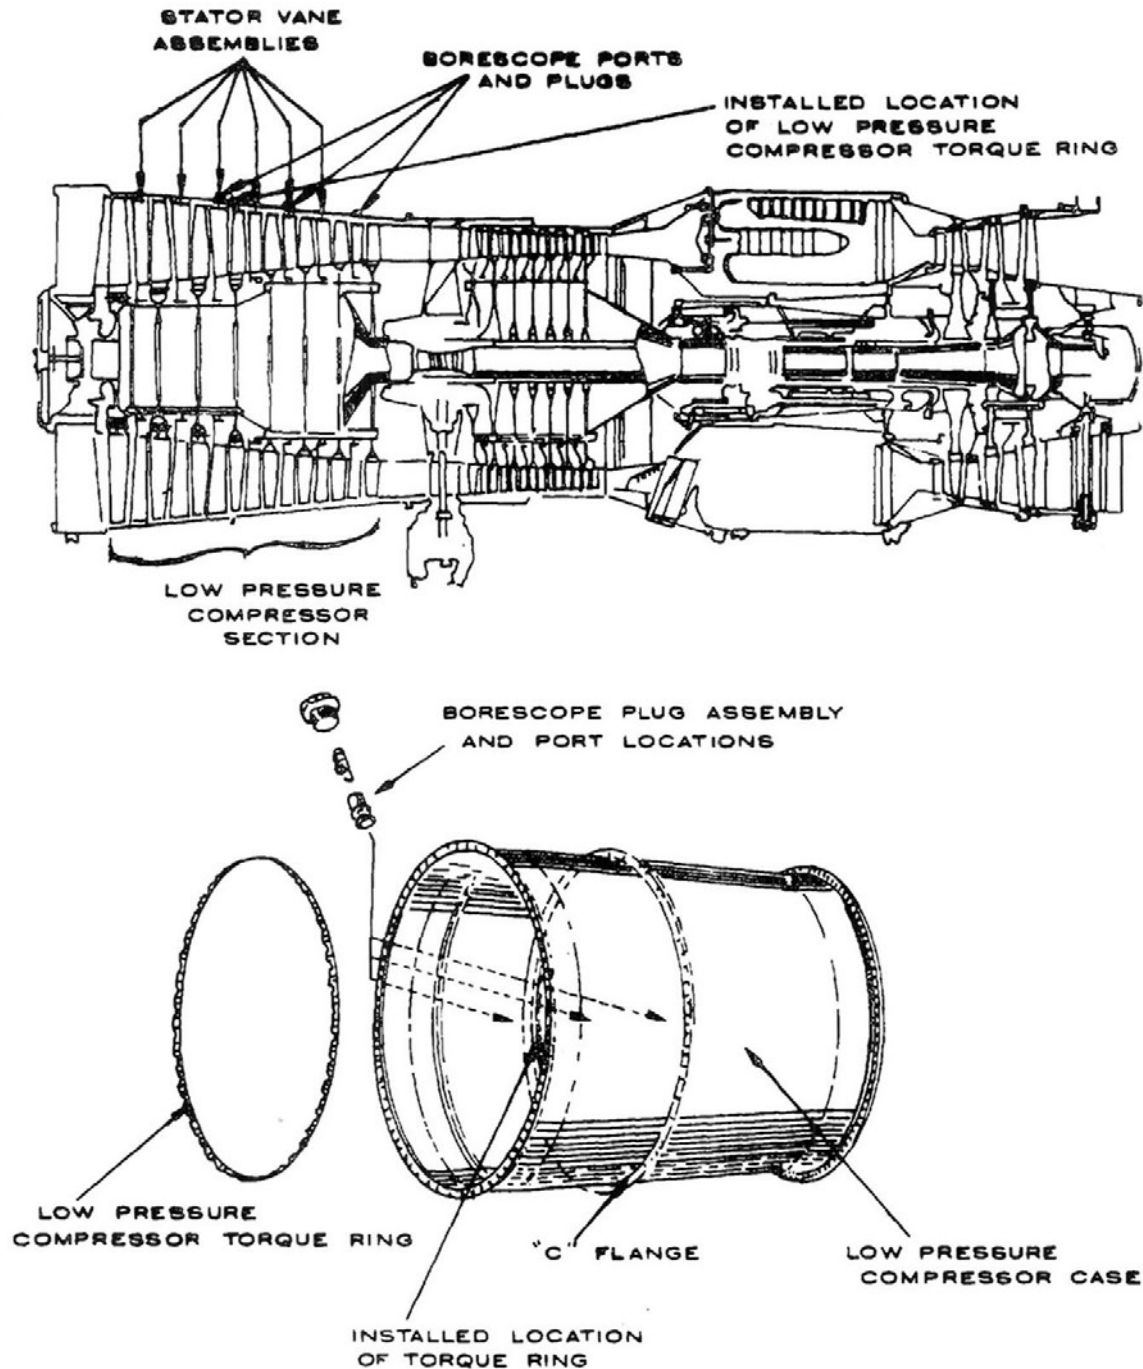
EXPLANATORY DIAGRAM

Engine overhaul records showed that during the course of the engine overhaul the low pressure compressor torque ring, P/N 310172, was found cracked and therefore replaced. The torque ring is located in the low pressure compressor at the area of the compressor case "C" flange adjacent to the fourth stage compressor stator assembly. ^{5/} It serves to prevent rotation of the compressor stators. In position, the ring is tightly fitted and a series of slots on the ring mate with a series of lugs on the outer diameter of the fourth stage stator shroud. By design the torque ring is secured in place by 90 rivets, P/N AN 13340, made of AMS 7232, a nickel base alloy. The design shear strength of each rivet is 16,000 p.s.i. at 350 degrees, C. The ring is riveted to the compressor case "C" flange.

There are three borescope inspection ports in the outer compressor case and stator outer shroud. Each of the ports is closed by a threaded plug. Though not designed for the purpose, the ports and plugs tend to impede rotation of the compressor stator assembly.

Since no rivet material was found and the rivet holes in the area of damage were not elongated, the Board concludes that the low pressure compressor torque ring designed to prevent rotation of the low pressure compressor stator assembly was not secured in place by riveting during overhaul of the engine. As a result, when the restraining effect of the tight fit of the ring and the three borescope inspection port plugs was overcome by the normal rotational forces within the compressor, the stator assembly and torque ring began to turn.

At high rotational speed the torque ring bearing on the low pressure compressor case literally ground through the case until the case was so weakened that it disintegrated with explosive force. This is clearly sustained by the extreme abrasive and heat damage found on the recovered pieces of compressor case and stator vane assembly which came from the precise location where the torque ring would make contact.
