Collision with approach lighting, Pan American World Airways, Inc., Boeing 747, N747PA, Flight 845, San Francisco, California, July 30, 1971

AIRCRAFT ACCIDENT REPORT
PAN AMERICAN WORLD AIRWAYS INC.
BOEING 747, N747PA
FLIGHT 845
SAN FRANCISCO, CALIFORNIA
JULY 30, 1971

ADOPTED: MAY 24, 1972

REPORT NUMBER: NTSB-AAR-72-17

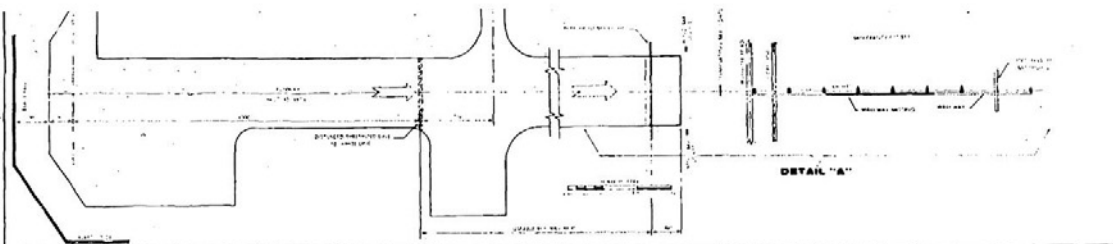
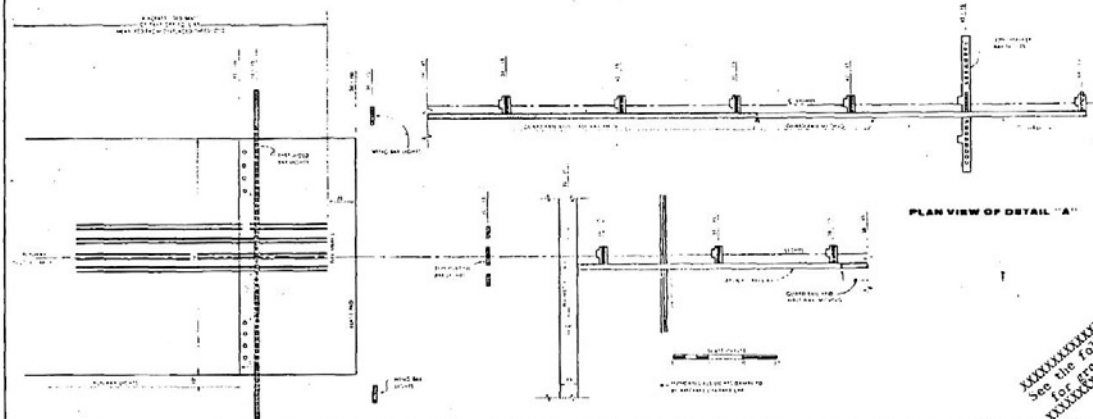
PLAN VIEW OF DETAIL "A"

DAMAGE TO APPROACH LANDING SYSTEM RUNWAY 16L
PAN AMERICAN AIRWAYS, INC. BOEING 747-121 N 143PA
SAN FRANCISCO INTERNATIONAL AIRPORT
SAN FRANCISCO, CALIF.
MAY 30 1975
