Landed short, Eastern Air Lines, Inc., Boeing 727-100, N8168G, Flight 9701, Atlanta, Georgia, December 21, 1971

AIRCRAFT INCIDENT REPORT

Report Number: NTSB-AAR-72-22

EASTERN AIR LINES, INC.
BOEING 727-100, N8168G,
FLIGHT 9701
ATLANTA, GEORGIA
DECEMBER 21, 1971

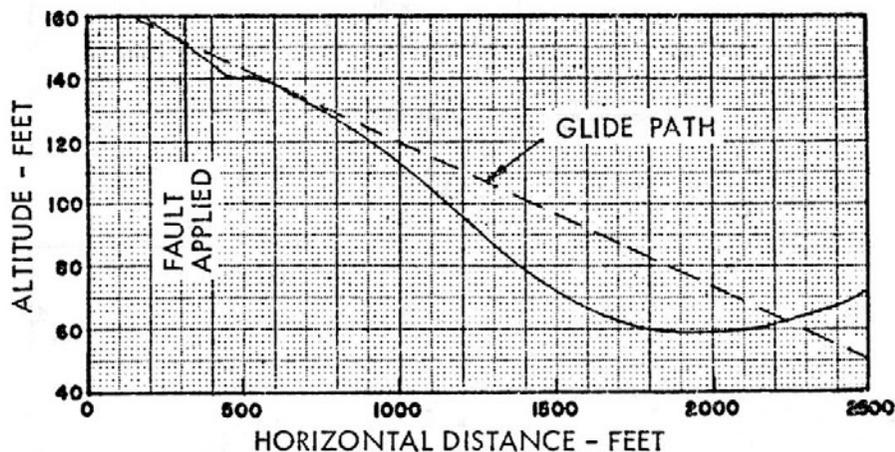
- (a) Altitude loss above 100 feet 24 feet below glide slope when recovery was initiated one second after pilot recognition. (See profile chart.)

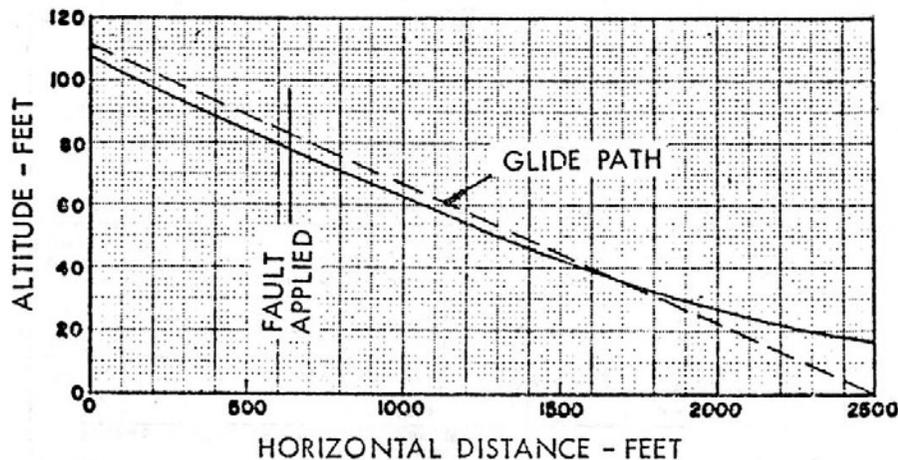
- (b) Altitude loss below 100 feet Negligible when recovery was initiated without delay after pilot recognition. (See profile chart.)
