Runway overrun, Piedmont Airlines, Boeing 737, N751N, Greensboro, North Carolina, October 28, 1973

AIRCRAFT ACCIDENT REPORT

**PIEDMONT AIRLINES
BOEING 737, N751N
GREENSBORO, N.C.
OCTOBER 28, 1973**

**NATIONAL TRANSPORTATION SAFETY BOARD
Washington, D.C. 20591
Report Number: NTSB-AAR-74-7**

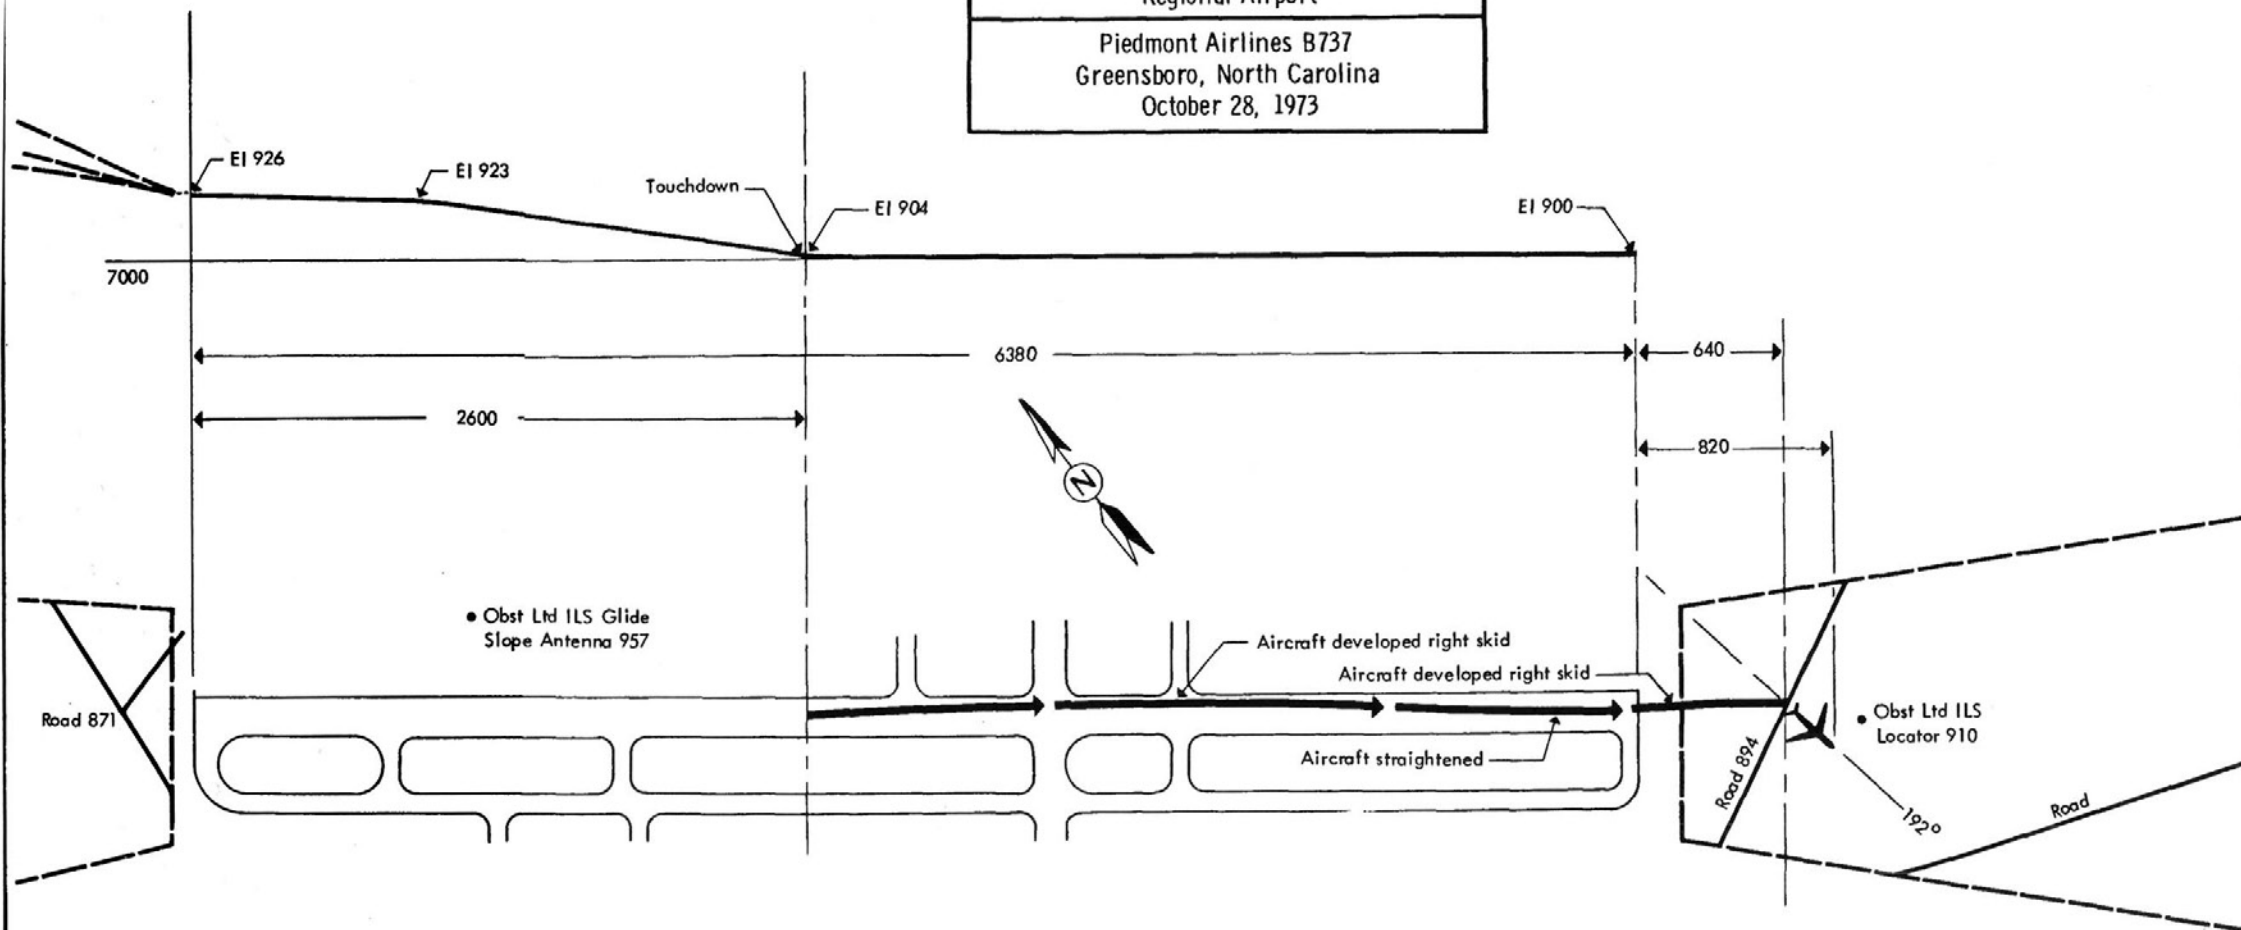
APPENDIX D

The aircraft continued about 640 feet, crossed a service road, and stopped on an incline 820 feet from the runway. (See Appendix D.)
