**Landed short, Delta Air Lines, Inc., McDonnell Douglas DC-9-32, N3323L, Chattanooga Municipal Airport, Chattanooga, Tennessee, November 27, 1973**

**DELTA AIR LINES, INC.  
McDONNELL DOUGLAS DC-9-32, N3323L  
CHATTANOOGA MUNICIPAL AIRPORT  
CHATTANOOGA, TENNESSEE  
NOVEMBER 27, 1973**

**NATIONAL TRANSPORTATION SAFETY BOARD  
Washington, D.C. 20591  
REPORT NUMBER: NTSB-AAR-74-13**

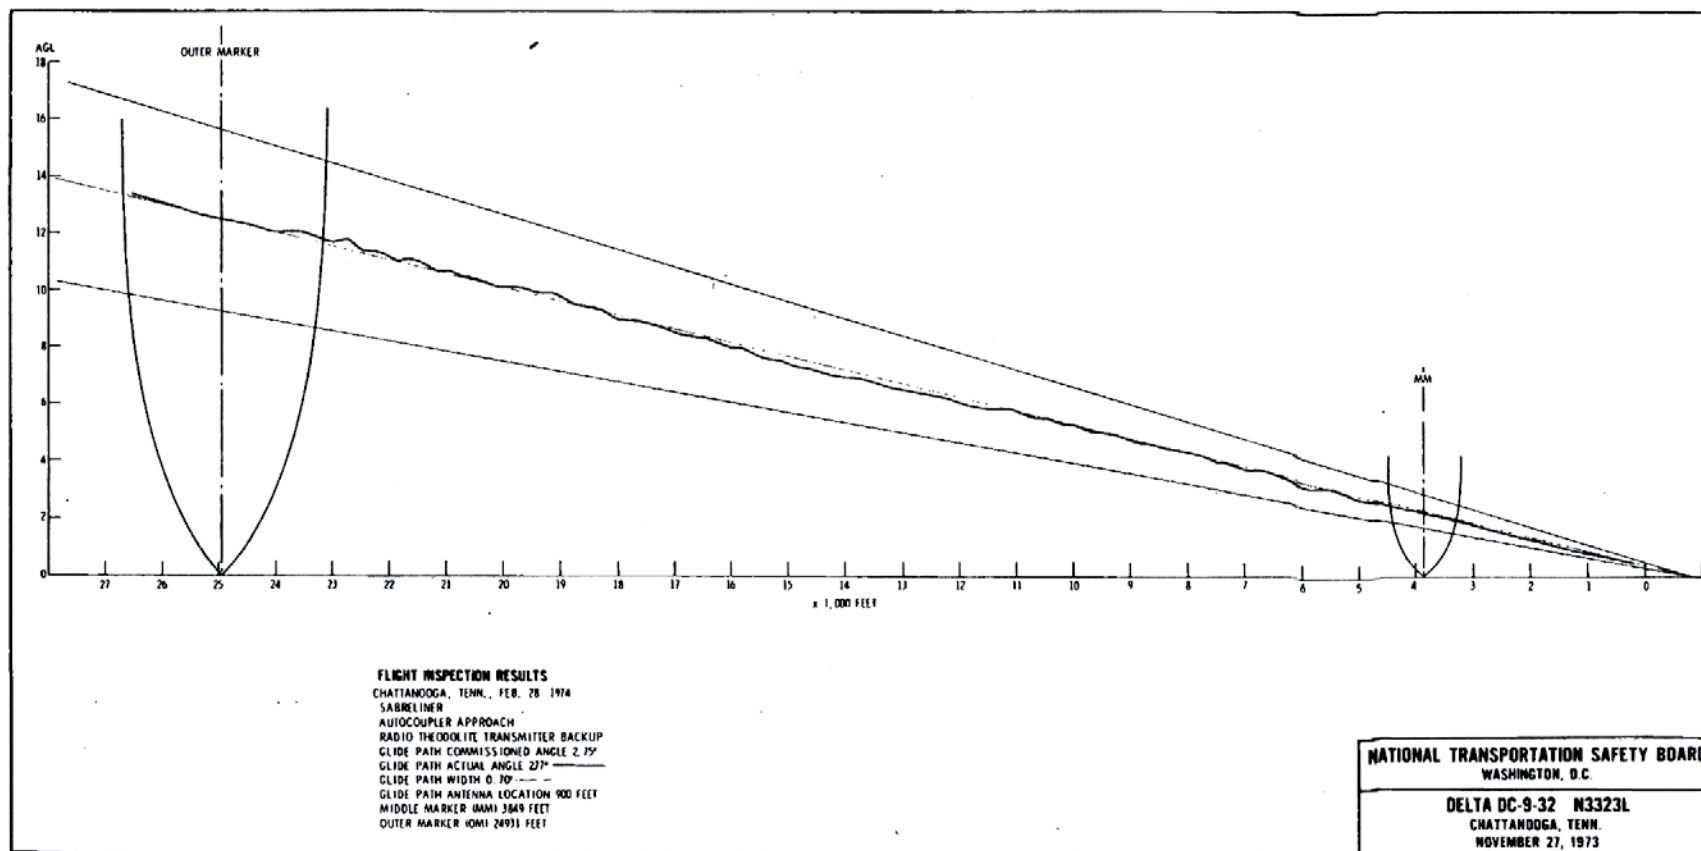
APPENDIX D

The glide slope beam approached the lower allowable tolerances for this facility in the vicinity of the MM. Since the glide slope beam caused a downward trend from the published glide slope, the autopilot in the autocouple mode would follow the beam, and thus start or establish a flightpath which could go below the published  $2.75^{\circ}$  glide-slope angle. If these conditions occurred as the aircraft approached the MM and if the pilot uncoupled at this time, it is possible that the aircraft could be in a less than perfect attitude to complete the approach. Evidence indicates that while this situation is possible, the magnitude of this trend would not cause an aircraft to exceed the safe lower limits of the glide slope. Although the aberration of the beam was most evident at a point just before the autopilot would normally be disengaged, the beam structure still remained within tolerances above DH.

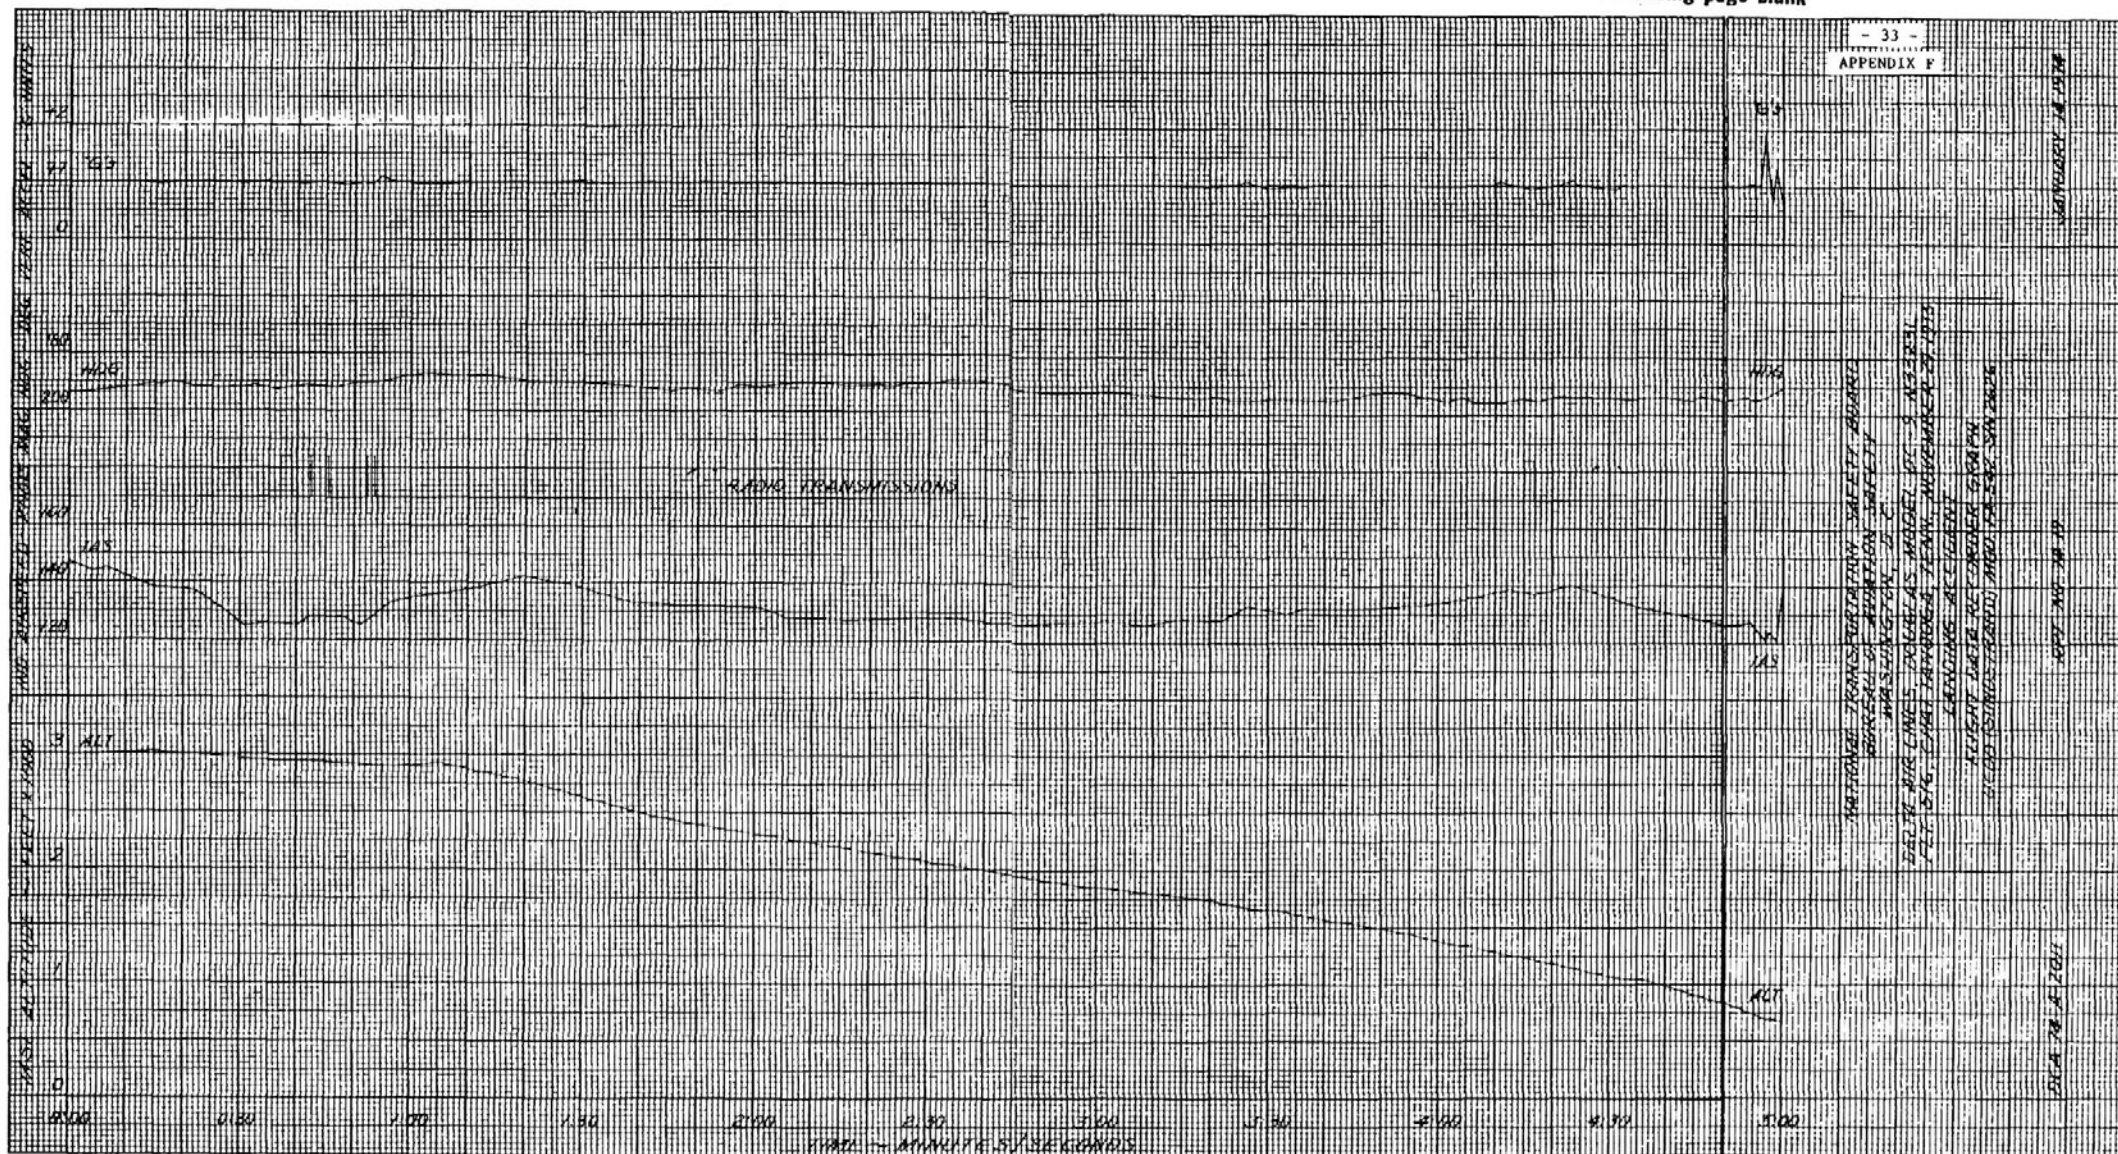
APPROACH PROFILE  
DELTA AIR LINE, DOUGLAS DC-9, N3323L  
FLT. 516, CHATTANOOGA, TENN.  
NOVEMBER 27, 1973  
[COMBINED F.D.R., C.V.R., COMPUTER PLOT]

Since Delta Air Lines procedures require that the pilot who is not flying call out significant deviations in airspeed, altitude, and descent rate, the first officer's calls should have alerted the captain that the descent rate trend was increasing with the aircraft less than 200 feet above the ground. Since the captain had noted the correct crossing altitude when the aircraft passed the MM, he needed to arrest the rate of descent of 900 to 1,000 feet per minute in order to land safely.

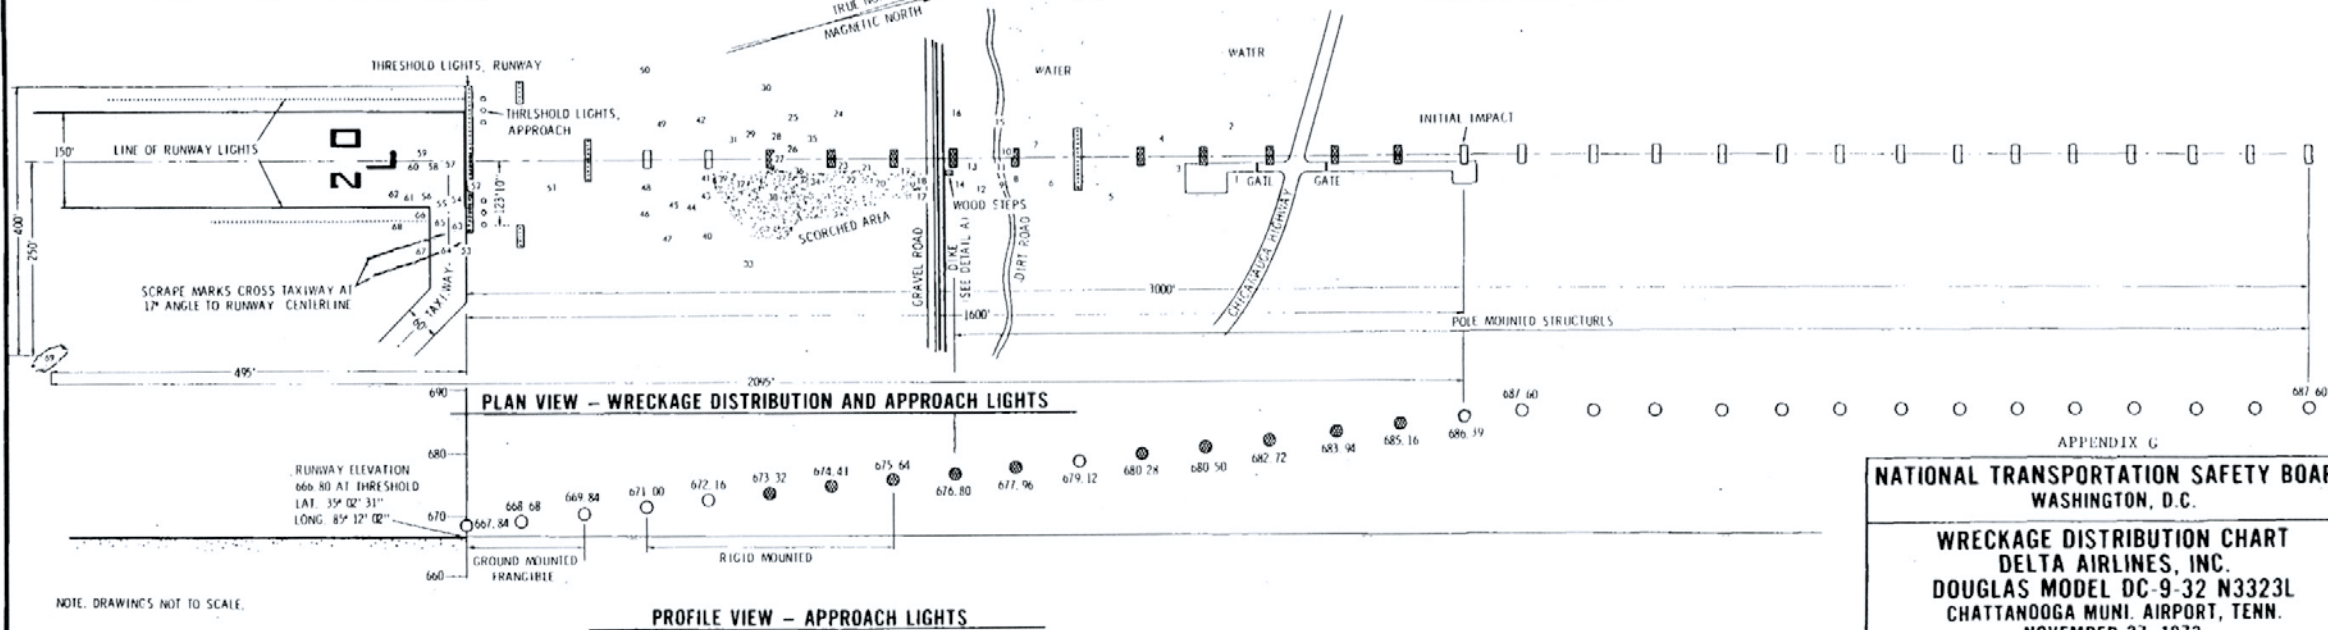
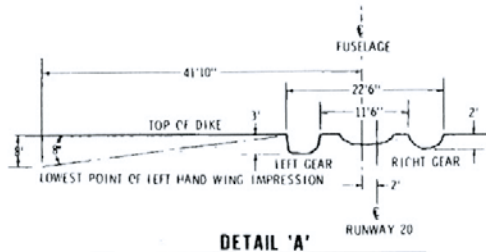
WRECKAGE DISTRIBUTION CHART  
DELTA AIRLINES, INC.  
DOUGLAS MODEL DC-9-32 N3323L  
CHATTANOOGA MUNI. AIRPORT, TENN.  
NOVEMBER 27, 1973  
DCA-74-A-11

The aircraft struck the approach lights 1,600 feet from the runway threshold. After initial impact, the aircraft continued through the approach lights and struck a flood-control dike located 785 feet from the runway threshold. The aircraft stopped on the airport 450 feet beyond the approach end of the runway and 250 feet left of the runway centerline. The aircraft was destroyed.
