**Landed short, Eastern Air Lines, Inc., Douglas DC-9-31, N8984E,
Charlotte, North Carolina, September 11, 1974**

**EASTERN AIR LINES, INC.
DOUGLAS DC-9-31, N8984E
CHARLOTTE, NORTH CAROLINA
SEPTEMBER 11, 1974**

**NATIONAL TRANSPORTATION SAFETY BOARD
Washington, D. C. 20594
REPORT NUMBER: NTSB-AAR-75-9**

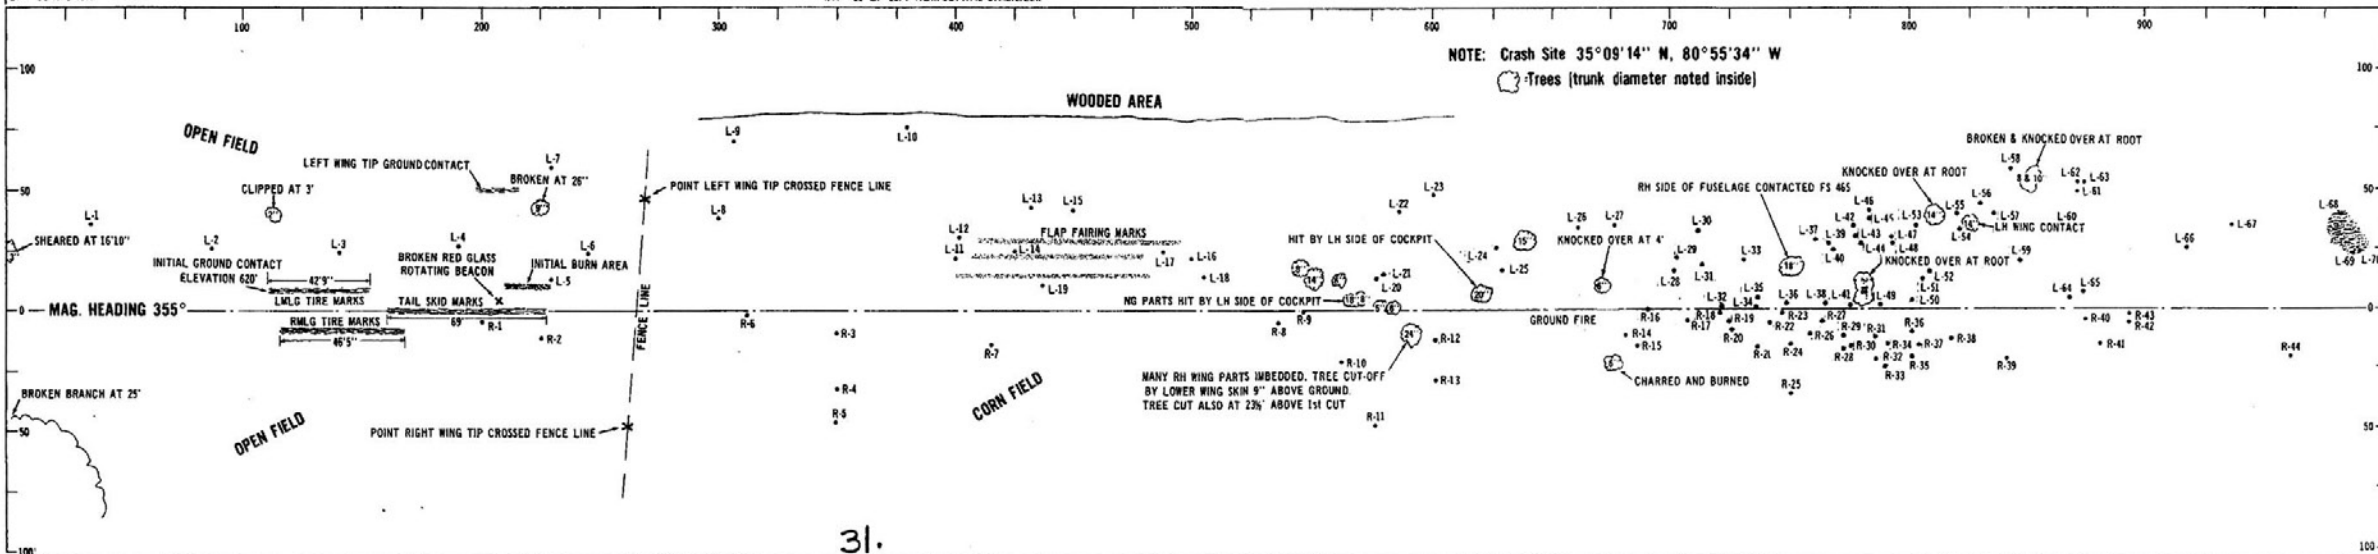
APPENDIX G

The aircraft wreckage came to rest in a ravine 995 feet from the initial impact point. The cockpit section came to rest on a magnetic heading of 310° ; the aft fuselage section came to rest on a magnetic heading of 290° . The wreckage area was 995 feet long and 110 feet wide. No parts of the aircraft were found outside the main wreckage area. (See Appendix G.)

WRECKAGE DISTRIBUTION CHART EASTERN AIRLINES, INC., DOUGLAS DC-9-31, N-8984E 3.3 STATUTE MILES SOUTH OF RUNWAY 36 DOUGLAS AIRPORT, CHARLOTTE, N.C. SEPTEMBER 11, 1974
