**Near-miss in cruise, Near Midair Collision, American Airlines, Inc., Douglas DC10, N124, and Trans-World Airlines, Inc., Lockheed-1011, N11002, Near Carleton, Michigan, November 26, 1975**

NATIONAL TRANSPORTATION SAFETY BOARD  
WASHINGTON, D.C. 20594

AIRCRAFT ACCIDENT REPORT

NEAR MIDAIR COLLISION  
AMERICAN AIRLINES, INC., DOUGLAS DC10, N124  
AND  
TRANS WORLD AIRLINES, INC., LOCKHEED-1011, N11002  
NEAR CARLETON, MICHIGAN  
NOVEMBER 26, 1975

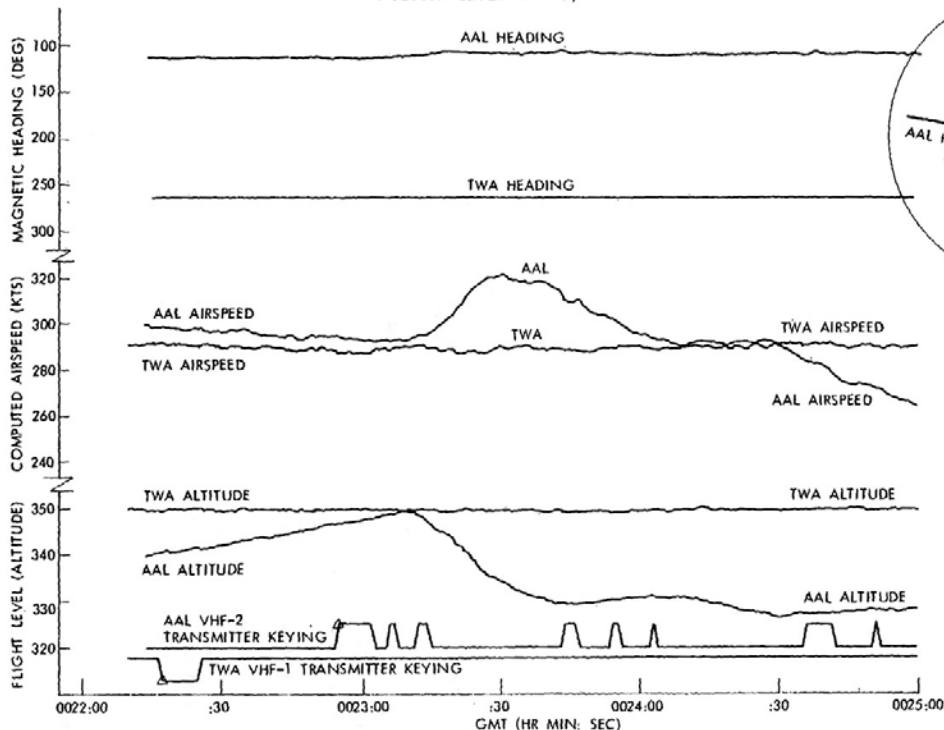
NOVEMBER 20, 1972  
23 NMI W OF CARLETON VORTAC, MICHIGAN  
AT FLIGHT LEVEL 350 (35,000 FT)

Thirty seconds after the evasive maneuver was started, the aircraft had reached FL 330. A maximum pressure altitude of 34,953 ft. was reached 4 seconds after the downward pitch movement began. At this time (1923:11) TWA 37's pressure altitude was 34,965 ft. (See Appendix C.)

- 1) NORMAL ALTITUDE ERROR FOR L-1011 AT 35,000 FT =  $\pm 70$  FT.
- 2) MINIMUM ACCURACY (ALTITUDE) FOR DC-10 AT 50,000 FT =  $\pm 80$  FT (LESS THAN  $\pm 80$  AT LOWER ALTITUDE)
