Loss of engine and stall on takeoff, American Airlines, Inc., DC-10-10, N110AA, Chicago-O'hare International Airport, Chicago, Illinois, May 25, 1979

Micro-summary: This McDonnell Douglas DC-10-10 stalled and crashed after the loss of the #1 engine caused a catastrophic flight control failure.

AIRCRAFT ACCIDENT REPORT

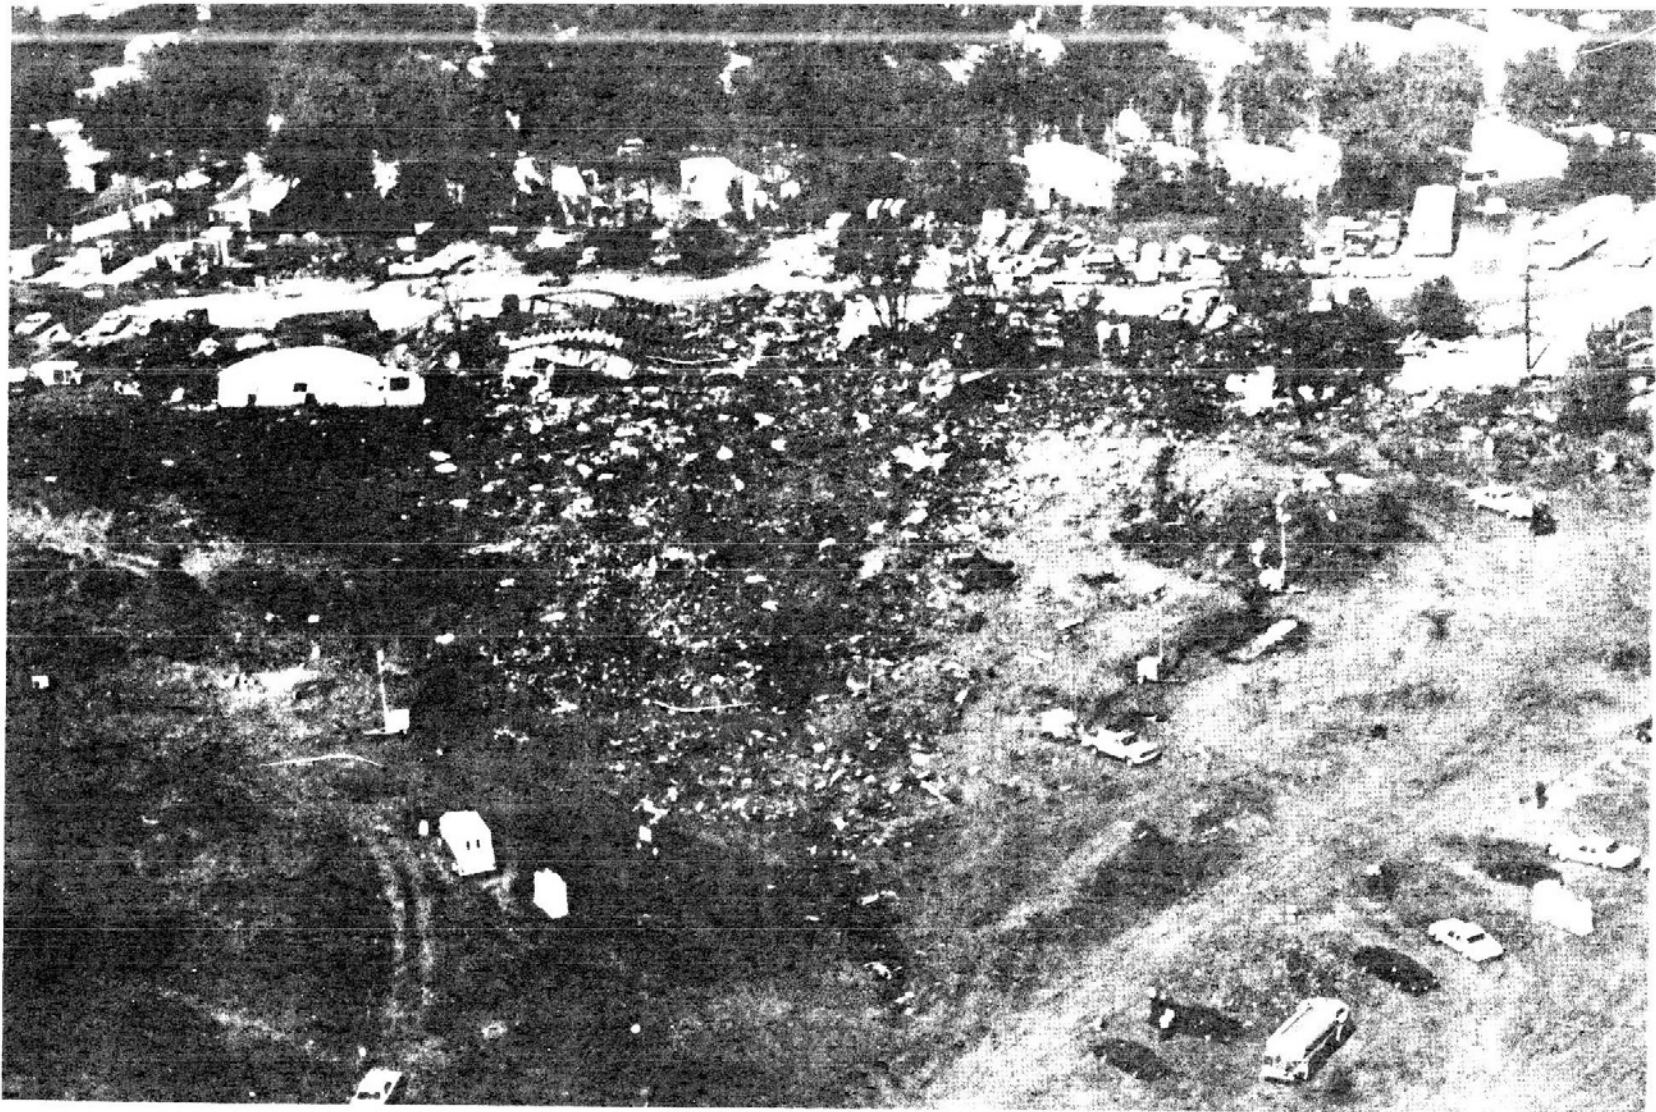
Figure 1. Accident site.

Flight 191 struck the ground in a left wing-down and nosedown attitude. The left wingtip hit first, and the aircraft exploded, broke apart, and was scattered into an open field and a trailer park. The disintegration of the aircraft structure was so extensive that little useful data were obtained from postimpact examination of the wreckage with the exception of the No. 1 pylon, which was found off the right side of runway 32R. (See figure 1.)

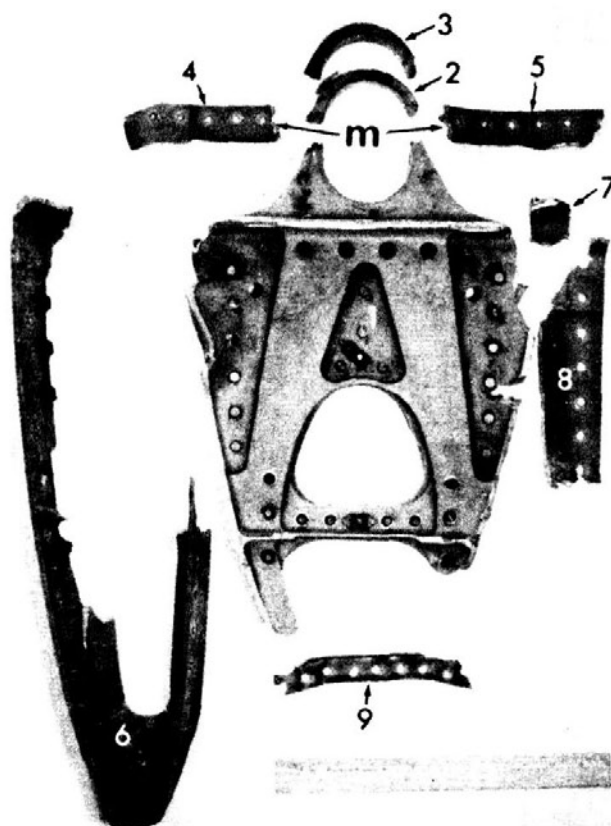
Figure 4. Overall view of the wing pylon aft bulkhead installation portions. Pieces are numbered for identification purposes and placed in relative locations as if intact.

N110AA's pylon aft bulkhead was examined at the Safety Board's metallurgical laboratory. The examination disclosed a fracture of the upper forward flange. (See figure 4.) The larger part of this fracture was just forward of the radius between the flange and forward bulkhead plane and was about 10 inches long in the inboard-outboard direction. (See figure 5.) The fracture characteristics were typical of an overload separation. Chevron and tear marks on the fracture indicated that the rupture progressed downward at the center of the flange, then in inboard and outboard directions on the flange. The bottom portion of the fracture exhibited smearing consistent with the compression portion of a bending fracture. The smear was more prevalent--about 6 inches long--in the thinner center portion of the upper flange structure, but became less prevalent at the outer ends of the fracture. The 10-inch-long fracture resulted from overstress. The overstress was initiated by the application of a downward bending moment at the center section of the flange just forward of the fracture plane. The surface of the fracture appeared to be relatively free of oxidation and dirt.

Fatigue cracking was evident at both ends of the fracture. At the inboard end, the fatigue progressed inboard and aft; then, it progressed downward and inboard to the upper inboard fastener that attached the forward section of the bulkhead to the aft section. The fatigue progressed past the fastener a short distance before exhibiting rapid overstress characteristics in the downward direction as it proceeded along the inboard side of the side flange radius of the forward flange section. At the outboard end of the fracture, the fatigue propagated forward and slightly outboard toward the most forward outboard hole in the upper flange. The total length of the overstress fracture and fatigue cracks was about 13 inches. The remainder of the fractures on the bulkhead and within the pylon structure resulted from overload.

The examination also disclosed that three shims were installed on the upper surface of the forward upper flange. Two shims (Part No. AUB-7034-25) were installed, one on the inboard top shoulder of the upper flange and one on the outboard top shoulder. These shims are about 2 inches long, 1 inch wide, and .063 inch thick. A 10-inch-long, .050-inch-thick shim was installed during production to fill a gap between the upper flange and upper spar web. (See figure 6.) The manufacturer's drawings specify that the AUB-7034-25 shim may be required along the side of the bulkhead; however, they do not indicate that shims may be required on the upper surface of the flange. The fatigue propagation on the inboard and outboard ends of the overstress fracture began in the area underneath the .063-inch-thick shims.

- Item 1. Aft bulkhead center section piece view looking aft.
- Items 2 & 3. Upper lug ears.
- Items 4 & 5. Two pieces of the forward portion of the upper flange. Those pieces mated together along the fracture indicated by arrows "m."
- Item 6. Side flanges and lower portion of the aft bulkhead.
- Item 7. Piece of the flange at the upper outboard corner.
- Item 8. Portion of the outboard side flange.
- Item 9. Piece of the intermediate flange.

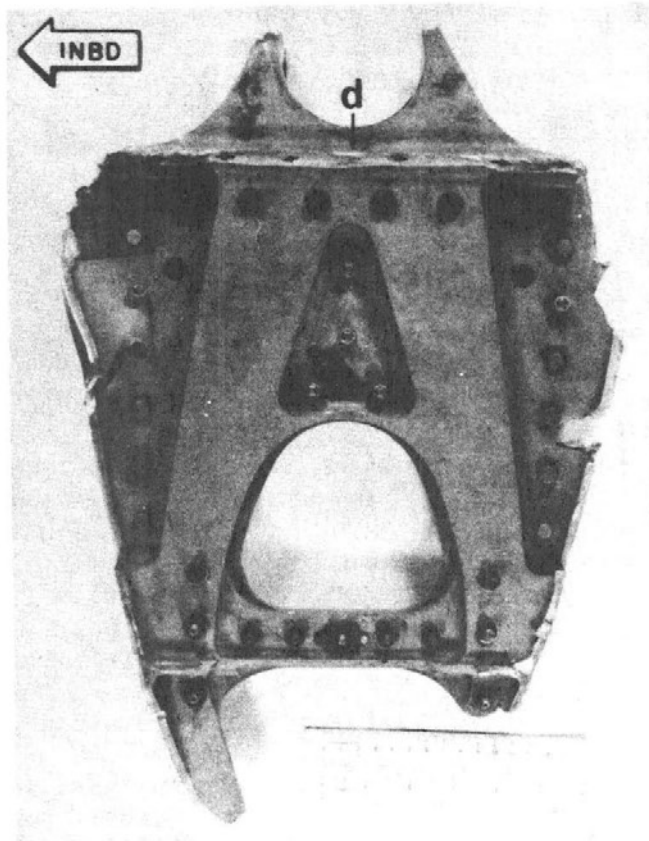
Figure 5. View of the aft bulkhead piece indicated as Item 1 in Figure 4.

The aft fracture surface of the upper flange contained a crescent-shaped deformation which matched the shape of the lower end of the wing clevis. This deformation was in line with the vertical centerline of the aft bulkhead attachment hole as indicated by arrow "d" in figure 7. A deformation was noted in the lower surface of the aft wing support fitting's forward clevis lug in the area indicated by the brackets in figure 9. A small shallow gouge was apparent in the area of the arrow in figure 10. This gouge was in a position which would conform to a fastener location on the top flange assembly of the aft bulkhead.

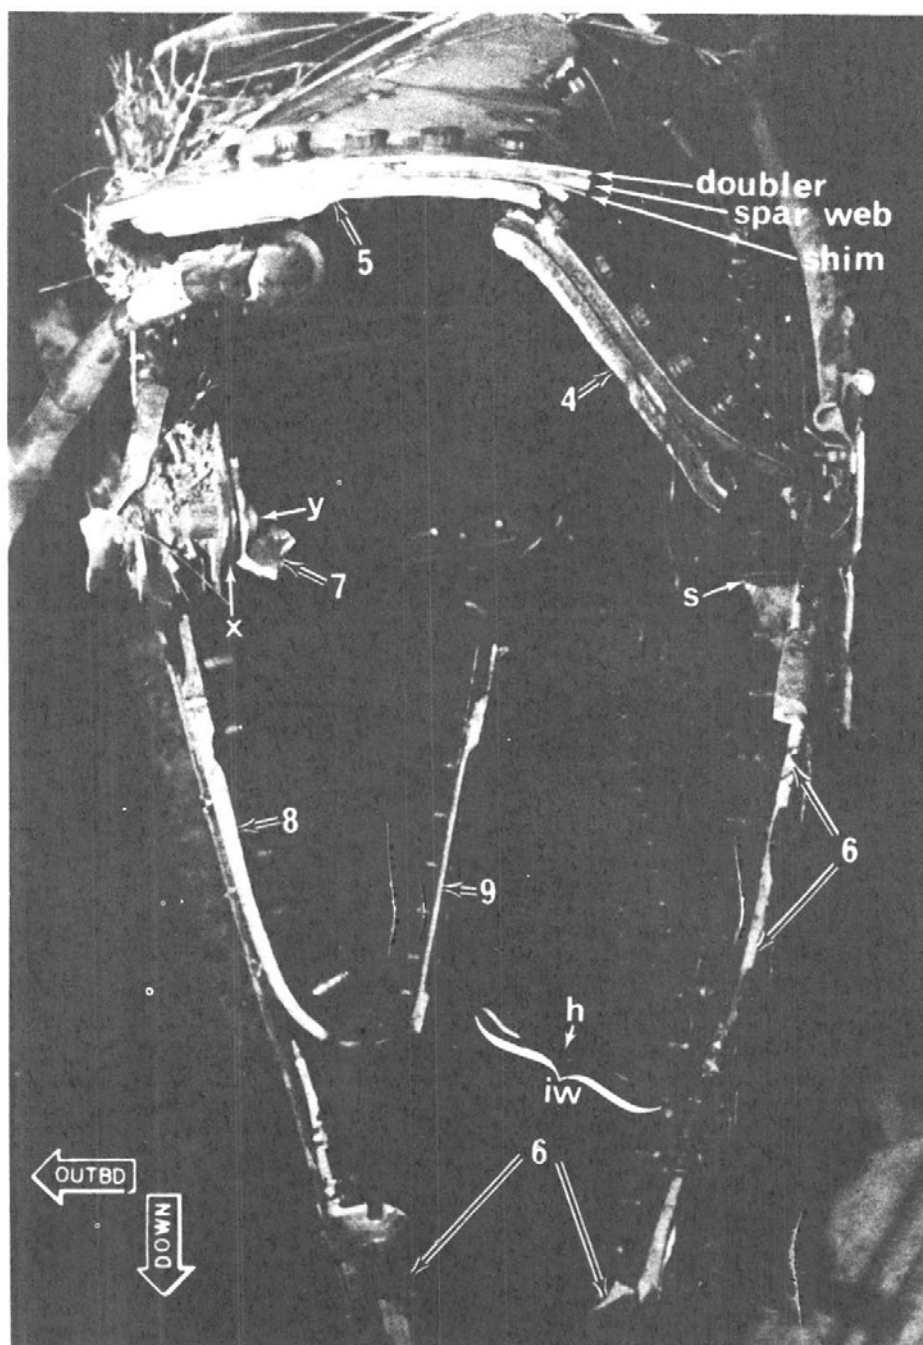
Figure 6. View looking forward and slightly down on the No. 1 pylon before disassembly of the flange pieces indicated as items 4 through 9 in Figure 4. Arrow "x" shows the shim on the outboard side between the angle and the top surface of the upper flange piece No. 7 held in place by the fastener arrowed "y". Arrow "s" shows the location for the shim on the inboard side between the angle and upper surface of the upper bulkhead flange.

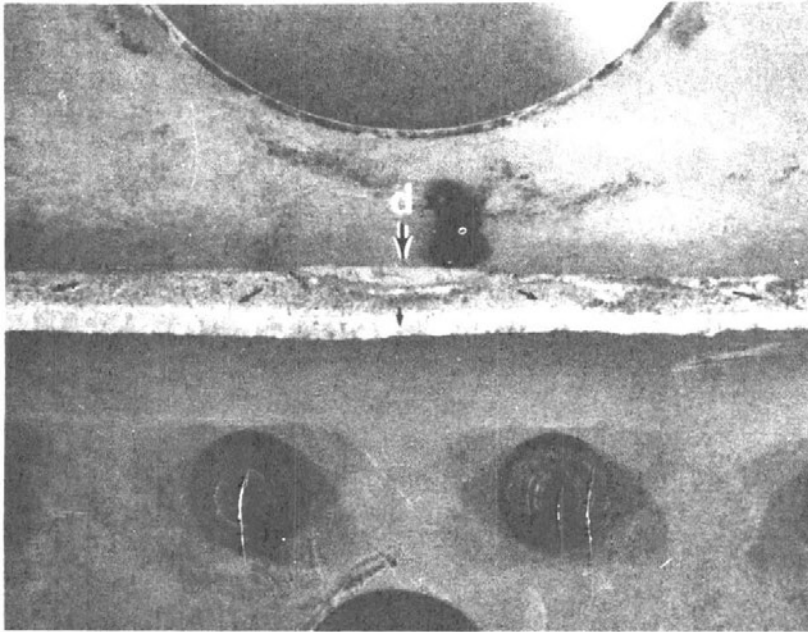
Figure 7. Closer view of fracture on upper flange in the area of deformation (arrow "d", see Figure 5).

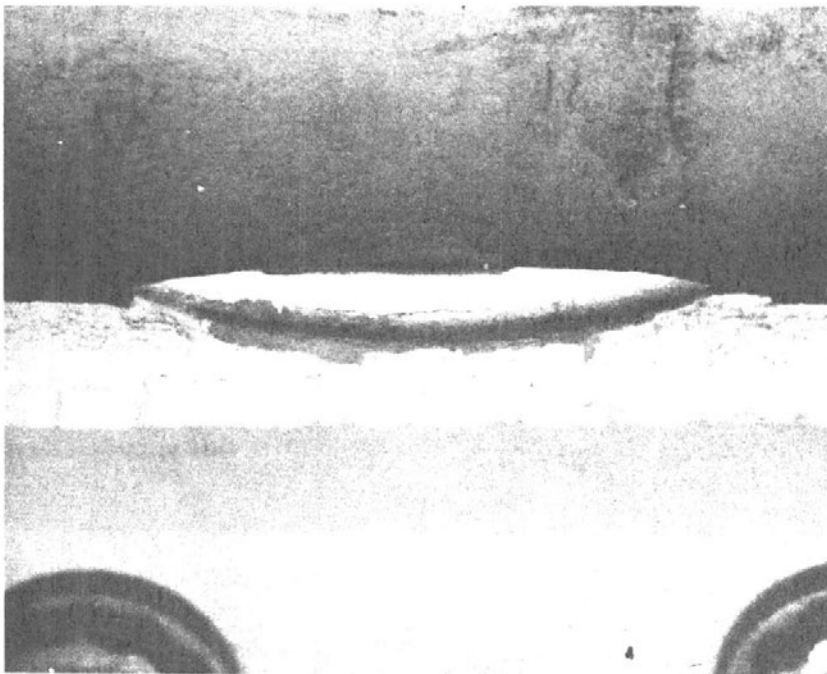
Figure 8. Detail of deformation denoted by arrows "d" in Figure 5 and 7.

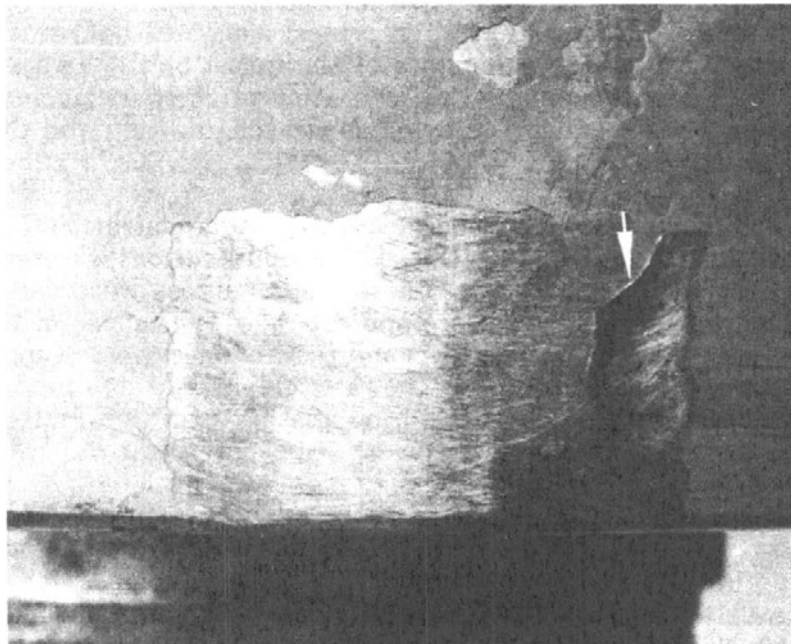
Figure 10. Close up view of damage in the area between the brackets of Figure 9.

The gouge appeared to be produced by a fastener head, hitting the clevis with a sliding movement. The upper flange aft fracture surface and radius appeared to have been deformed by the wing clevis' striking these surfaces in the downward direction.

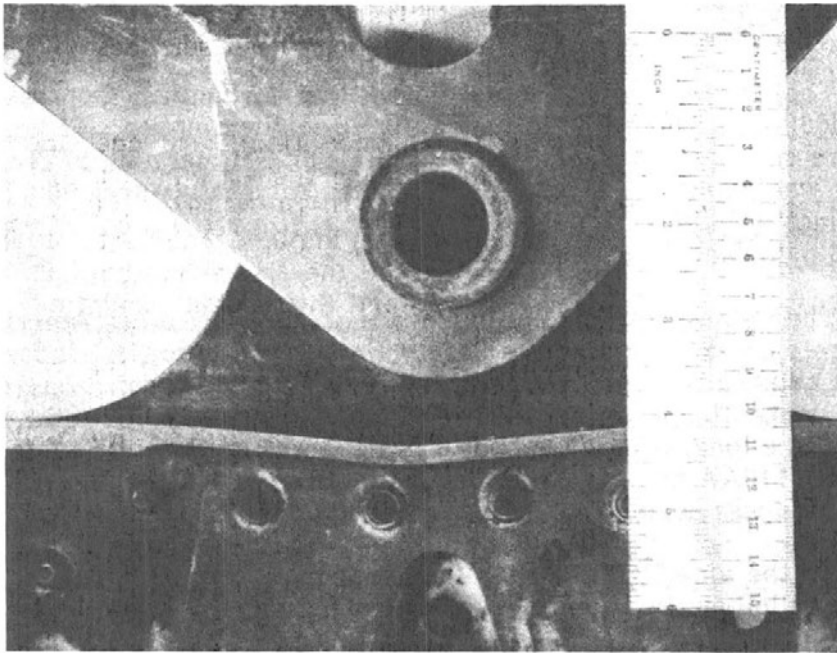
Figure 11. Wing pylon aft bulkhead from N119AA assembled to wing mounted aft support fitting of N110AA showing normal position of wing fitting clevis with respect to the upper forward flange of the aft bulkhead.
Note: The wing fitting on this figure is canted relative to the bulkhead to simulate the dihedral of the left wing relative to the bulkhead.

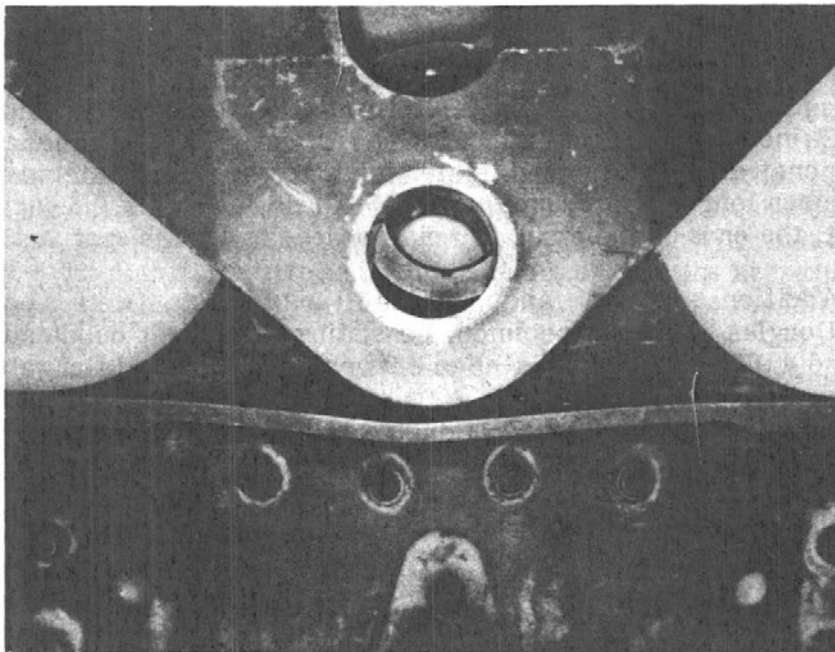
Figure 12. Same as Figure 11 except the attachment bushing was removed and the aft bulkhead was moved up against the far inside portion of the wing fitting. Note the location of the bottom portion of the wing fitting clevis with respect to the fracture on the bulkhead.

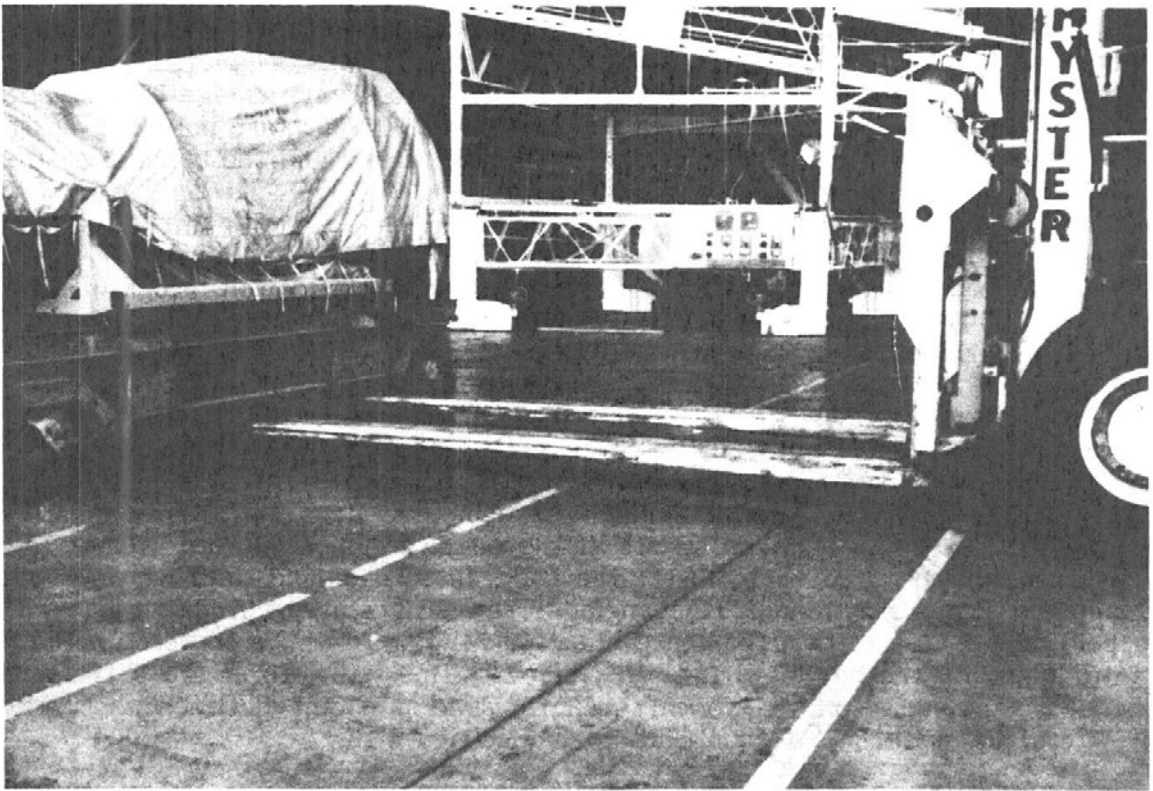
Figure 13. View of forklift and engine stand.

American Airlines' maintenance personnel testified about their experiences with the forklift while handling the engine and pylon assembly. Directions were transmitted to the lift operator either by voice, hand signals, or both. The testimony varied regarding the capability to raise or lower the lifting forks a finite distance. One mechanic said it could be limited to .001 inch; the estimates of others ranged from .25 to .06 inch.

When the full weight of the engine and pylon assembly was on the lifting forks, the pressure gauge reading was 18,000 lbs. Maintenance personnel stated that a 2,000-lb to 3,000-lb pressure bleedoff on the pressure gauge was common; however, they all stated that the lifting forks did not move. Supervisory personnel stated that it was normal for the gauge reading to bleed off 2,000 to 3,000 lbs during a 15-min period without any perceptible load movement. The load remains fixed because of the frictional load on the mast and rollers. Although mechanics testified that the load did not move, they also said that they would manipulate the controls to restore the original reading on the pressure gauge. One mechanic stated that the pylon and engine assembly would "jump" as lowering began. He said the "jerking" motion moved the forks about 1 or 2 inches.

From March 29 through 31, 1979, the accident aircraft underwent the spherical bearing modification. On April 19, 1979, the forklift's maintenance log contained a writeup which noted, in part, "trouble shooting, forks creeping down under load." There was no record that any corrective action was taken. On May 17, 1979, the log showed "Inspect lift cylinder--per Engineering." There was no record of any findings. On June 20, 1979, the forklift was tested for drift down. An engine-pylon assembly was placed on the lifting forks, and the forks drifted down 1 inch in 30 min. A lift cylinder check valve was found to be defective and was replaced.
