Uncontained engine failure, Aircraft Incident Report, Northwest Airlines 79, McDonnell Douglas DC-10-40, N143US, Leesburg, Virginia, January 31, 1981

AIRCRAFT INCIDENT REPORT

**NORTHWEST AIRLINES 79
McDONNELL DOUGLAS DC-10-40, N143US
LEESBURG, VIRGINIA**

NTSB-AAR-81-10

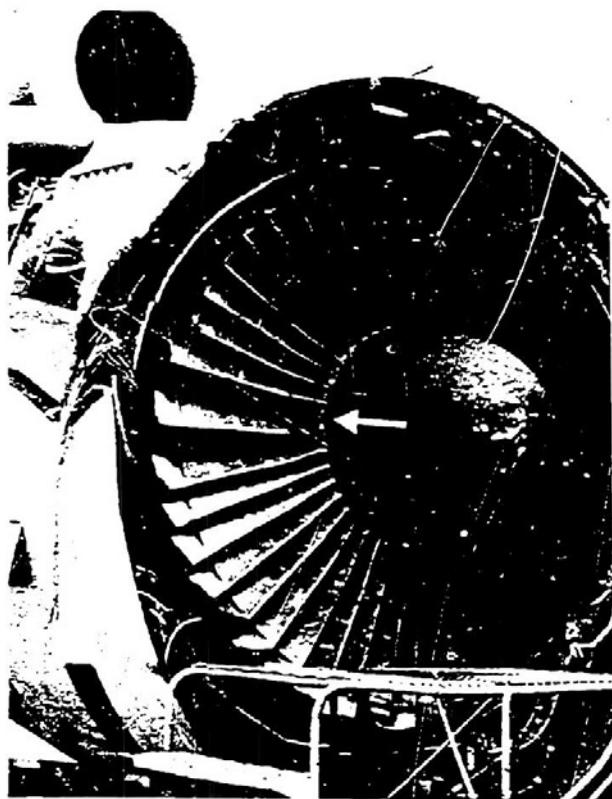
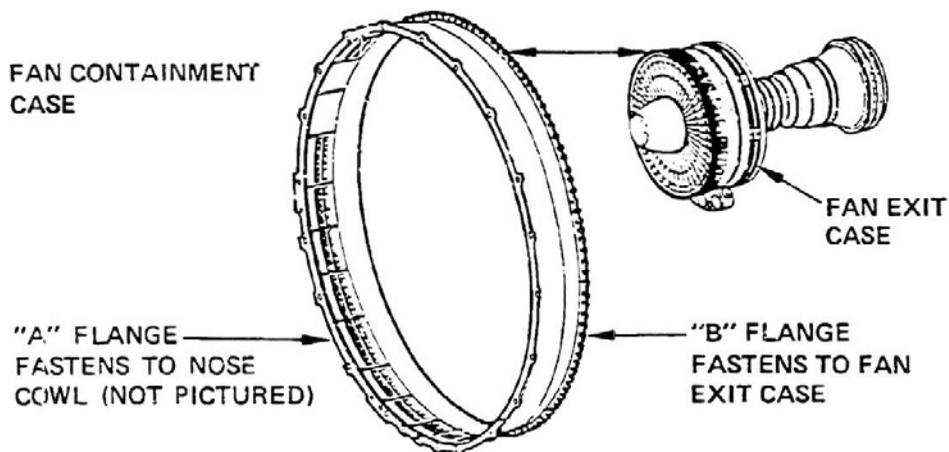
Figure 1.--No. 3 engine after incident.

The nose cowl assembly, the fan containment case forward of the B-flange, and their associated fixtures and components were missing from the aircraft. (See figure 1.) The rear of the nose cowl and the front of the fan case are mated at A-flange. The rear of the fan case and the front of the fan exit case are mated at B-flange. The fan exit case was torn and crushed around its leading edge. The compressor blades were damaged, all fan blades were damaged at the tips, and the No. 30 blade was missing.

The No. 30 blade had separated at a point about 1 inch outward from the blade platform. Two pieces of blade, representing about 80 percent of the blade area, were recovered. One piece was imbedded in the fan exit case stators and the other was found on the runway after the aircraft landed. The critical areas of the leading edge of the remaining 45 fan blades were inspected with a 10-power magnification lens and were found to exhibit no cracks or other significant anomalies. Minor in-service and typical FOD nicks were present in the areas examined. A 1/2-inch outward bulge was found in the trailing edge of the fan spinner in front of the No. 35 fan blade. There was no other damage to the spinner. A 1/4- by 7/16- by 3/8-inch section was missing from the convex side of the No. 35 blade slot in the fan disk forward surface.

NO. 3 ENGINE AFTER INCIDENT.
ARROW DENOTES SEPARATED
NO. 30 FAN BLADE.

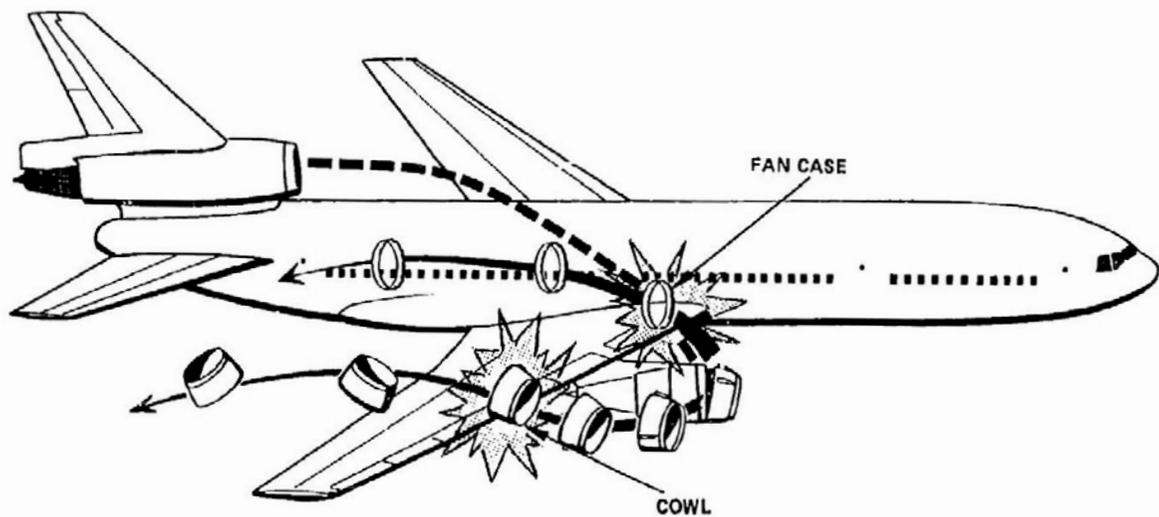
Figure 4.--Graphic analysis of the loss of the nose cowl and fan case.

When the fan blade fractured, it struck the fan case and the inner nose cowl near the 6-o'clock position, causing the loss of two to five A-flange inlet cowl retention bolts in the area of the impact. The impact loads may have also caused the B-flange bolt

fractures or the flange breakout in an area corresponding to the A-flange failures. The engine dynamic imbalance and the aerodynamic loads on the engine nose cowl loaded the remaining A-flange fasteners beyond their tensile strength and the flange joint began to separate. The bolts sheared in a sequential circumferential (unzipping) manner until only fasteners between the 1- and 3-o'clock positions remained. Aerodynamic forces then lifted the cowl away from the engine, pivoting about the remaining bolts, stripping the bolts from their nut plates, and bending the flange backward and outboard. The cowl separated upward and outward and struck right wing slat No. 5. As the A-flange fasteners progressively separated, additional aerodynamic loading caused interaction between the fan blade tips and the fan case and caused increased loading on the B-flange. The torsional loads imposed by fan blade tips striking the fan case and the additional aerodynamic loading caused failure of the B-flange fasteners. The unrestrained fan case moved in and out of the fan exit case and struck the fan exit guide vanes at random locations. The fan case was driven forward and was radially swung away from the engine, striking the fan exit case. The impact caused the fracture of a small section of the fan exit case B-flange and bent it backward and inboard. The fan case departed upward and inward and struck the leading edge Nos. 1 and 2 slats on the right wing. (See figure 4.)

7. The nose cowl, which separated upward and outward, struck and damaged slat No. 5.
8. Increased aerodynamic loading and fan blade tip/fan case interaction caused shearing and overloading of the B-flange fasteners.

9. The fan case, which separated upward and inward, struck and damaged slats Nos. 1 and 2.
10. The No. 2 engine was damaged by material from the fan case and/or fan exit case.
