Landing with gear-up, Eastern Airlines, Boeing 727-25, N8140N, John F. Kennedy International Airport, Jamaica, New York, April 8, 1981

**EASTERN AIRLINES
BOEING 727-25, N8140N
JOHN F. KENNEDY INTERNATIONAL AIRPORT
JAMAICA, NEW YORK
APRIL 8, 1981**

NTSB-AAR-81-14

Adopted: September 1, 1981

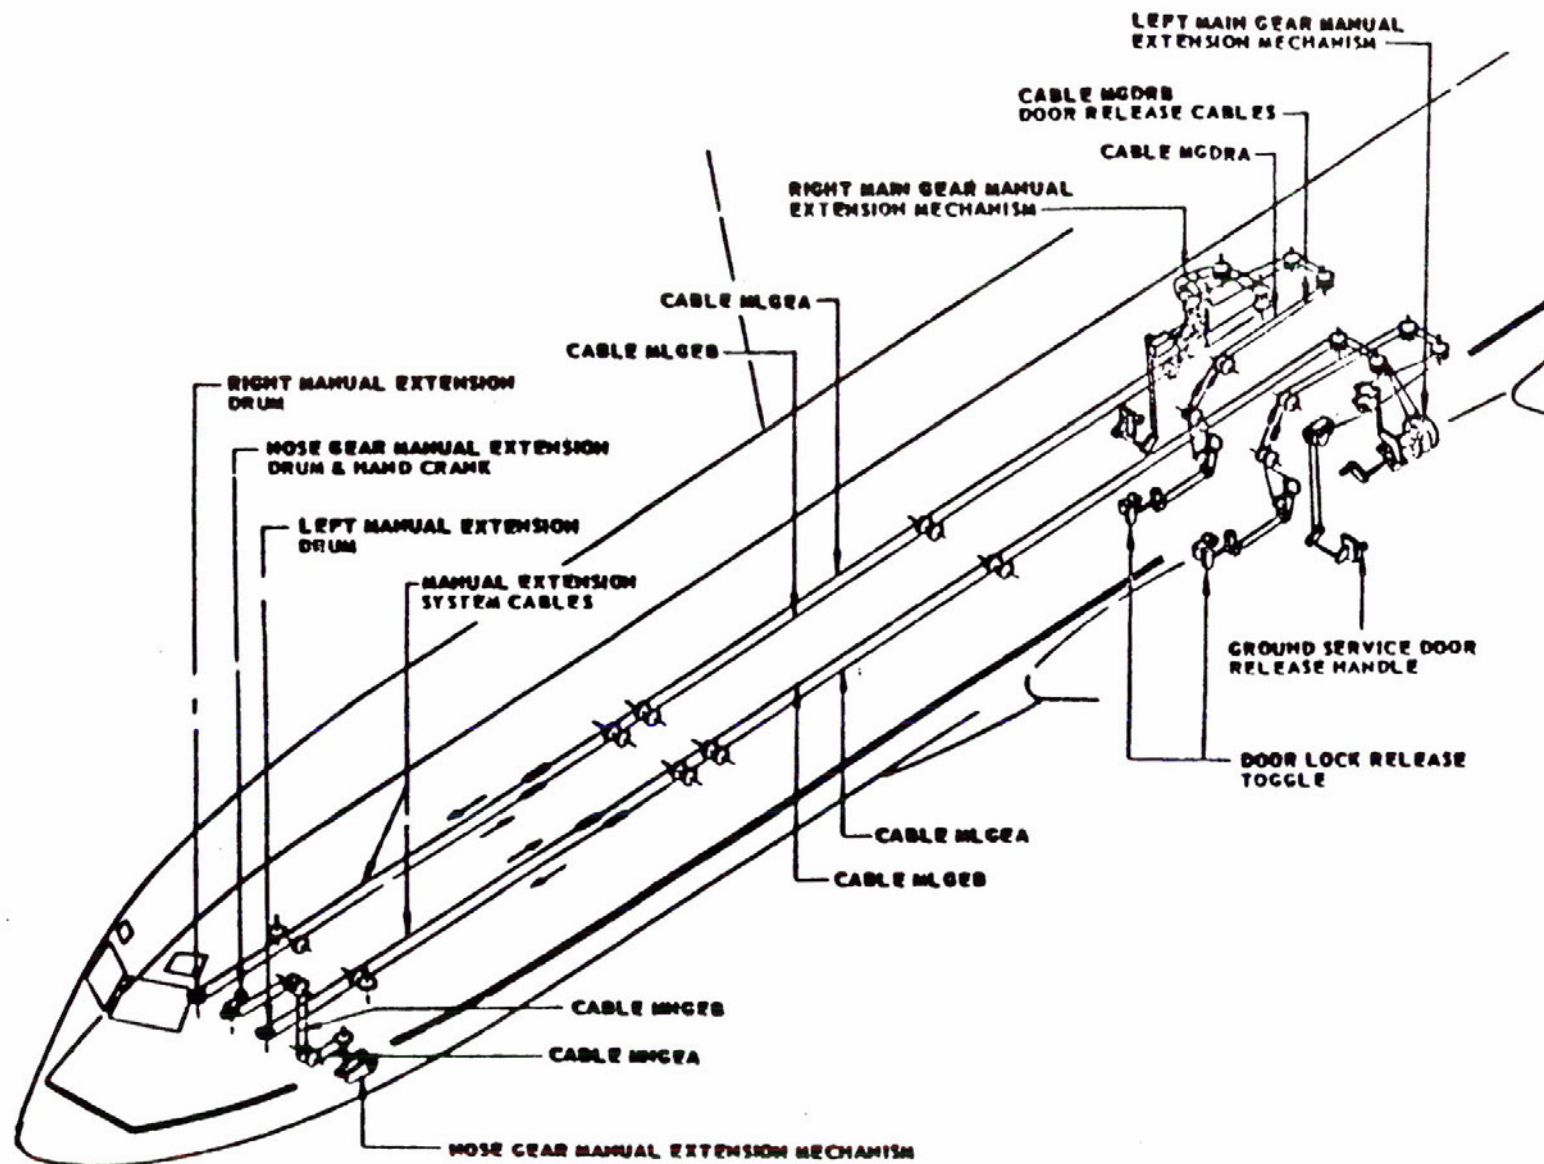
Figure 1.—Manual gear extension system.

The aircraft was lifted off the runway by cranes. Both inboard main landing gear doors were hanging by the attached actuators and sequencing push-pull rods. After the loose doors had been cleared, the nose and both main gears were extended manually by a Safety Board investigator and pinned in the down and locked position. (See figure 1.)

In normal manual operation, the handcrank must be rotated 3 turns clockwise (CW) to release the door uplock and gear uplock. When the door and gear fall free, the crank must be rotated 6 turns counterclockwise (CCW) to lock the gear down. When the aircraft was lifted from the runway, the Safety Board investigator rotated the left main gear manual extension handcrank in a clockwise direction to release the gear uplocks. The investigator said that he felt increasing resistance to rotation after about one turn, and after about 1 3/4 turns, he heard a "thud," the resistance eased, and the gear fell free from the retracted position. The crank rotated counterclockwise six turns without any resistance and the gear locked down normally.

The handcrank was rotated counterclockwise about 1 1/2 to 2 turns until the manual extension gearbox crank roller contacted the side strut cam. Resistance to the rotation of the handcrank increased, accompanied by slackening of the cable on the upper side of the drum, sufficiently to allow the cable to move out the groove and ride between the drum lands and the cable guard. When force on the handcrank was reduced, the cable tension caused the crank to spring back.
