**Runway excursion, Scandinavian Airlines System Flight 901, McDonnell Douglas DC-10-30, Norwegian Registry LN-RKB, John F. Kennedy International Airport Jamaica, New York, February 28, 1984**

## **AIRCRAFT ACCIDENT REPORT**

**SCANDINAVIAN AIRLINES SYSTEM  
FLIGHT 901  
McDONNELL DOUGLAS DC-10-30  
JOHN F. KENNEDY  
INTERNATIONAL AIRPORT  
JAMAICA, NEW YORK  
FEBRUARY 28, 1984**

**NTSB/AAR-84/15**

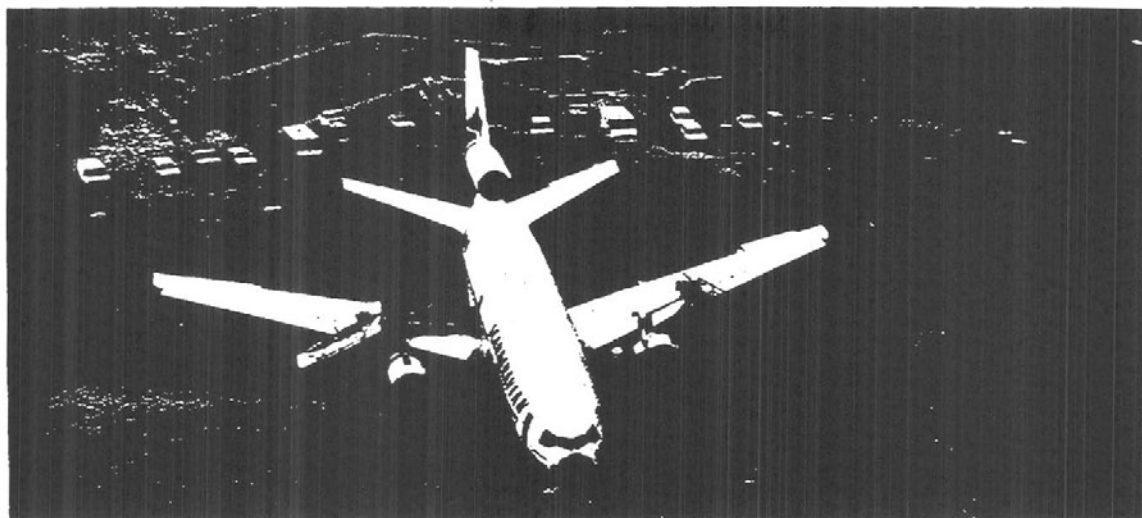
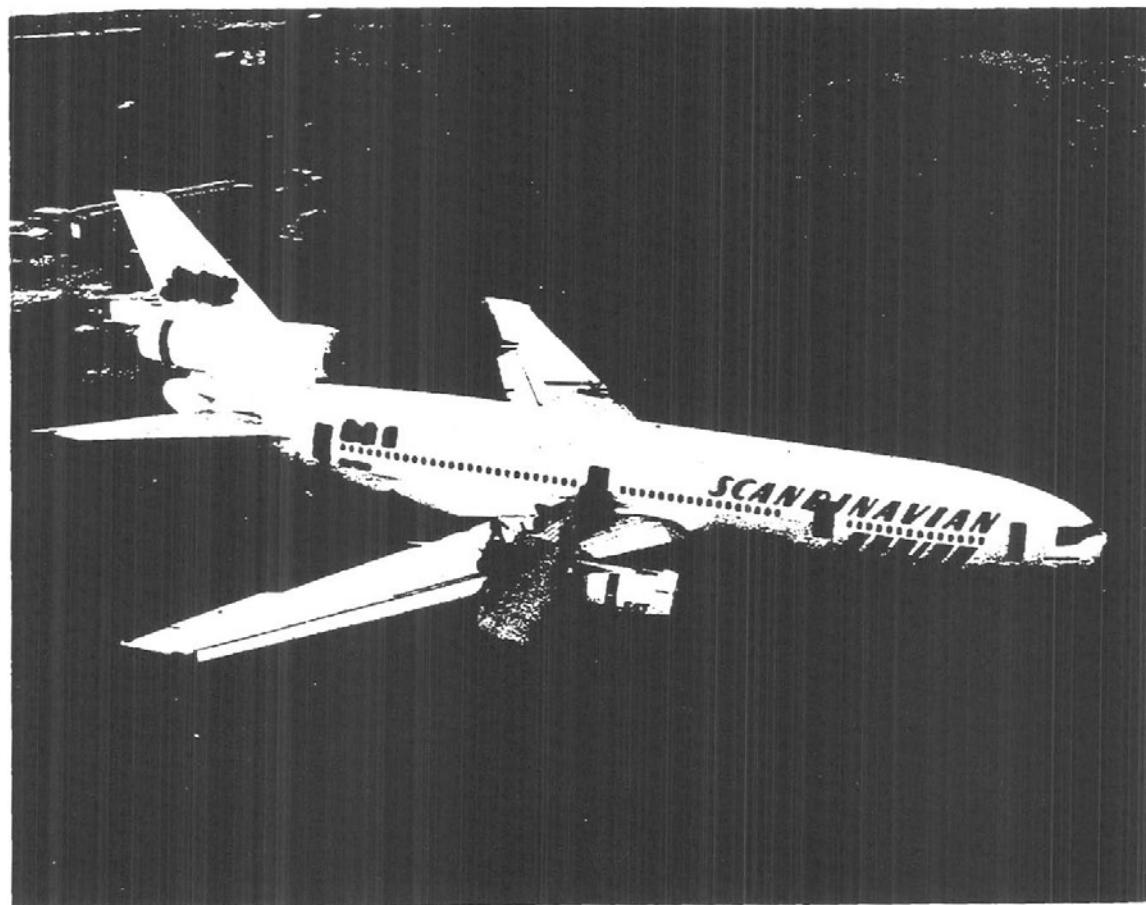
Figure 2.—Flight 901 at rest in Thurston Basin.

The forward section of the airplane fuselage came to rest in Thurston Basin, a tidal waterway about 600 ft (182.88 meters) from the runway 4R departure end. The airplane was damaged substantially. (See figure 2.) The captain immediately began to execute the memory items of the "On-Ground Emergency Check List." However, neither he nor the systems operator could move the engine fire selectors or fuel cutoff levers to their full off positions.

The aft portion of the fuselage remained generally intact. There was major damage at the lower nose area, to the radome, and to the forward pressure bulkhead at fuselage station (FS) 275. The nose landing gear structure had collapsed under the fuselage. The drag braces were fractured and had separated from their attachment fittings. The interior of the forward fuselage area was deformed and exhibited fractures at the flight deck and galley floor locations. Several floor beams below the galley floor were fractured and twisted.

The wings, leading edge slats, and flaps sustained moderate damage from impact with the wooden pier structure. The leading edge slats were extended fully and the trailing edge flaps were extended to the 40° position.

The No. 1 engine pylon structure was buckled and twisted; the No. 2 and 3 engine pylons exhibited no major structural damage. The No. 1 and No. 3 engines sustained major impact and salt water damage. The No. 2 engine sustained no impact damage. All three fan and turbine thrust reversers were in the fully deployed (reverse thrust) positions.
