Collision with localizer on takeoff, United Airlines Flight 663, Boeing 727-222, N7647U, Denver, Colorado, May 31, 1984

AIRCRAFT ACCIDENT REPORT

UNITED AIRLINES FLIGHT 663
BOEING 727-222, N7647U
DENVER, COLORADO
MAY 31, 1984

NTSB/AAR-85/05

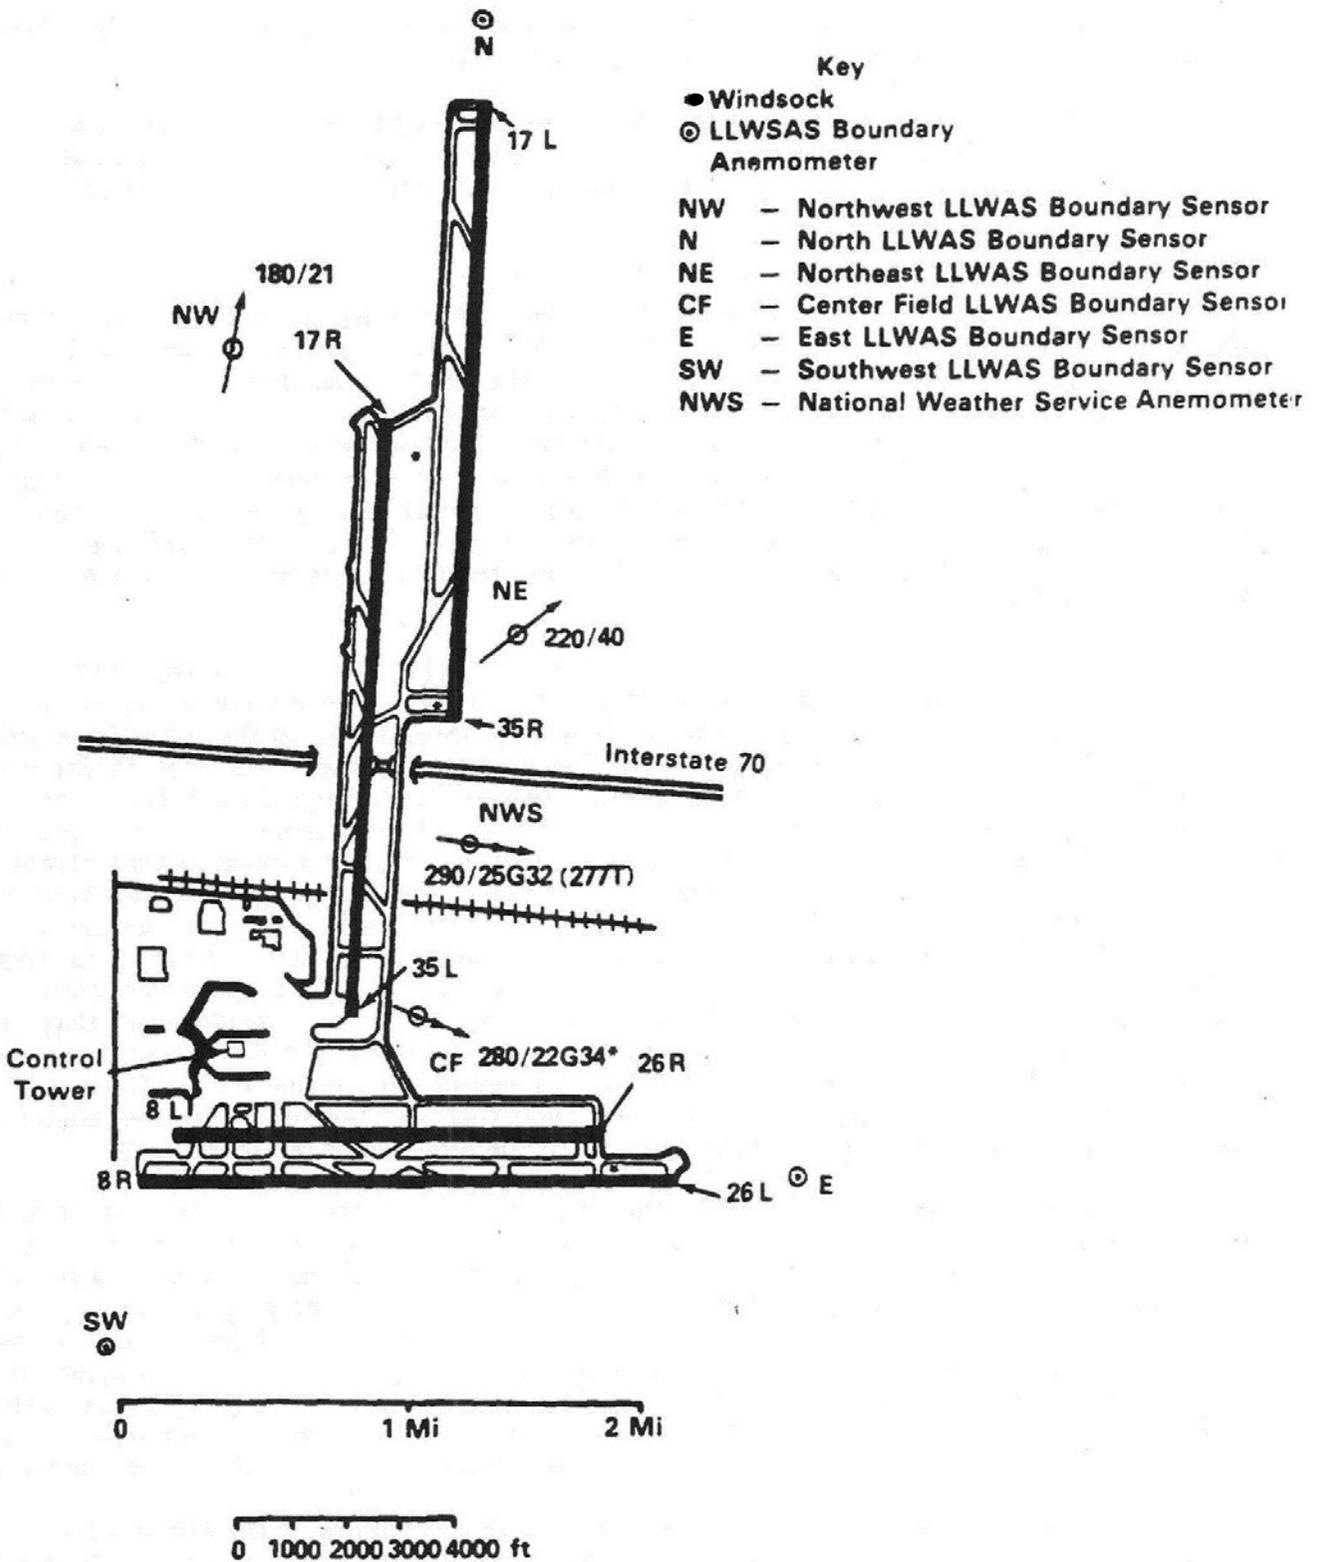
Figure 1.--Partial plan view of Denver Stapleton Airport showing locations of LLWAS boundary sensors and the microburst winds recorded about 1333.

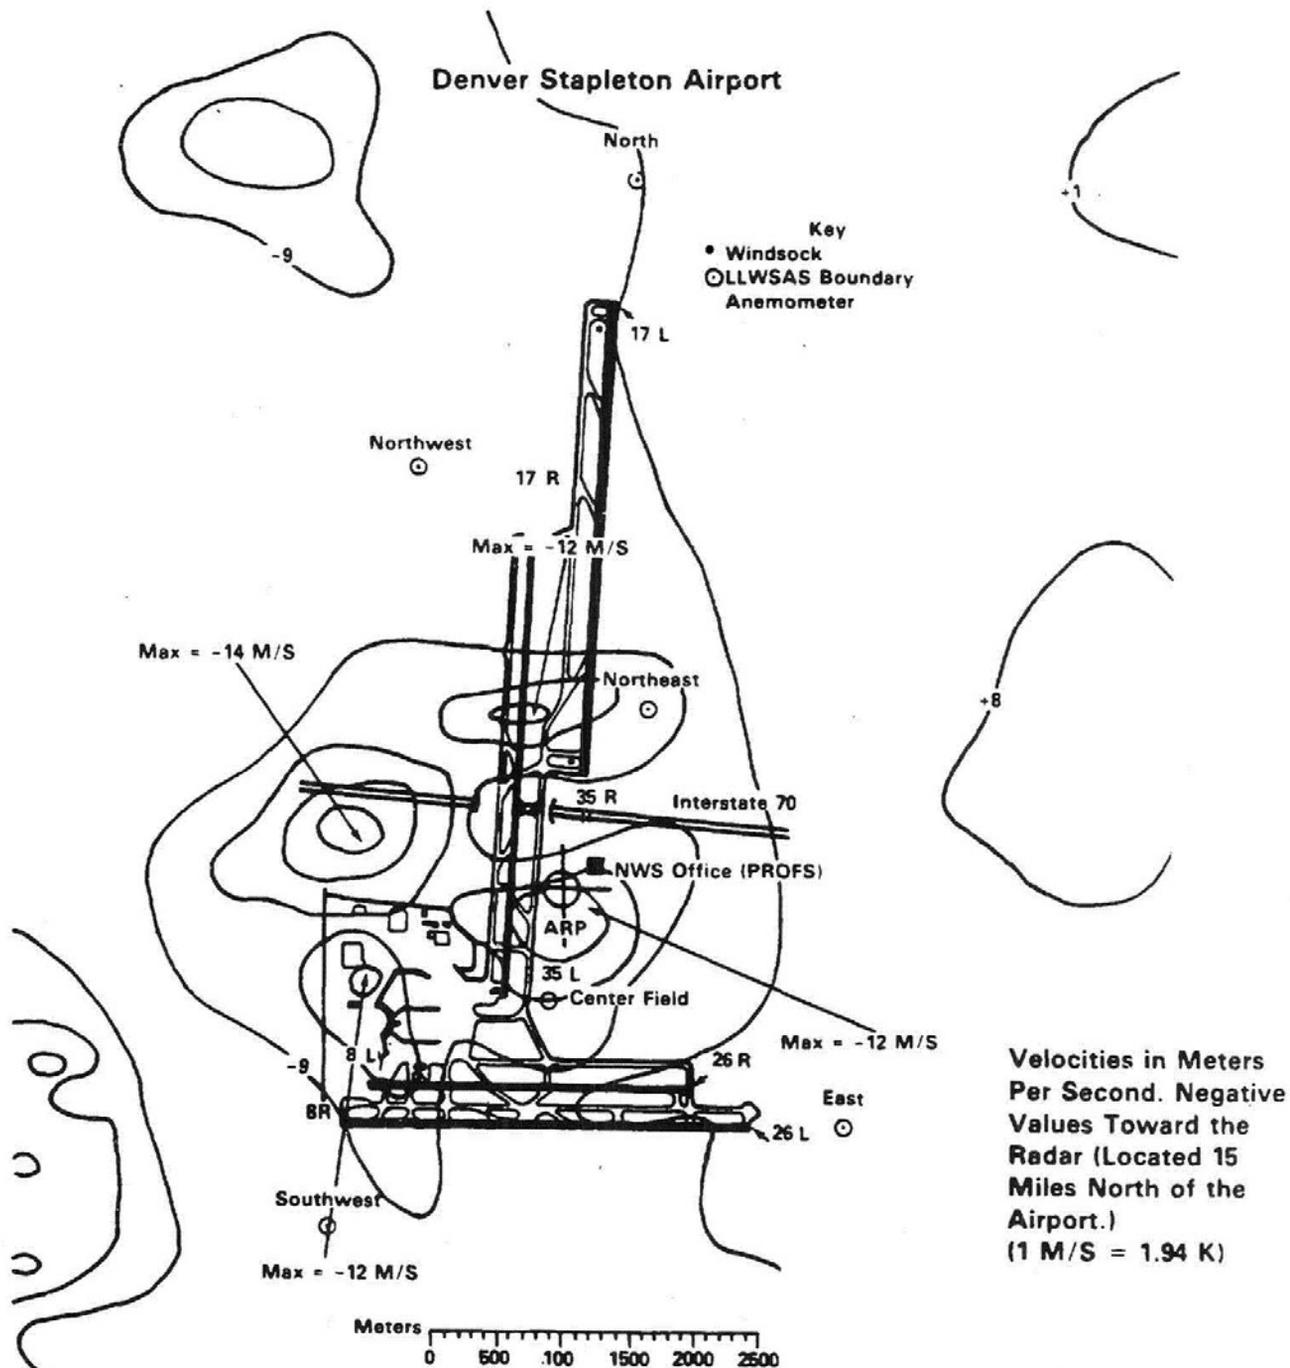
The available weather data showed that "high base" thunderstorm activity had been approaching Stapleton from the southwest. This type of thunderstorm has a base high above the ground, generally between 8,000 and 12,000 feet, and a dry adiabatic lapse rate ^{14/} in the atmosphere below the thunderstorms. These high-based thunderstorms are quite common in the summertime over the high plains east of the Rocky Mountains and over the desert to the southwest where the combination of very hot dry surface air and mid-level moisture are present. Descending virga were associated with this activity near Stapleton creating downdrafts which spread outward as they reached the ground, causing strong surface gusts. The evidence disclosed that this event was the result of a microburst. Wind shear from a microburst, as compared to wind shear resulting from a gust front, is particularly hazardous because it is a short-period event which creates very strong wind gusts with a large variation in direction over a very short distance (1/2 to 2 1/2 miles in diameter). All indications were that the microburst which affected the departures on runways 35L and 35R was from a cell which was passing about 1 mile northwest of the control tower. From 1326 to 1334, the microburst apparently affected the surface of the airport only north of runway 8L/26R and south of the departure end of runway 35R. This is based upon the fact that neither the southwest, east, or north LLWAS boundary anemometers showed the effects of a gust during this time. (See figure 2 and appendix E.)

NCAR Doppler radar scan at 0.7° elevation at 1334:38 MDT, 31 May 84, representing radial flow with respect to CP-4 radar to the north, at 500-700 meters above runway level. Runway location approximate

Figure 2.—Radial velocities observed by the NCAR CP-4 doppler radar at 1334.38.

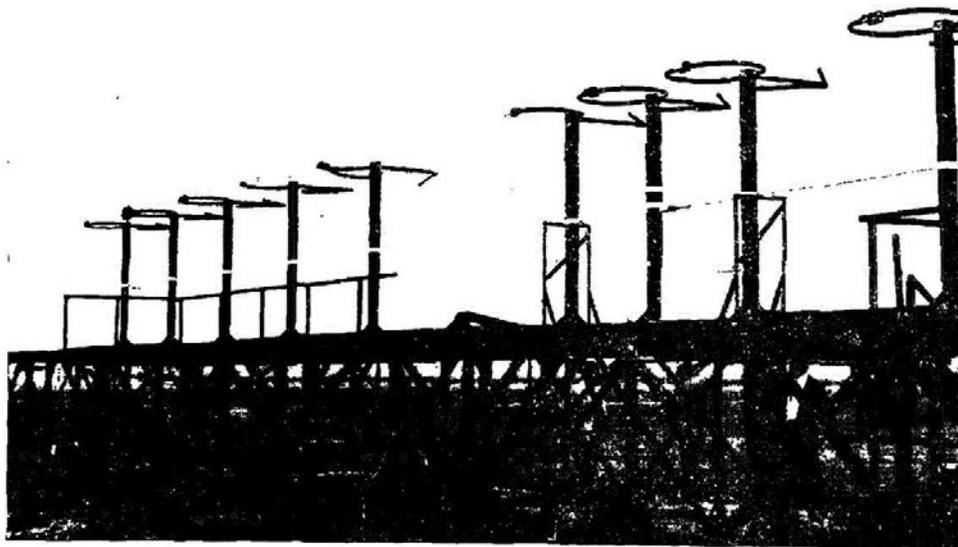
Figure 3.—Runway 35L ILS localizer antenna.

The ILS V-ring localizer antenna array platform located 1,074 feet from the departure end of runway 35L was damaged. The No. 6 antenna array stanchion was bent over, the antenna arrays on top of the Nos. 4, 5, and 7 stanchions were damaged, and some of the platform railing was damaged. The grass was scorched by jet exhaust from a point 300 feet beyond the end of the runway to a point 245 feet in front of the antenna platform.

The airplane struck the localizer antenna located 1,074 feet beyond the end of runway 35L about 2 to 3 feet from the top of the antenna array. (See figure 3.) The airplane sustained substantial impact damage to the right side of the fuselage, just forward of the aft cargo door between body stations (BS) 1010 and 1090 (see figure 4), and minor impact damage on the opposite side of the fuselage between BS 992 and BS 1246. There also were minor impact damage and paint transfer marks on the number one, outboard main landing gear tire, on the underside of the right inboard trailing edge flap, and on the number four, right main landing gear tire.
