Runway excursion, Piedmont Airlines Flight 467, Boeing 737-222, N752N, Charlotte Douglas International Airport, October 25, 1986

AIRCRAFT ACCIDENT REPORT

**PIEDMONT AIRLINES FLIGHT 467
BOEING 737-222, N752N
CHARLOTTE DOUGLAS INTERNATIONAL AIRPORT
CHARLOTTE, NORTH CAROLINA
OCTOBER 26, 1986**

NTSB/AAR-87/08

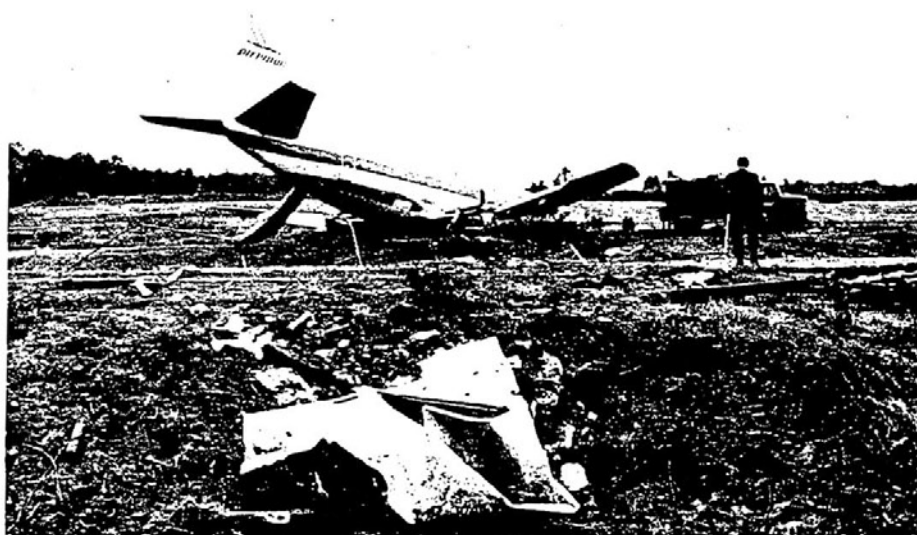
The National Transportation Safety Board determines that the probable cause of the accident was the captain's failure to stabilize the approach and his failure to discontinue the approach to a landing that was conducted at an excessive speed beyond the normal touchdown point on a wet runway. Contributing to the accident was the captain's failure to optimally use the airplane decelerative devices. Also contributing to the accident was the lack of effective crew coordination during the approach. Contributing to the severity of the accident was the poor frictional quality of the last 1,500 feet of the runway and the obstruction presented by a concrete culvert located 318 feet beyond the departure end of the runway.

Figure 2.—Concrete culvert area and rear view of airplane.

As a result of its investigation, the Safety Board issued a recommendation to the Federal Aviation Administration (FAA) to require airport managers, at the earliest opportunity, to repair or remove obstacles, such as concrete culverts, that are adjacent to airport operating areas. The Safety Board also issued recommendations to the FAA urging it to issue operations bulletins to principal operations inspectors of air carriers operating aircraft with flight attendants informing them of the need to cease providing alcohol to passengers who are in, or appear that they are about to be in, an intoxicated state; and to require a one-time inspection of flight attendant seat pan roller assemblies. In addition two recommendations concerning the measurement of runway friction were issued to the FAA.

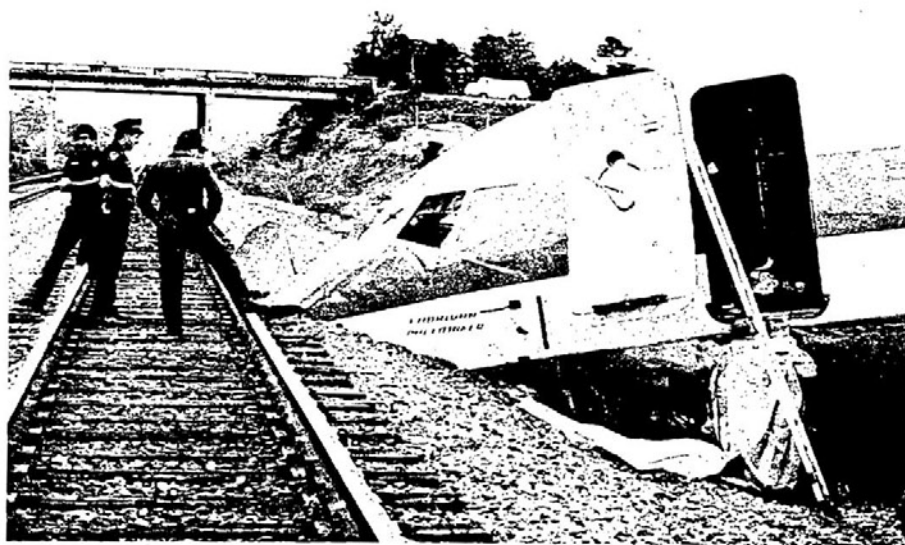
Figure 3.—Left side of airplane nose against railroad track.

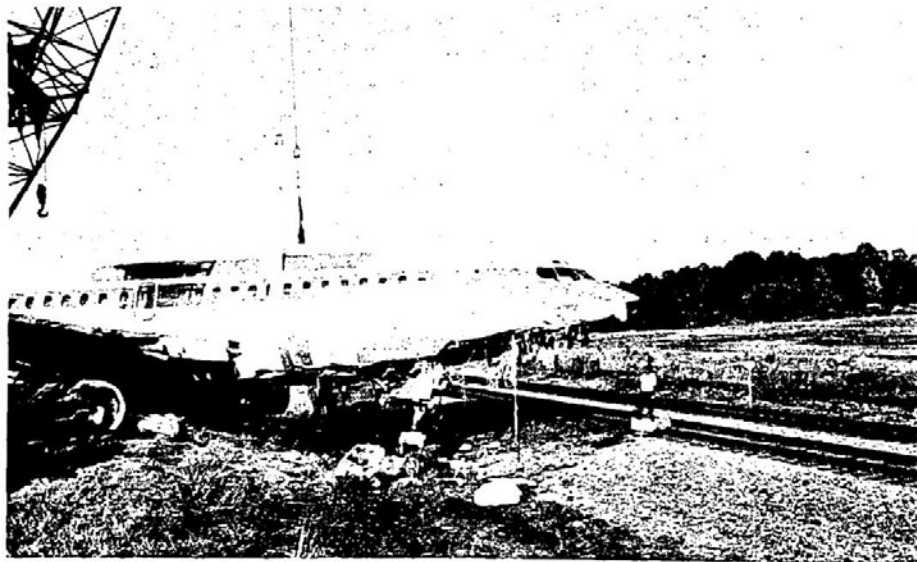
The airplane wreckage was confined to the area between the localizer antenna array, located north of the departure end of runway 36R, and the railroad tracks. Most of the damage to the airplane occurred to its underside, resulting mostly from contact with the concrete culvert located beyond the runway. (See figures 5 and 6.)

Figure 6.—Right side of forward fuselage

trailing edges, suffered decreasing degrees of damage. The keel beam was fractured aft of the wing center, and there was compression buckling of the fuselage skin forward of the aft exit. The empennage was undamaged.

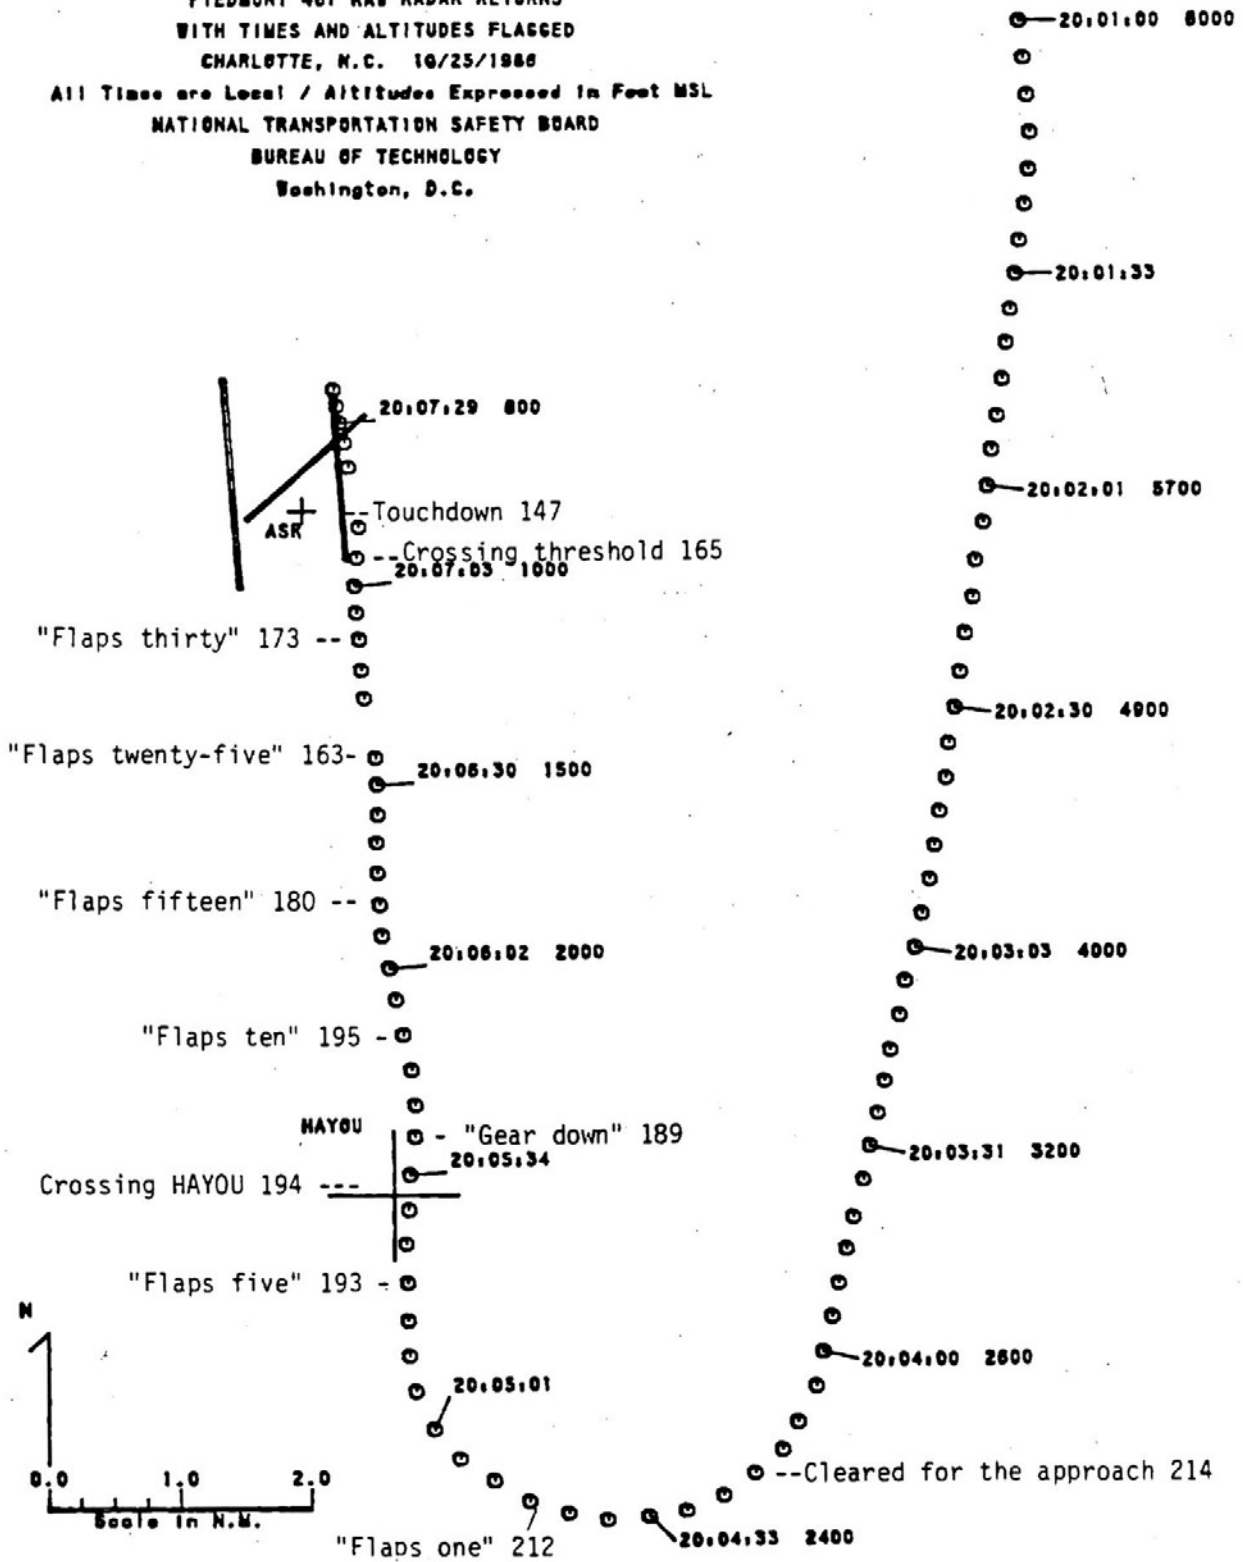
Figure 7.—Airspeeds and airplane configuration
at selected points in the approach of PI 467.

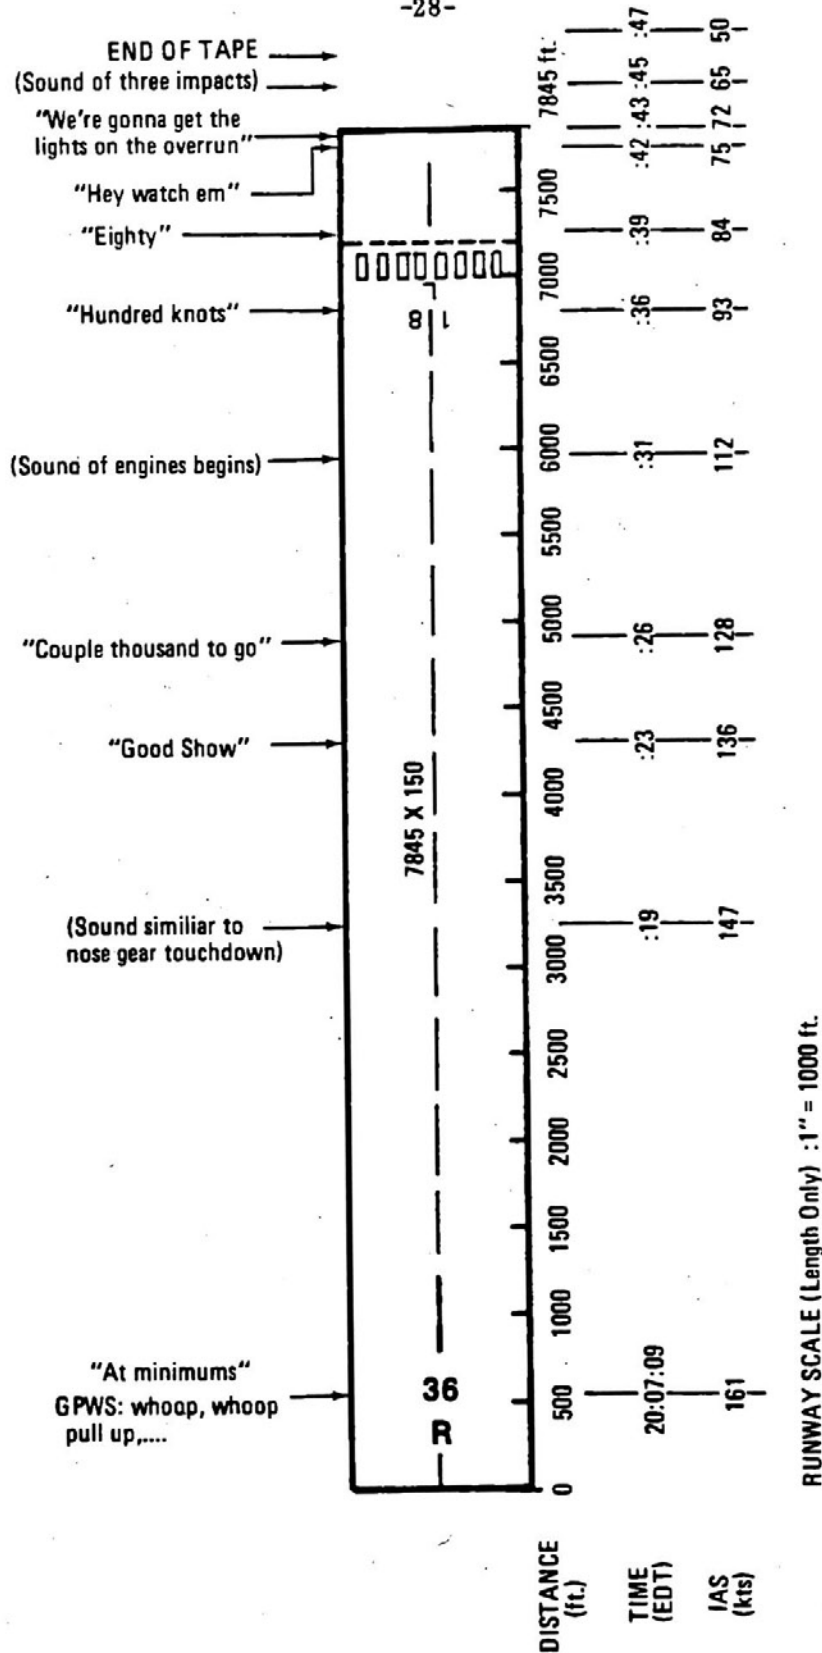
According to data supplied by Boeing, on a wet, grooved runway without spoiler extension, the airplane could have been stopped in about 3,500 feet provided full reverse thrust was obtained within 3 seconds of touchdown. However, significant reverse thrust was not obtained until about 12 seconds after touchdown when the airplane had slowed to about 112 KIAS, at which time less than 1,900 feet of runway remained. (See figure 8.) Consequently, although the frictional qualities of the last 1,500 feet of

Figure 8.—Speeds of PI 467 at selected points on the runway.

runway 36R were substandard, the lack of any spoiler extension could account for the delay in obtaining reverse thrust, the airplane poor stopping performance with the last 1,900 feet of runway, and its departure from the runway at a speed in excess of 70 KIAS.

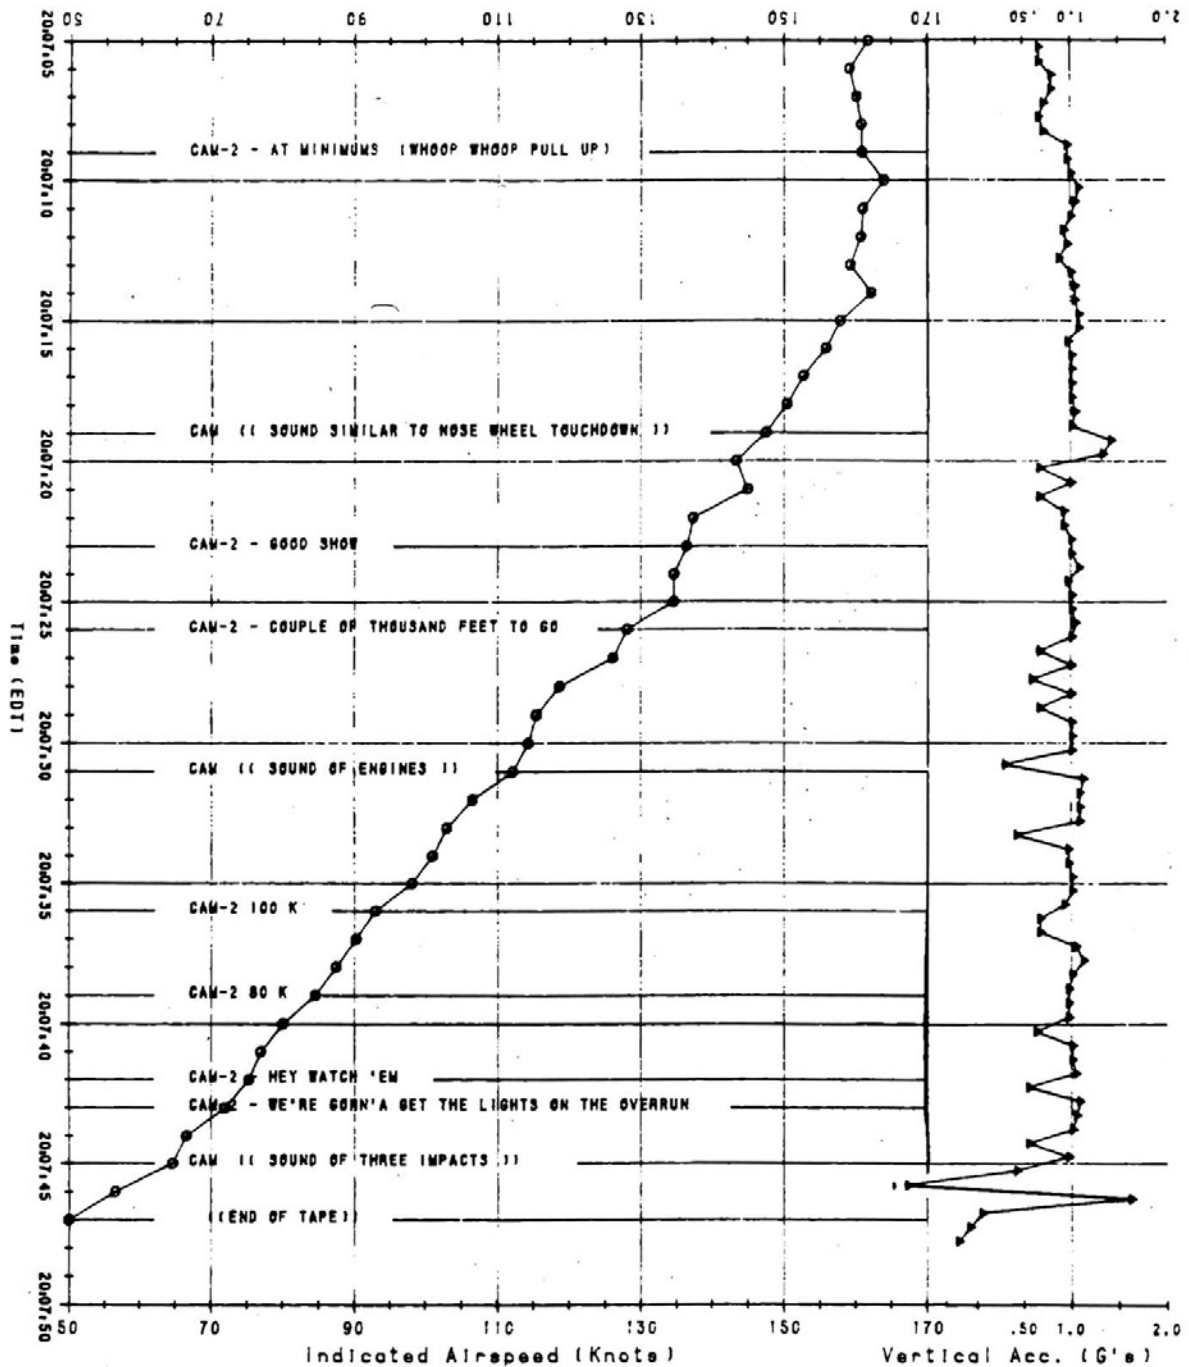
During the 6 seconds after touchdown, the airplane slowed from about 147 knots to about 135 knots, a deceleration of about 2 ft/sec². Since the brakes on the inboard wheels would not have been available immediately due to locked wheel protection, the performance of PI 467 in the first 6 seconds after touchdown suggests that the outboard wheels may have locked up within 3 to 4 seconds after touchdown, most likely due to the captain's application of wheel brakes before synchronous speed was achieved.

Figure 9.—Vertical acceleration and speeds of PI 467 following touchdown.

During that 6-second period, the airplane rolled about 1,400 feet. As the NASA research with pressure-bias-modulated antiskid systems demonstrated, on an ungrooved, wet runway, brake application before synchronous speed is reached can result in a locked wheel condition. This can prolong the time required for the wheels to reach synchronous speed by as much as 25 seconds. Under locked wheel conditions, the effective braking coefficients are less than 0.05, at speeds over 70 knots.
