Aircraft Accident Report, Piper PA-23-150, N2185P and Pan American World Airways Boeing 727-235, N4743, Tampa, Florida, November 6, 1986

**PIPER PA-23-150, N2185P
AND PAN AMERICAN WORLD AIRWAYS
BOEING 727-235, N4743
TAMPA, FLORIDA
NOVEMBER 6, 1986**

NTSB/AAR-87/06

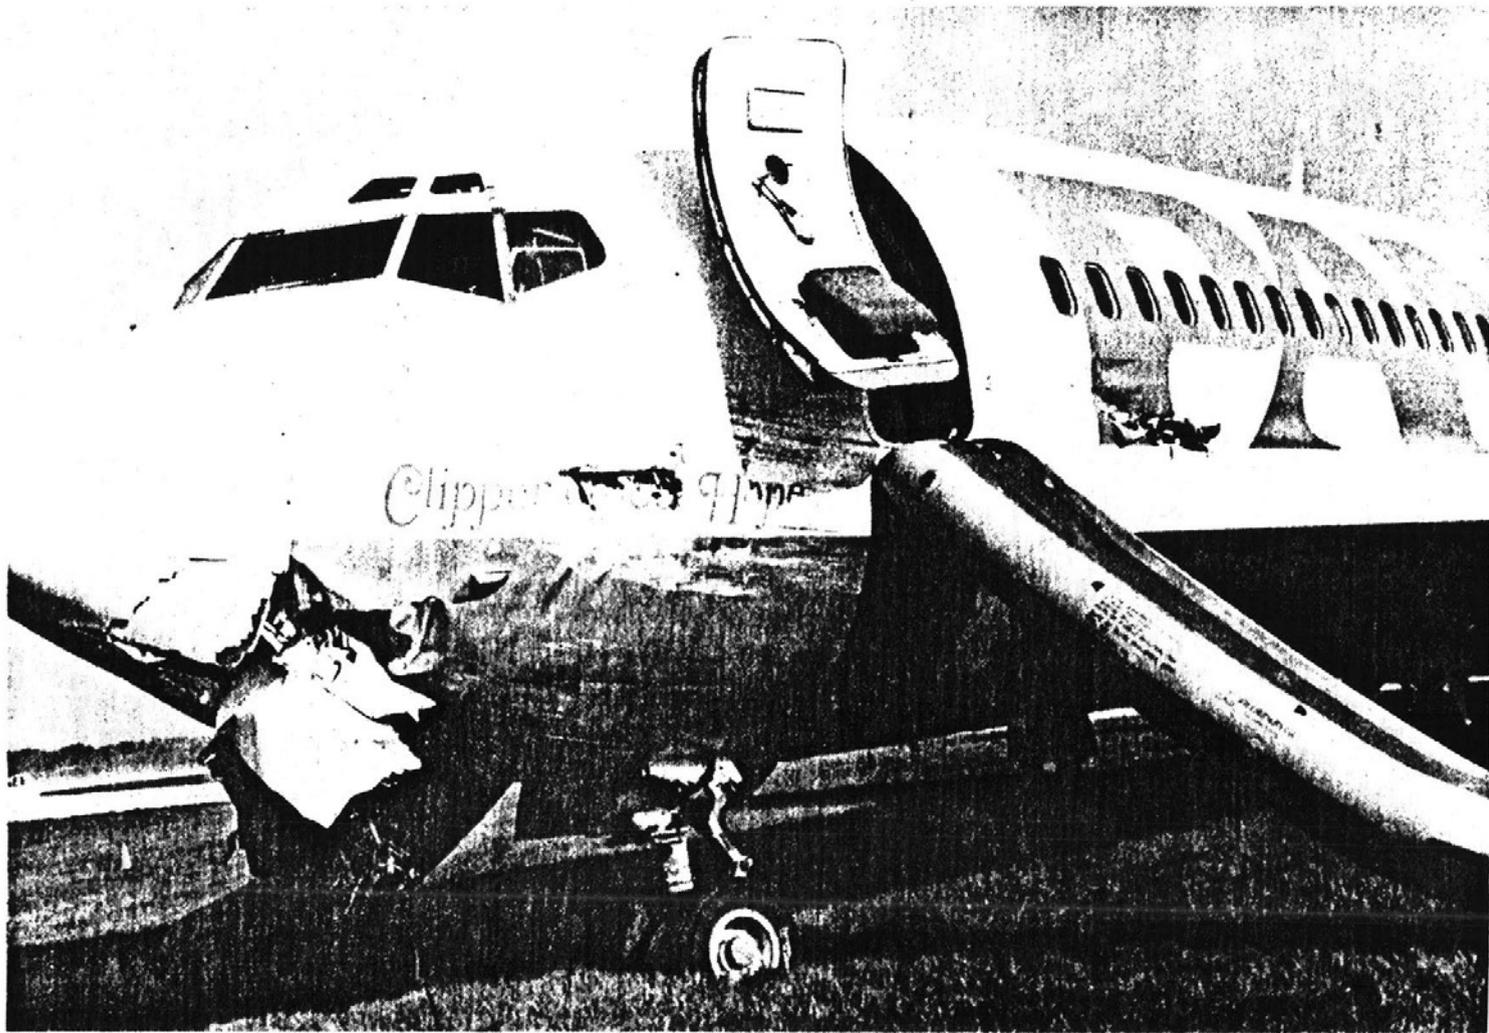
Figure 3.--N4743, a Boeing 727.

The Boeing 727, N4743, sustained substantial damage in the area of the radome and forward electronic compartment. The left side fuselage skin was scratched, dented, and torn. Fire damage was confined to the surface of the left lower wing and adjacent fuselage area.

The left engine and propeller of the Apache separated at impact and remained imbedded in the B-727 in the radome area. The radome and radar antenna were destroyed. The forward half of the B-727 nose gear left wheel well door was torn away. The electrical cable for the left main landing gear anti-skid system was severed. The horizontal stabilizer control drum mechanism and all mechanical systems located in the forward electronic compartment were damaged by the impact. The left side of the B-727 fuselage sustained scratches; dents and tears, including a deep dent; and scratches on the lower surface of the left forward entry door. Heat and fire damage were evident on the underside of the left wing between the fuselage and the midwing area. The left fuselage area and air conditioning bay access panels also were damaged by heat and fire.

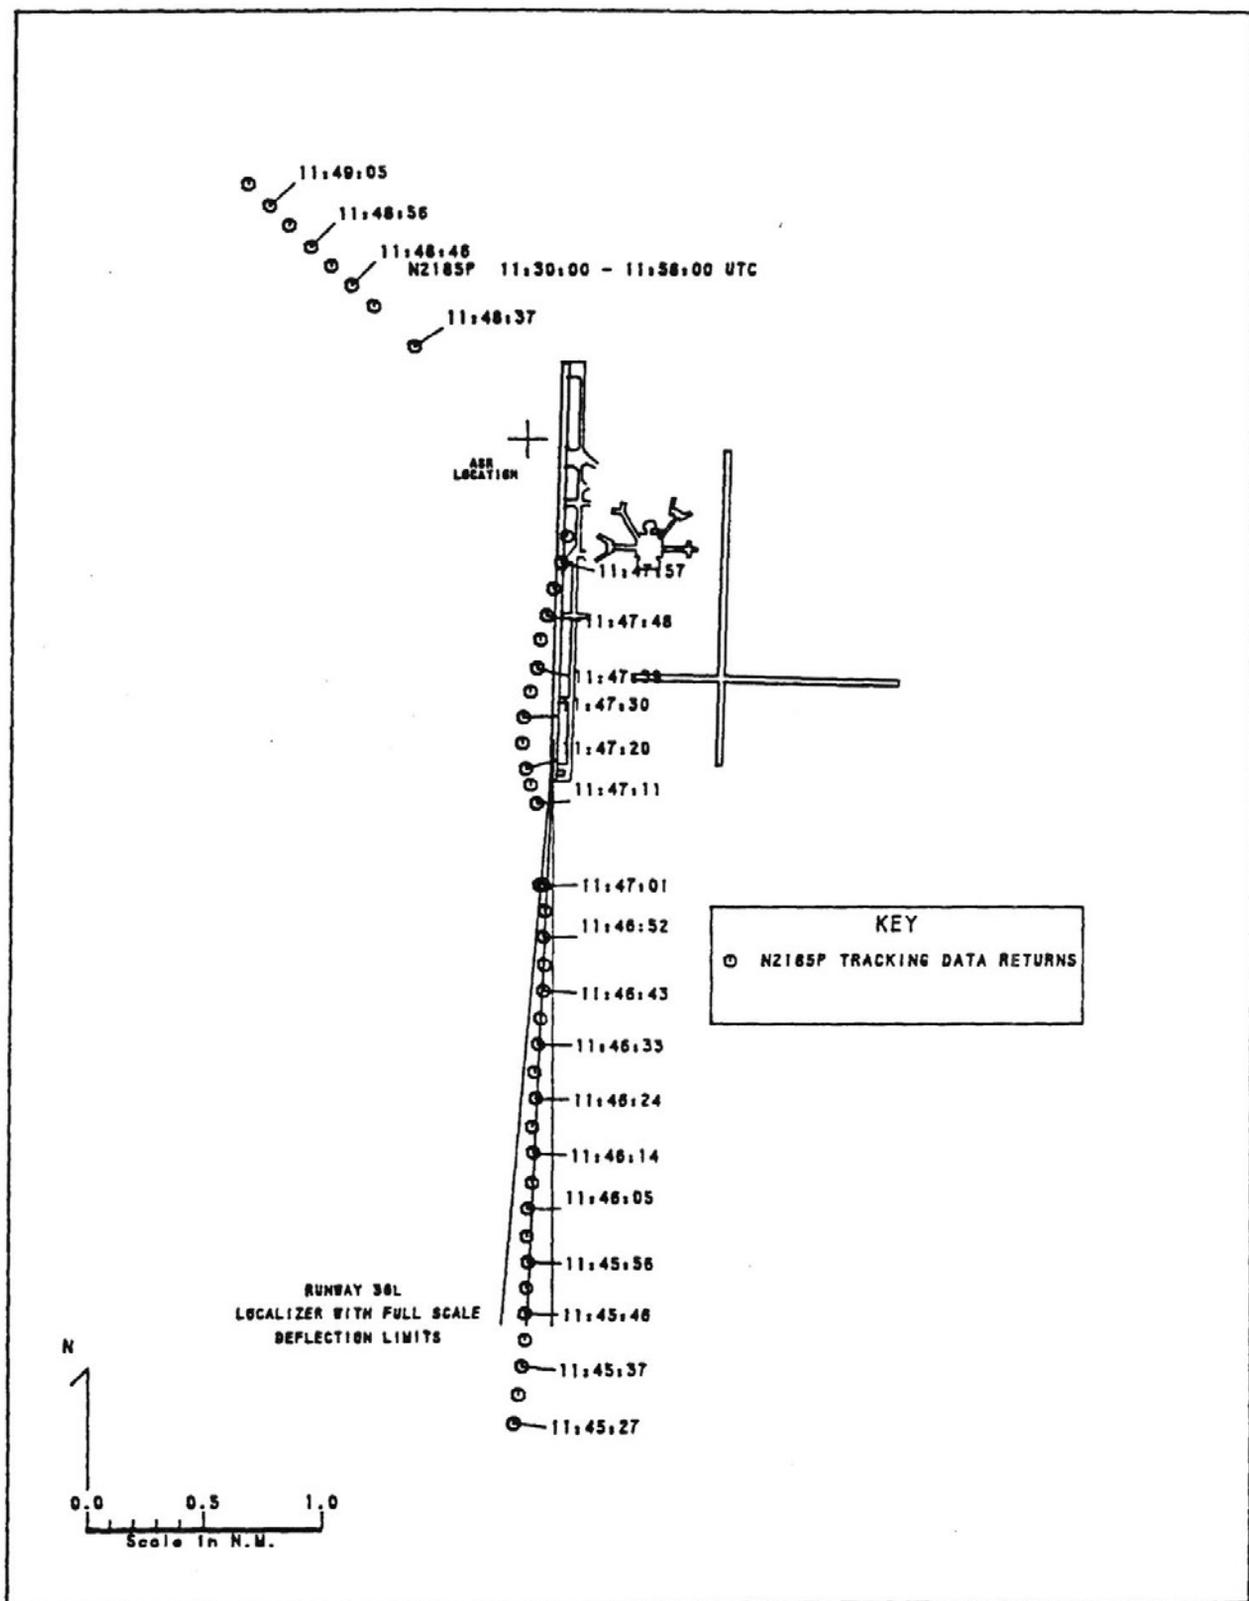
Figure 4.--First approach of the Piper Apache.

The only information available concerning the Apache pilot's execution of the two ILS approaches is found in the radar data recorded by Tampa Approach Control. Although the airplane was equipped with a transponder, it did not have an altitude reporting capability or an encoding altimeter. Therefore, there is no data available to determine the altitudes flown during those approaches. The course data indicate that both approaches were flown with a high degree of precision. There was normal bracketing of the localizer centerline, but no significant deviations were evident. As the two approaches progressed toward the middle marker, located 0.5 nautical mile from the end of the runway, the slight deviations decreased. Just inside the middle marker, however, at a point where the airplane should have been arriving at DH, slight excursions from the localizer were noted. On the first approach, this deviation was to the left (west) of course, and on the second approach, the airplane moved to the right (east) and lined up with taxiway W. At this point, the pilot would probably have been looking for the visual

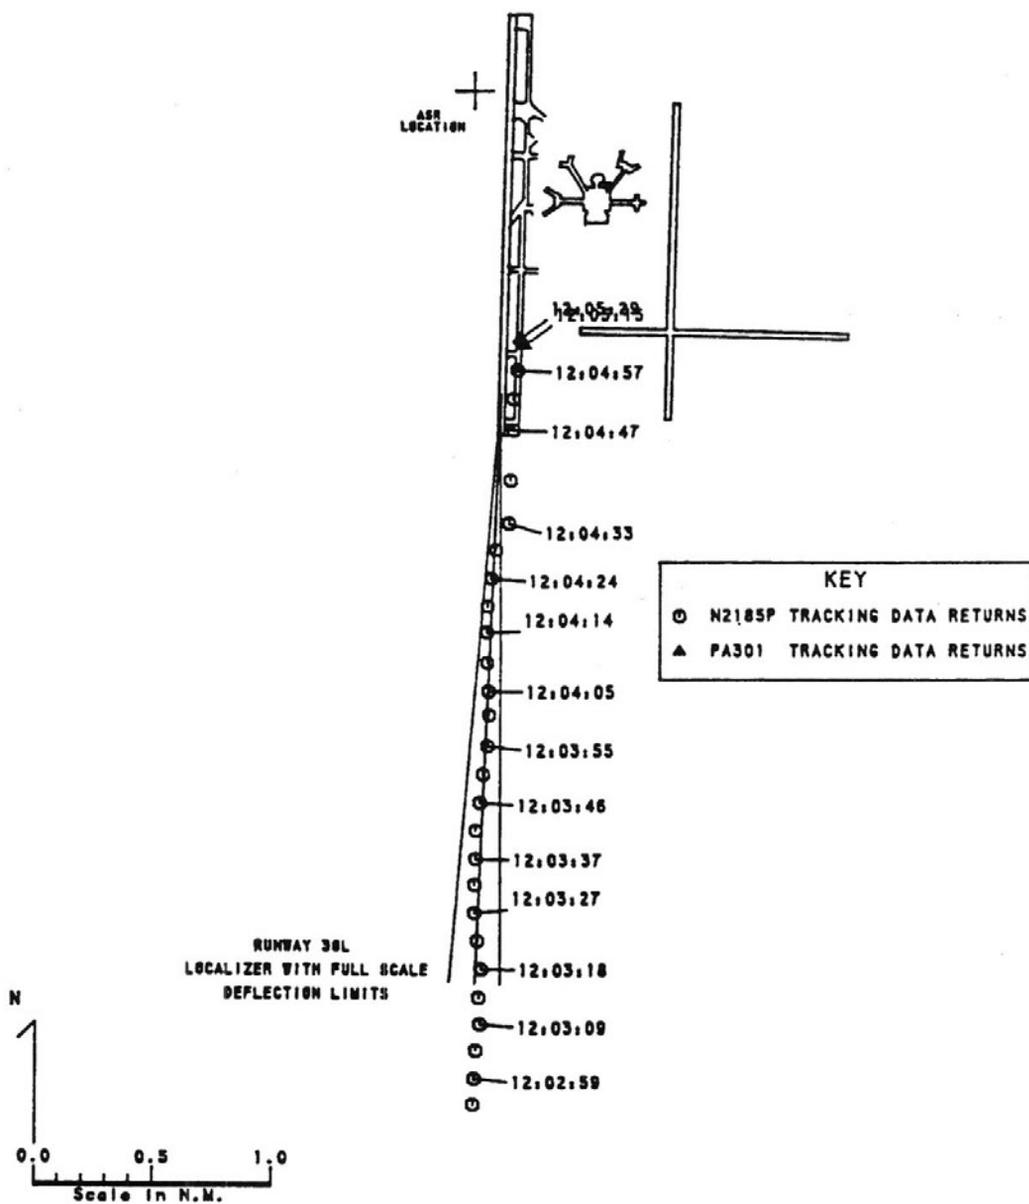
Figure 5.--Second approach of the Piper Apache.

11. The failure of the local controller to issue a landing clearance during the Apache's first approach did not contribute to the accident.
12. The Apache pilot flew both approaches with precision until he passed the middle marker, after which slight deviations from the localizer occurred.
