Crash after takeoff due to icing, Continental Airlines, Inc., Flight 1713, McDonnell Douglas DC-9-14, N626TX, Stapleton International Airport, Denver, Colorado, November 15, 1987

AIRCRAFT ACCIDENT REPORT

**CONTINENTAL AIRLINES, INC., FLIGHT 1713
McDONNELL DOUGLAS DC-9-14, N626TX
STAPLETON INTERNATIONAL AIRPORT
DENVER, COLORADO
NOVEMBER 15, 1987**

NTSB/AAR-88/09

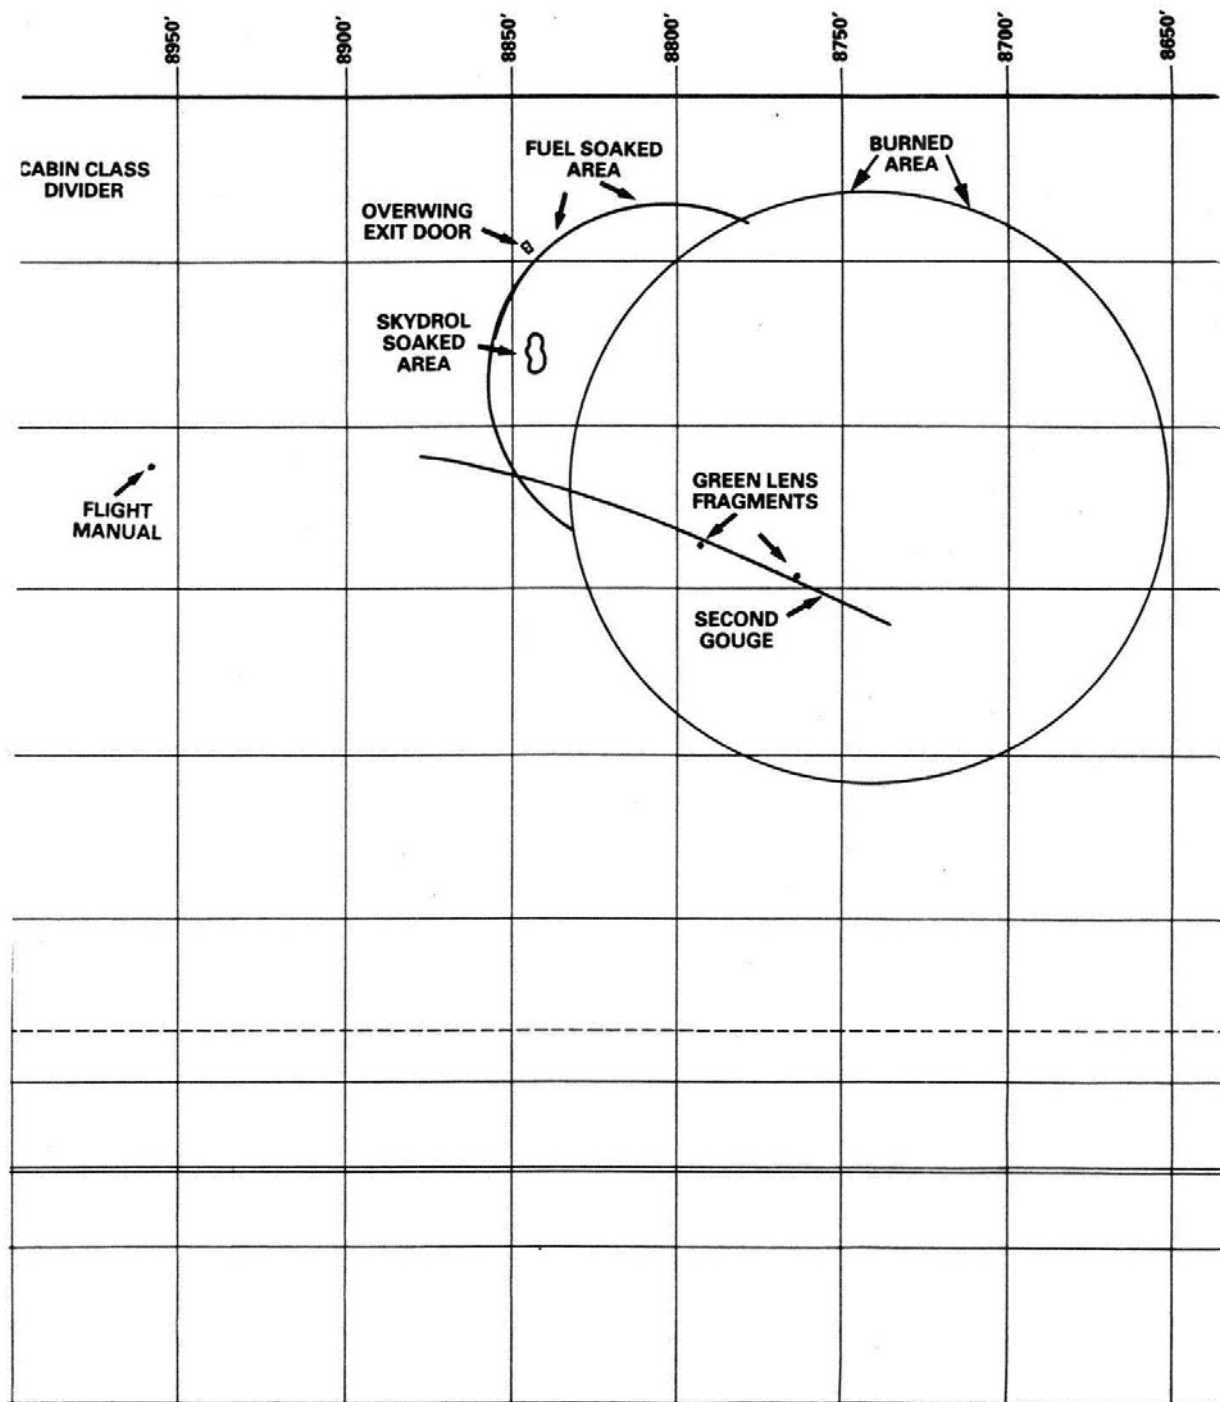
Figure 4. -- Wreckage diagram at accident site.

Three major ground scars were found at the accident site. The first ground scar began 8,244 feet down and 114 feet to the right of the runway 35L centerline. The 214-foot scar angled away from the runway approximately 20° and then turned slightly back toward the runway. The left wingtip landing light lens retaining ring was located 8,257 feet down and 130 feet to the right of the runway centerline. The red glass left navigation light lens also was found in this area. Left wing debris was found in a line between this area and the second ground scar, a crater 11 feet by 11 feet by 9 inches. Examination of the dirt in the crater revealed pieces of glass identified as the outer glass panel of the left cockpit "eyebrow" window. A third major ground scar contained green glass lens material. Other debris in the area of the third crater consisted of various airplane components, including pieces of cabin interior, overhead compartment fragments, and passenger luggage.

The nearly intact empennage/tail cone section of the airplane was located approximately 250 feet down from the third scar. It was inverted and aligned on a magnetic heading of 234°. The empennage was coated with soot but showed no signs of thermal damage. The left horizontal stabilizer tip and left elevator tip were missing. Fragments from these components were located earlier along the wreckage path, south of the empennage.

The fuselage and right wing were located approximately 200 feet down from the empennage. The forward portion of the fuselage, which had split at fuselage station 446, was resting on its left side. Longerons 1R through 15R were intact but severely bent and distorted. This was the only structure connecting the forward fuselage to the rear fuselage. The left side of the forward fuselage was badly damaged. Much of the exterior skin and underlying structure was torn away and found along the wreckage path. The right side of the fuselage was distorted and dented in several areas near the forward baggage door. The aft portion of the fuselage was aligned with the forward half of the fuselage and resting inverted. The section of fuselage just aft of the break was collapsed to within inches of the cabin floor. The portion of the fuselage adjacent to the engines was collapsed to the level where the forward part of the engine was resting on the ground. The right wing remained attached in its proximate correct position. (See figures 4 and 5.)

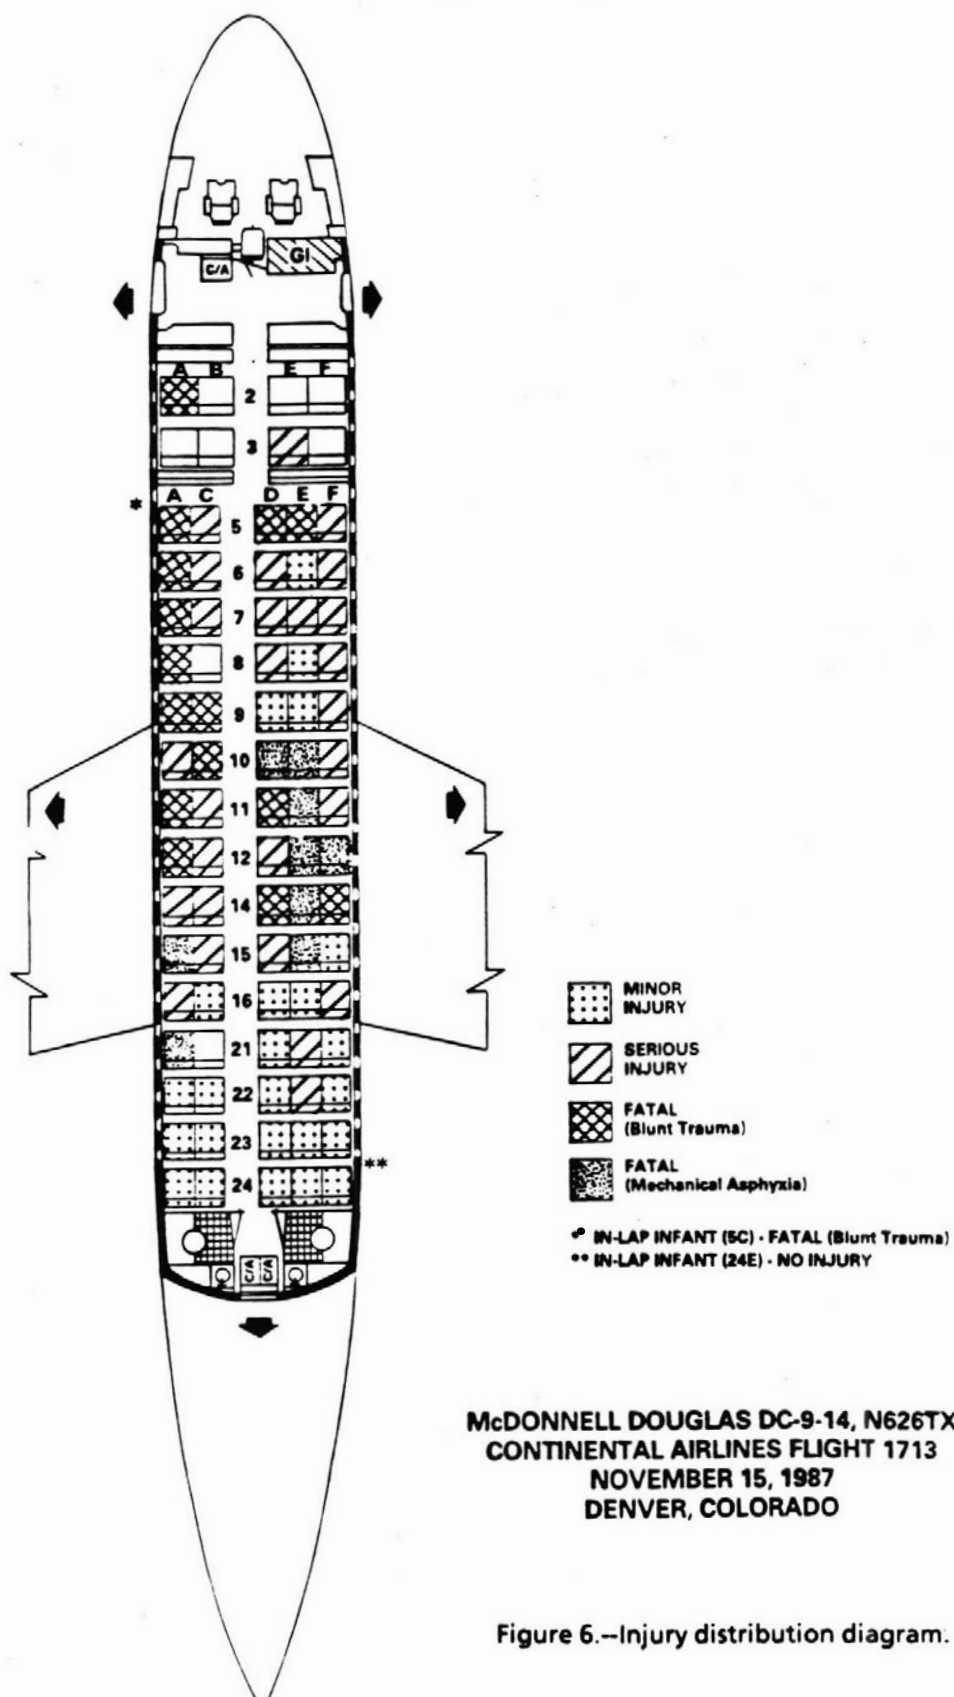
There was extensive damage to the forward left side of the airplane. The fuselage was missing on the left side from aft of the boarding door to about station 466. No one in a window seat in rows 2-9 on the left side survived. Cabin dividers, overhead compartments, and passenger seats were ejected during the impact and were found along the wreckage path. Some survivors in this section were thrown from the airplane while still belted in their seats and other survivors (including a passenger in seat 8E who was asleep and whose seatbelt was not fastened) remained in the fuselage. Several survivors in the forward cabin escaped through breaks in the fuselage while other passengers in this section required extrication. A 6-month old infant who was in his mother's lap in seat 5C died of multiple blunt trauma injuries and his mother survived with serious injuries. (Refer to figure 6 for distribution of injuries.)

Rows 10-15 were inverted and in an area of extreme compression. All occupants in this area required extrication. All survivors in this area had serious injuries and eight of the nine passengers who died of traumatic asphyxia were seated in this section.

Rows 15 aft were also inverted and the fuselage was compressed to within inches of the floor at row 15. There was progressively less fuselage compression toward the rear of the airplane. With the exception of the passenger in 22E who received a serious injury, all of the injuries to passengers in the last three rows were minor. The only occupant who was not injured was a 6-week-old, in-lap infant held by her father in seat 24E. Two flight attendants were seated on the aft jumpseat: one sustained a serious injury, the other minor injuries. Some passengers in the aft cabin were able to evacuate after the tailcone exit hatch was opened while others required extrication.

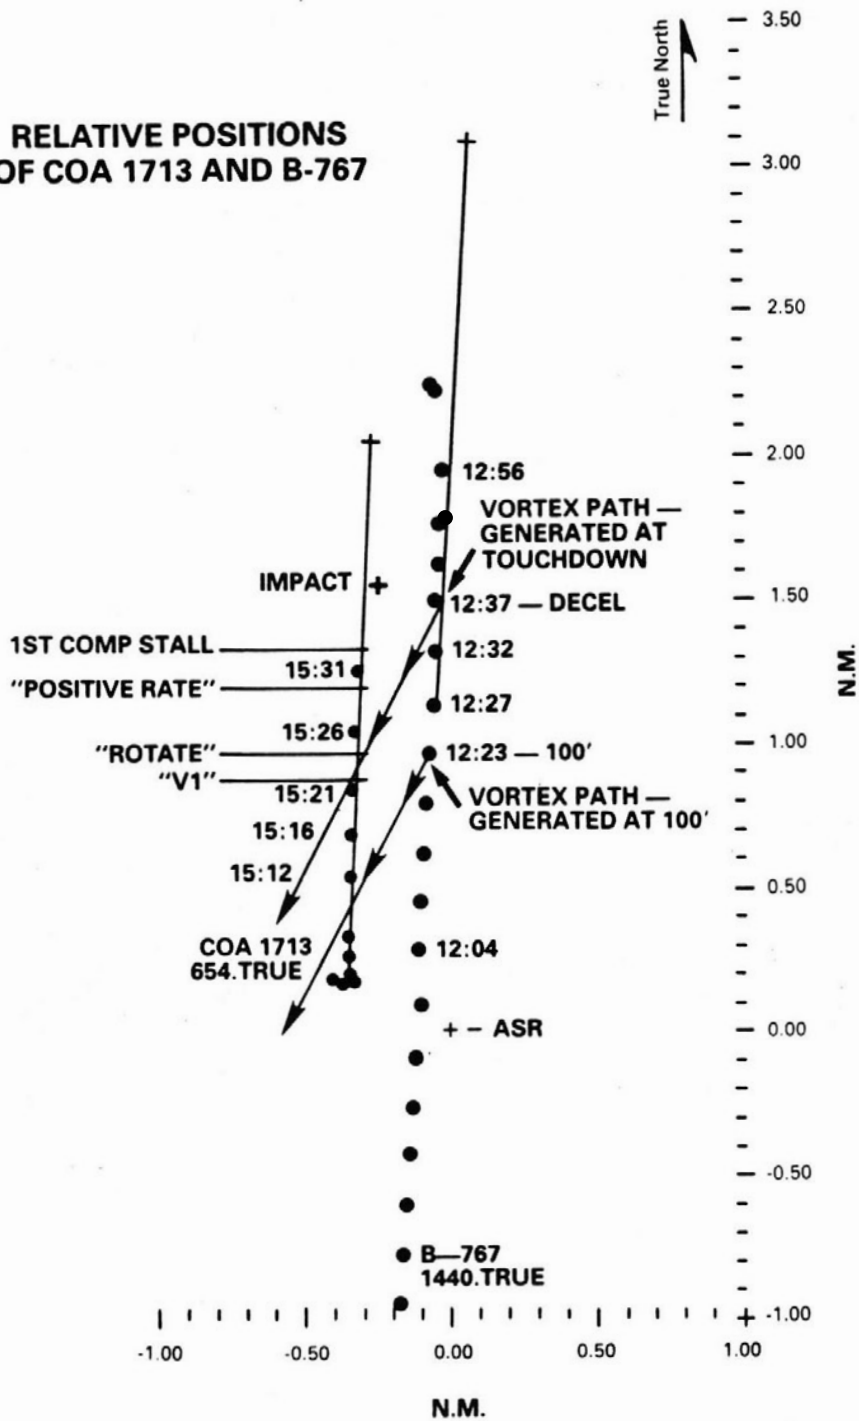
Figure 7.--Vortex path based on LLWAS sensor data.

The points and times on figure 6 were derived from recorded airport surveillance radar plots of the two airplanes and indicate that the Delta Boeing 767 landed approximately 3 minutes before the first sound of a compressor surge from the DC-9. The wind vector, determined from the LLWAS sensor readings, was about 24° from the right of runway heading and is aligned in figure 7 with the diagonal lines. The diagonal line to the south represents the direction of travel of a vortex segment generated at 100 feet above the ground under these wind conditions. The diagonal line to the north represents the direction of travel of a vortex segment generated when the Boeing 767 touched down. Due to the characteristics of wingtip vortices, none are generated after the nosewheel of an airplane is on the ground.

The Safety Board believes that any vortex generated below 100 feet above the ground would have quickly dissipated. Therefore, the south diagonal line on figure 6 is the last possible path of a "strong" vortex, and the north line is the last possible path of any vortex before its complete dissipation. The length of the diagonal lines is not representative of the distance which a vortex may travel before dissipating. The vortex may dissipate at any position along the lines, depending on the atmospheric conditions. Initial abnormal events during the takeoff of flight 1713 occurred about 1415:37 when the airplane had just lifted off the ground. The recorded altitude dip is large, indicating a larger than normal pitch attitude at liftoff and there is also a small uncharacteristic drop in the vertical acceleration trace. Beginning at 1415:39.5, there was a sharp drop in the vertical acceleration trace, an abrupt heading trace change to the left, then an exclamation from one of the pilots, and then the first sound of a compressor surge. For a wake vortex segment from the Boeing 767 to have affected the DC-9 at 1415:39.5, when airplane control became questionable, the vortex segment would have had to have moved from the Boeing to the position represented by the point on flight 1713's flightpath marked "1st COMP STALL." As can be seen, that position is well clear of any expected vortex movement area.

In general, any vortex traveling on lines south of the "strong" vortex line could only have affected flight 1713 while it was still within the first 1,000 feet of its takeoff roll. In fact, it can be seen from the plot that all vortices from the B-767, if they survived the 1,600 feet of lateral movement between the runways at all, would have encountered the DC-9 while it was still on the ground.
