**In-Flight Fire, McDonnell Douglas DC-9-83, N569AA, Nashville
Metropolitan Airport, Nashville, Tennessee, February 3, 1988**

HAZARDOUS MATERIALS INCIDENT REPORT

**IN-FLIGHT FIRE,
McDONNELL DOUGLAS DC-9-83, N569AA,
NASHVILLE METROPOLITAN AIRPORT
NASHVILLE, TENNESSEE,
FEBRUARY 3, 1988**

NTSB/HZM-88/02

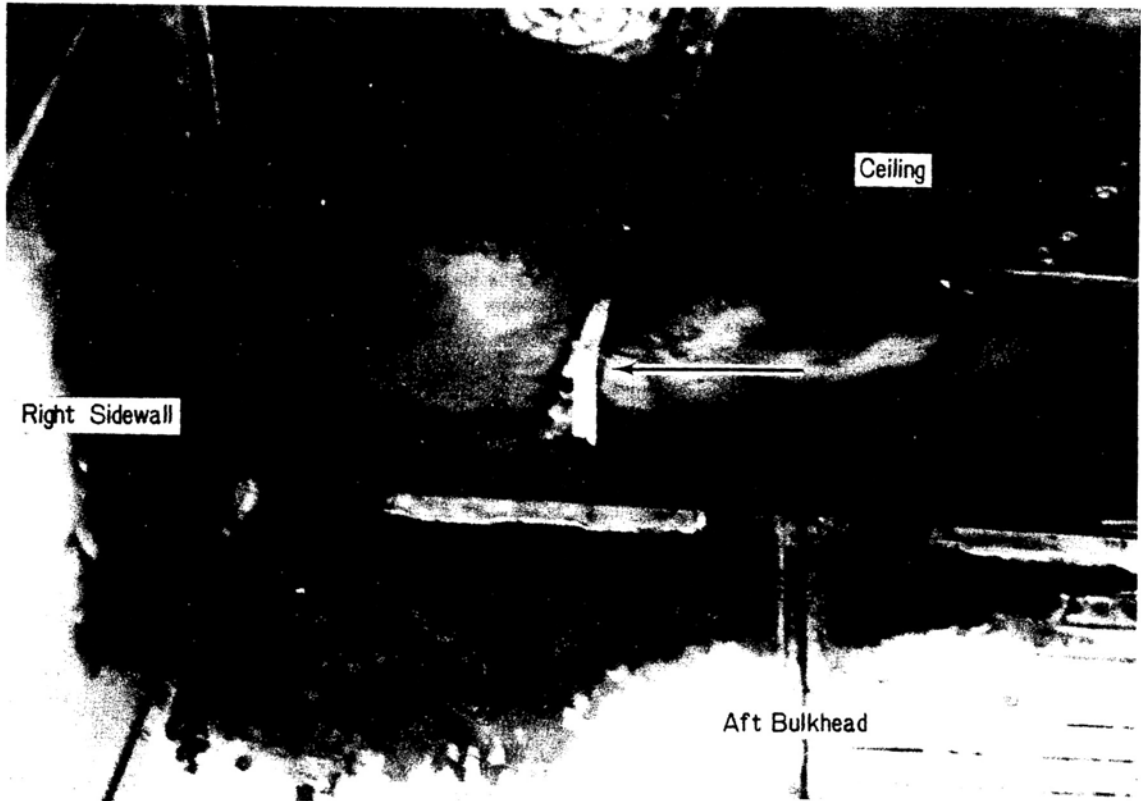
Damage to the airplane was limited to the aft 1/3 of the midcargo compartment and the area immediately above the compartment ceiling panels up to and including the cabin flooring. Varying degrees of thermal damage were evident on the aft ceiling, aft right sidewall, and aft bulkhead liners from about Fuselage Station (F.S.) 750 aft to and including the bulkhead liners at F.S. 798. The liners were constructed of S-2 fiberglass cloth reinforced phenolic sheets of varying thickness and met the fire penetration requirements of Special Federal Aviation Regulation (SFAR) 25 Amendment 25-60.

Figure 1.--Fire damage to midcargo compartment. Arrow points to section of the longitudinal support strap which had melted and separated at F.S. 770.

Varying degrees of thermal damage and sooting was evident in the channel between the cargo compartment ceiling panels and the cabin floor. Five lateral floor beams, constructed of 7075T6 aluminum alloy, were exposed to substantial heat that escaped from the cargo compartment. Rockwell B hardness tests were conducted on the beams to determine if the beams were affected, and three of the five beams required replacement due to loss of strength from exposure to heat. Location of the beams replaced were F.S. 750, 769, and 788; beams at F.S.731 and 807 were satisfactory.

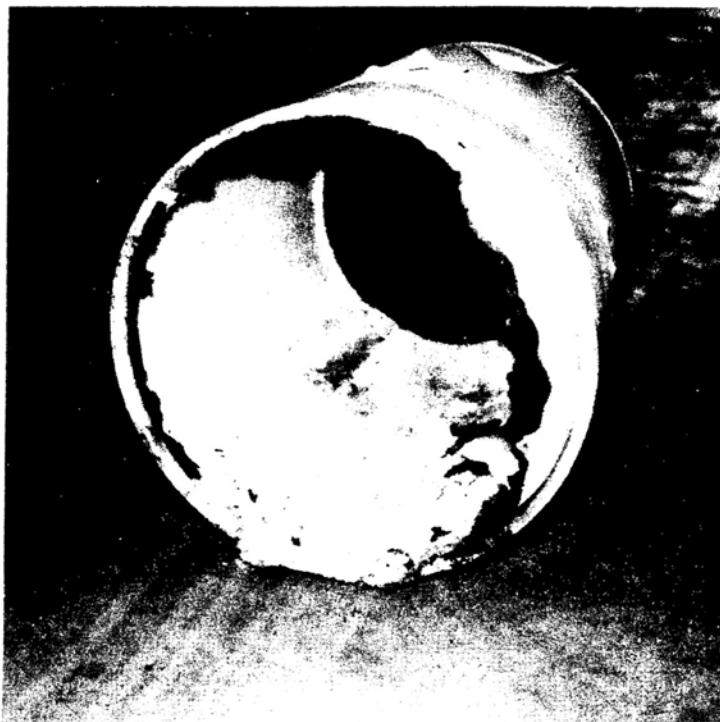
In summary, ignition and flaming were experienced only in tests when the cardboard boxes or fiber drums were presoaked with 50 percent hydrogen peroxide and dried before the tests. Presoaking cardboard boxes or fiber drums in 35 percent hydrogen peroxide did not produce ignition in tests, and cardboard boxes or fiber drums not prewet did not ignite or flame.

Figure 4.—Bottom of test fiber drum was consumed by fire after the fiber drum was presoaked with 50 percent hydrogen peroxide solution, dried, and then exposed to a 50 percent peroxide solution and sodium orthosilicate-based mixture.

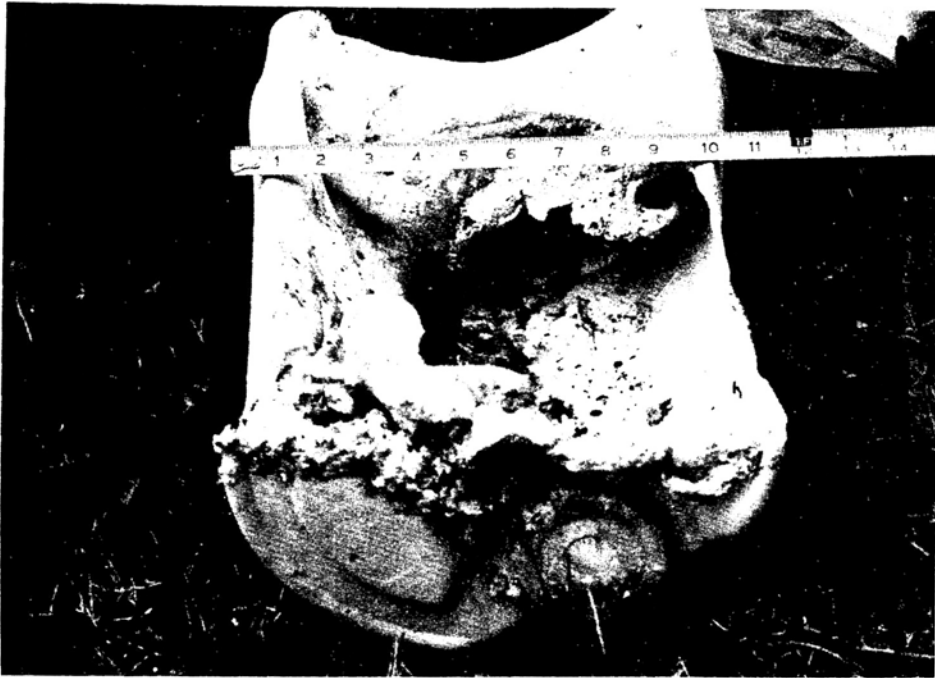
The hydrogen peroxide solution (H₂O₂) was packaged in a 5-gallon nonvented Department of Transportation Specification 34 (DOT-34) polyethylene drum. (See figure 5.) It had been filled from one of two 55-gallon drums at the shipper's facility. One of the drums contained 35 percent (weight percent) hydrogen peroxide and the other contained 50 percent hydrogen peroxide. Both 55-gallon drums were marked with the proper DOT shipping name and oxidizer labels. (See figure 6.) The shipper could not conclusively determine which concentration of hydrogen peroxide was put into the 5-gallon drum; 35 percent hydrogen peroxide is normally used in the company's textile treatment process. According to the Manufacturing Chemists Association Chemical Safety Data Sheet SD-33, hydrogen peroxide may present the following hazards:

Figure 5.--Damaged 5-gallon polyethylene drum used to transport the hydrogen peroxide solution.
