Runway collision of Eastern Airlines Boeing 727, Flight 111 and Epps Air Service Beechcraft King Air A100, Atlanta Hartsfield International Airport, Atlanta, Georgia, January 18, 1990

AIRCRAFT ACCIDENT REPORT

RUNWAY COLLISION
OF EASTERN AIRLINES BOEING 727, FLIGHT 111
AND EPPS AIR SERVICE BEECHCRAFT KING AIR A100
ATLANTA HARTSFIELD INTERNATIONAL AIRPORT
ATLANTA, GEORGIA
JANUARY 18, 1990

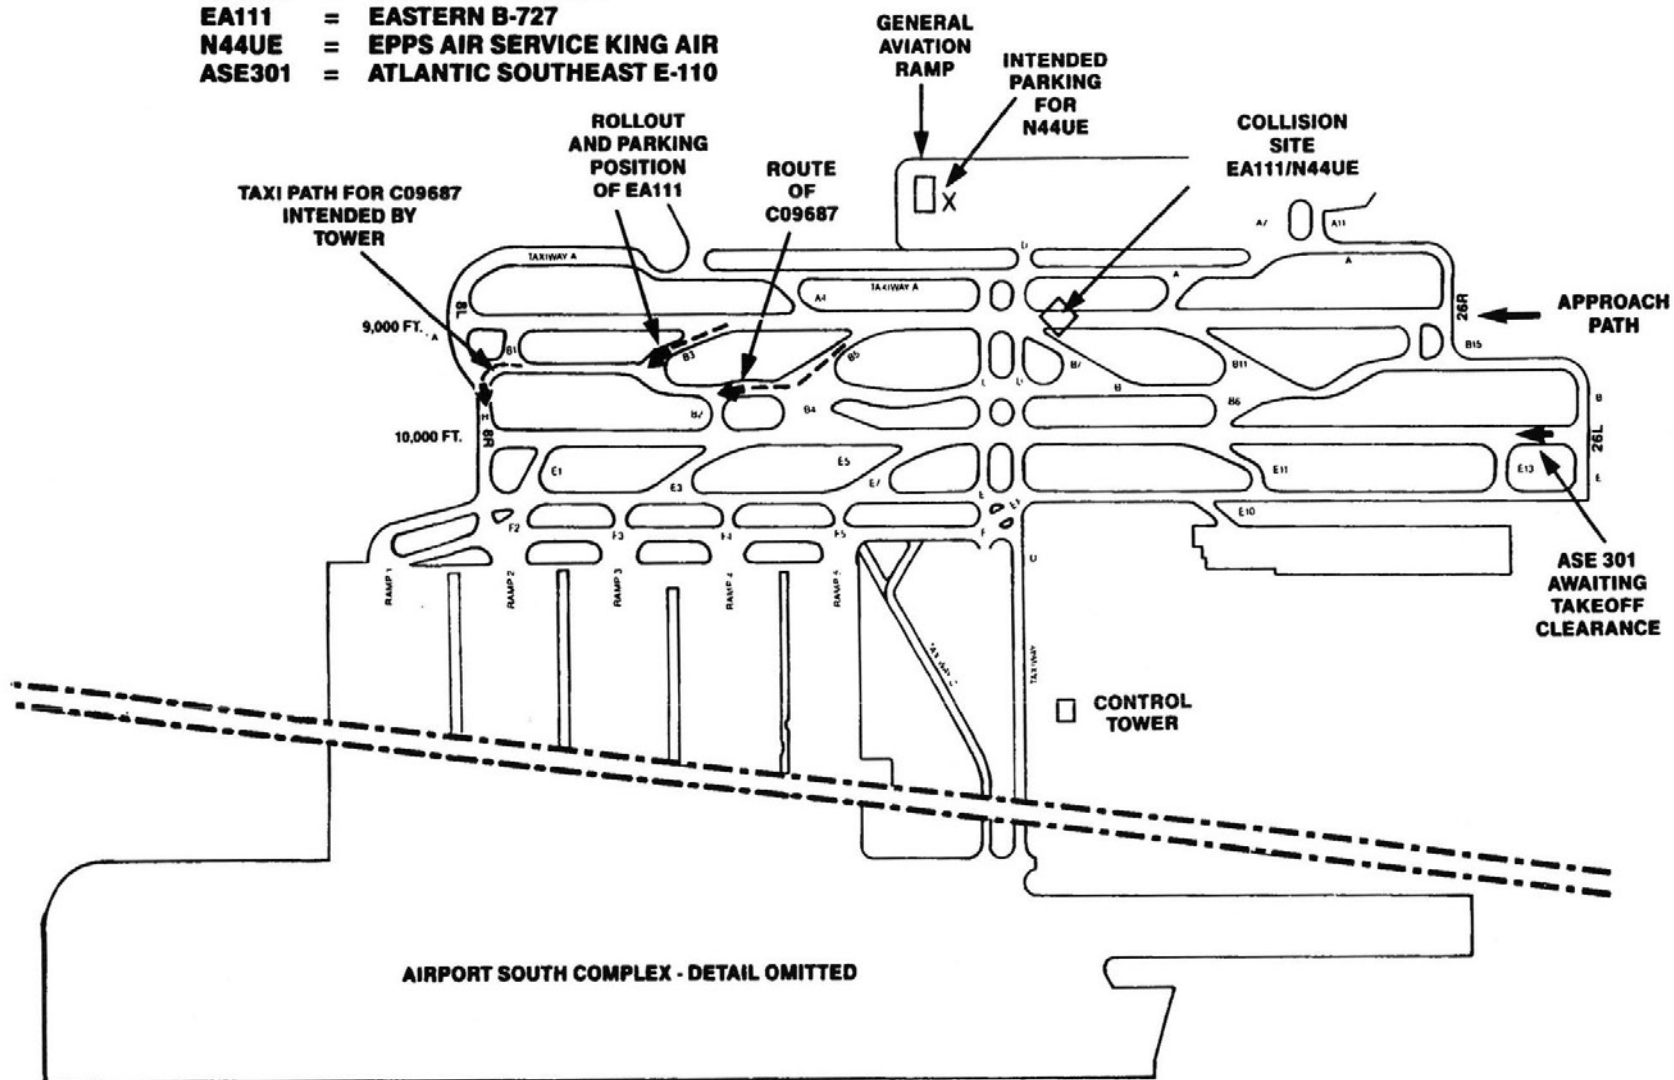
Figure 2.--Airport diagram with overlay of activity related to collision.

Grounds scars from the collision indicated that the King Air had moved to the right side of runway 26 at the time of the collision and was near taxiway "D," the primary taxiway for general aviation airplanes. The turnoff for taxiway "D" was about 3,800 feet from the approach end of the runway. The right wing of the B-727 struck the tail cone and structure of the King Air, separating the horizontal and vertical stabilizers from the fuselage and shearing the top of the fuselage/cockpit from the airplane. The King Air was destroyed. It came to rest at the turnoff for taxiway "D" with the engines still running. There was no postimpact fire. Airport Rescue and Fire Fighting (ARFF) personnel shut down the engines and secured the electrical system.

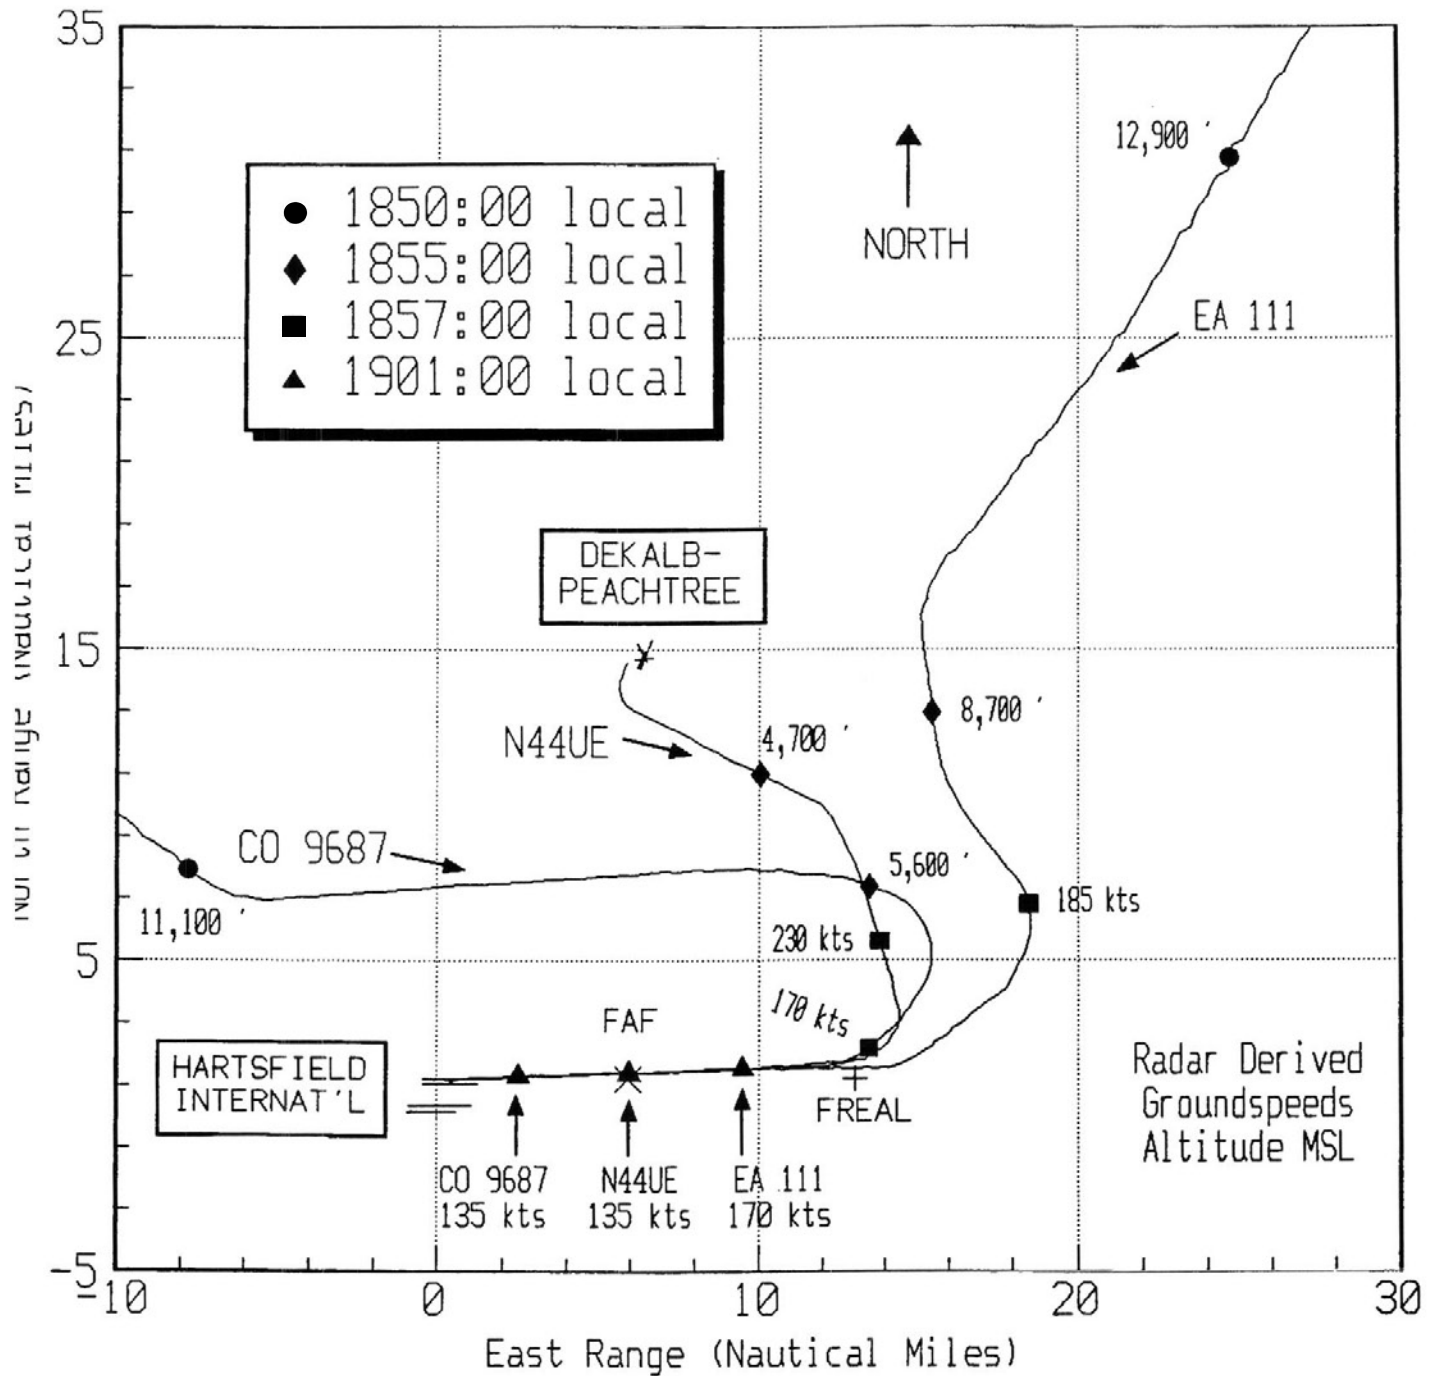
Figure 3.--Data showing landing sequence for runway 26 right.

ATC radar and communications data reveal that vectors were issued to three inbound airplanes to establish the landing sequence for runway 26 right immediately before the accident. (See figure 3). The three airplanes were CO 9687, a Continental Airlines DC-9; N44UE, the Beech King Air; and EA 111. A complete description of the air traffic actions is contained in paragraph 1.17.2, Air Traffic Handling.
