Runway Incursion and Collision, Northwest Airlines, Inc. Flights 1482 and 299, Detroit Metropolitan/Wayne County Airport, Romulus, Michigan, December 3, 1990

Investigative Body: National Transportation Safety Board (NTSB), USA

AIRCRAFT ACCIDENT REPORT

**NORTHWEST AIRLINES, INC.
FLIGHTS 1482 AND 299
RUNWAY INCURSION AND COLLISION
DETROIT METROPOLITAN/WAYNE COUNTY AIRPORT
ROMULUS, MICHIGAN
DECEMBER 3, 1990**

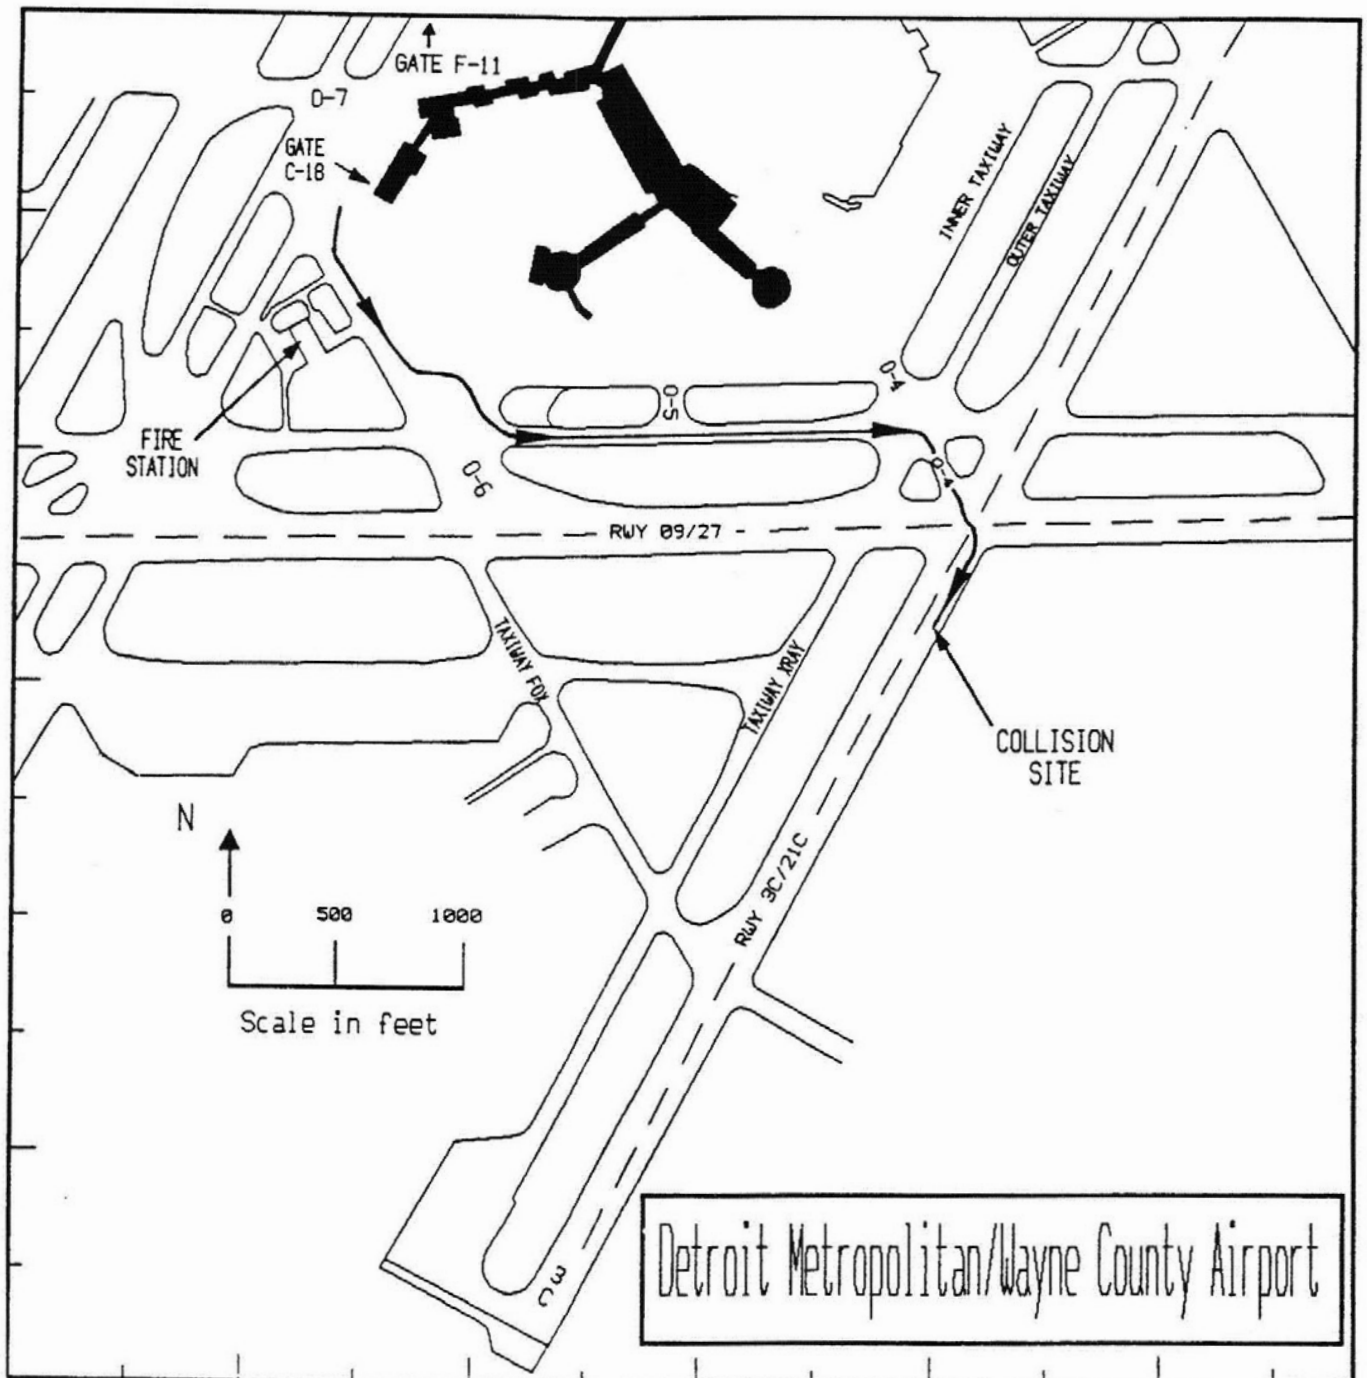
Figure 1.--DTW layout and DC-9 taxi route.

In a subsequent discussion with ground control about their position, the first officer stated to the controller: "approaching the parallel runway on Oscar 6...headed eastbound on Oscar 6 here...." He then said that they had missed Oscar 6 and that they "...see a sign here that says, ah, the arrows to Oscar 5. Think we're on Foxtrot now." According to the first officer, he realized that they had missed taxiway Oscar 6 after he observed the sign for that taxiway behind him. The controller then stated "Northwest 1482, ah, you just approach[ed] Oscar 5 and you are you on the Outer?" The first officer then responded "yeah, that's right."

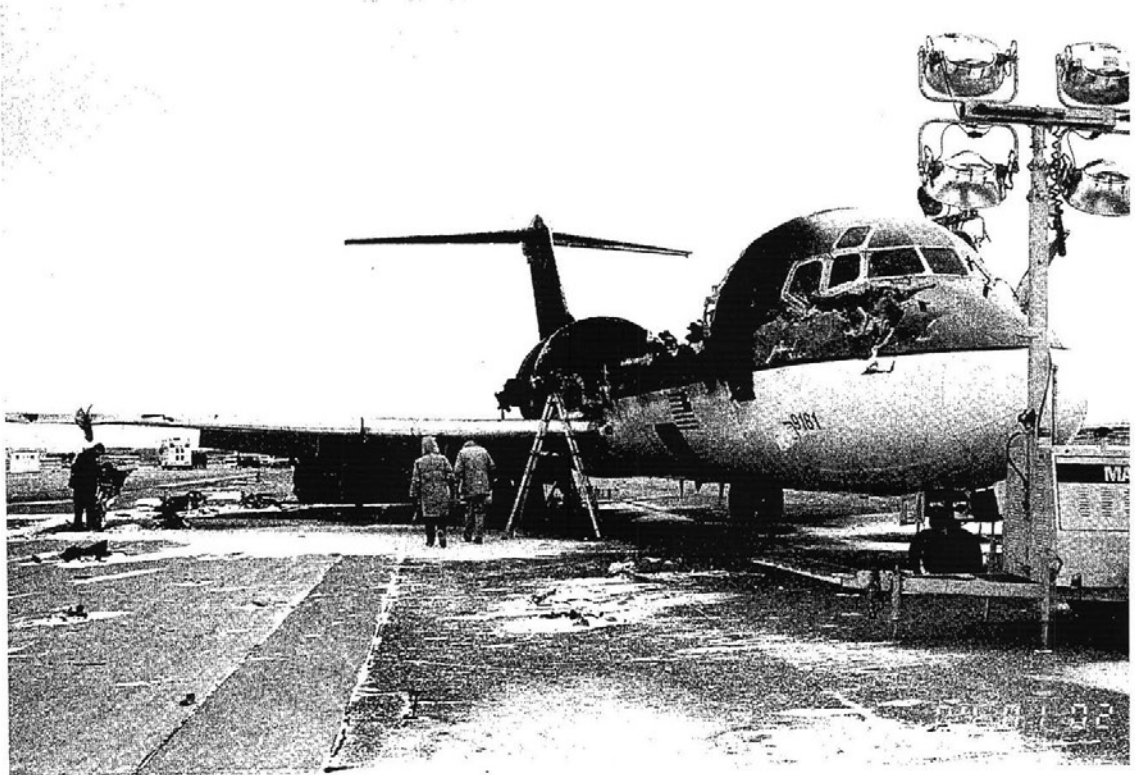
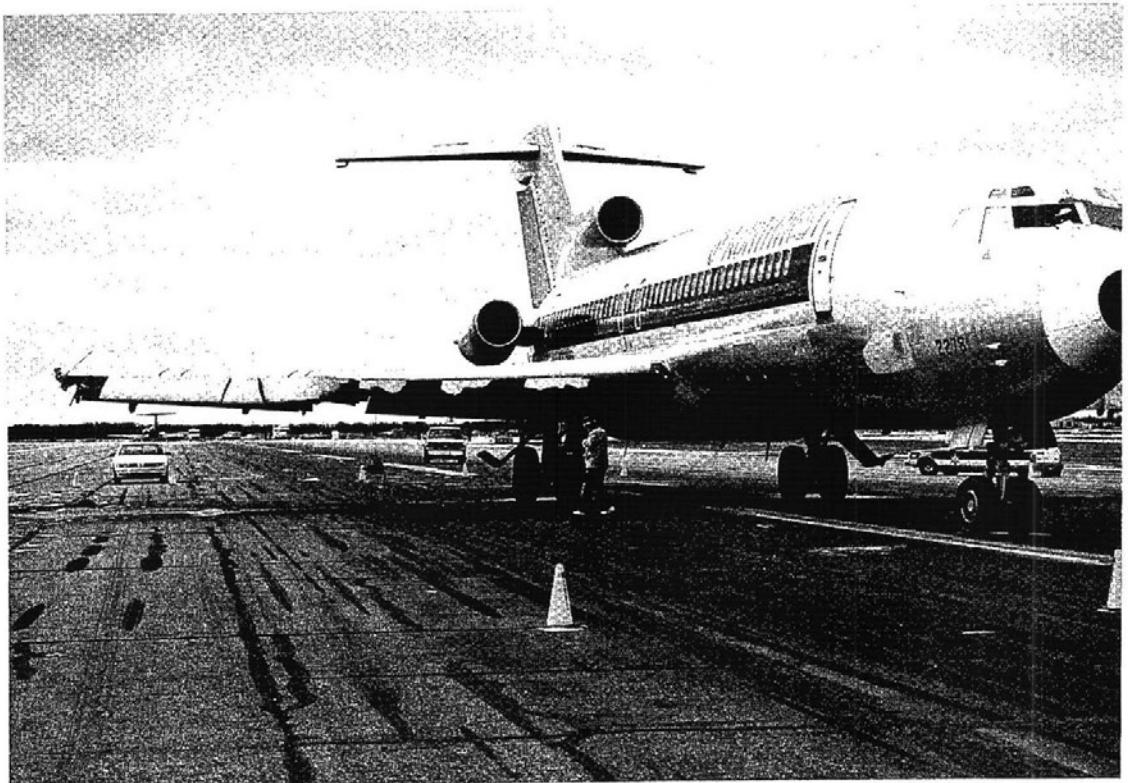
Figure 4.--Photographs of the DC-9 and the B-727.

The B-727 was only damaged on its right side, most of which affected the right wing. Approximately 13.5 feet of the outboard wing had been sheared off during the collision. Much of the debris from this wing area was found in and around the DC-9. The remaining portion of the wing was attached to the fuselage but was heavily damaged. Most of the Nos. 4, 5, and 6 leading edge flaps had broken off, but the actuators were still in place. Most of the forward, lower fixed leading edge panels aft of the No. 4 leading edge flap had also broken off. The Nos. 7 and 8 leading edge slats and slat tracks had separated from the wing and were found on the runway beside the DC-9. The mid fairing and most of the aft fairing for the outboard flap track of the inboard trailing edge flap had been torn off during the collision and were found lodged in the leading edge of the right wing of the DC-9. Among other wing components, the lower, outboard end of the inboard aileron was slightly damaged, as was the outboard end of the outer spoiler.

The three fuselage-mounted engines did not appear to sustain any damage as a result of the collision. They were not examined internally. Both right tires exhibited several cuts on their treads and sidewalls. (See figure 4.)

The airplane's fuselage was cut in a straight line just below the bottom of the windows on the right side of the airplane. The cut line remained along the right side of the fuselage, and the fuselage structure above this cut line to the top was destroyed by fire. The majority of the fuselage was burned from just aft of the cockpit to just forward of the aft bulkhead, from the top to just above the window line on the left side of the airplane.

The left wing was undamaged and all left wing control surfaces were intact. The right wing was heavily damaged, and about 3.5 feet of the wing tip was missing. Portions of the right wing tip were found in the right main landing gear door of the B-727. Several areas of the wing's top skin just aft of the leading edge were torn. Scrape marks existed on several areas of the upper surface of the DC-9 right wing. These scrape marks and those on the right wing of the B-727 indicated a collision angle between the two airplanes of approximately 50°.

The left engine was intact and did not exhibit any external damage except for soot found in the inlet and exhaust areas. The right engine was knocked off its pylon by the B-727 during the collision sequence. It was found beside the DC-9 in a heavily battered and burned condition. Neither engine was examined internally.

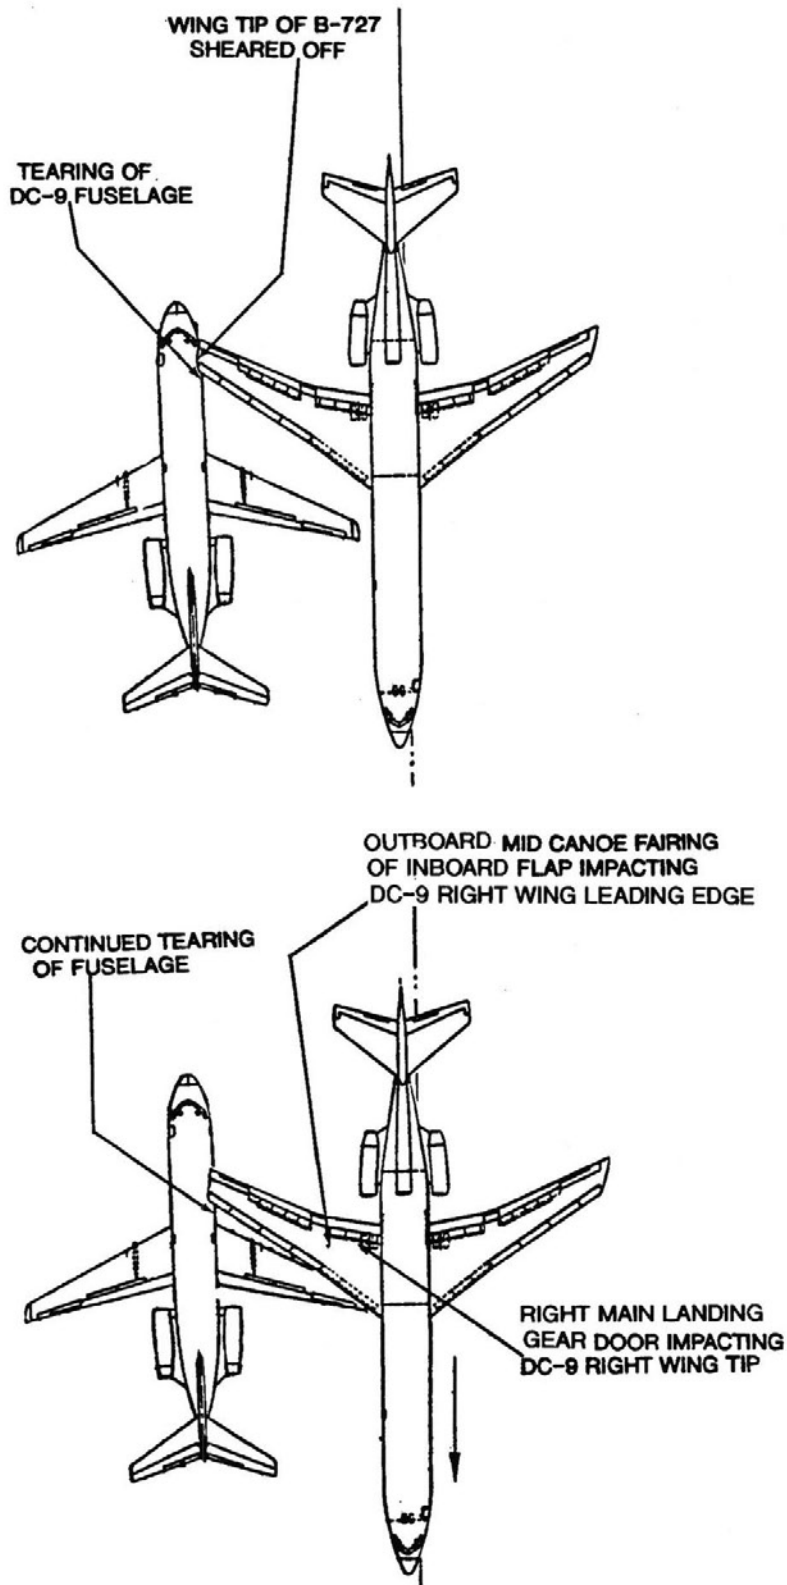
Figure 5a.--Impact sequence.

No. 8 LEADING
EDGE SLAT COMING
IN CONTACT WITH RIGHT HAND
ENGINE COWL

DC-9 WING TIP SHEARS OFF
AND LODGES IN B-727 GEAR DOOR

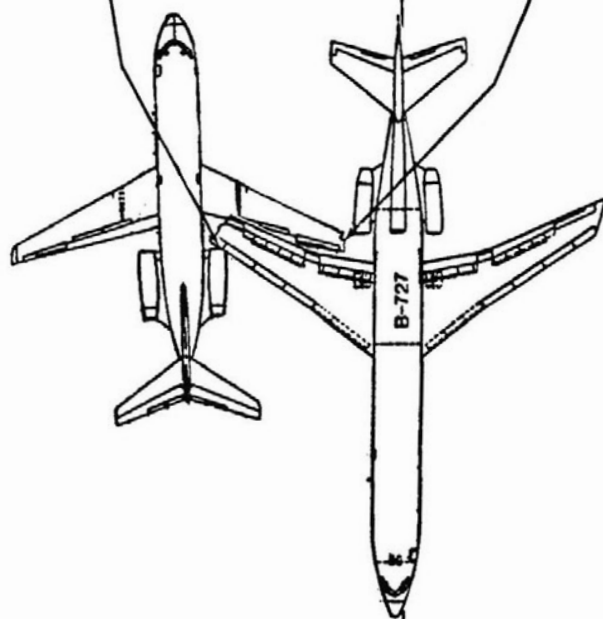
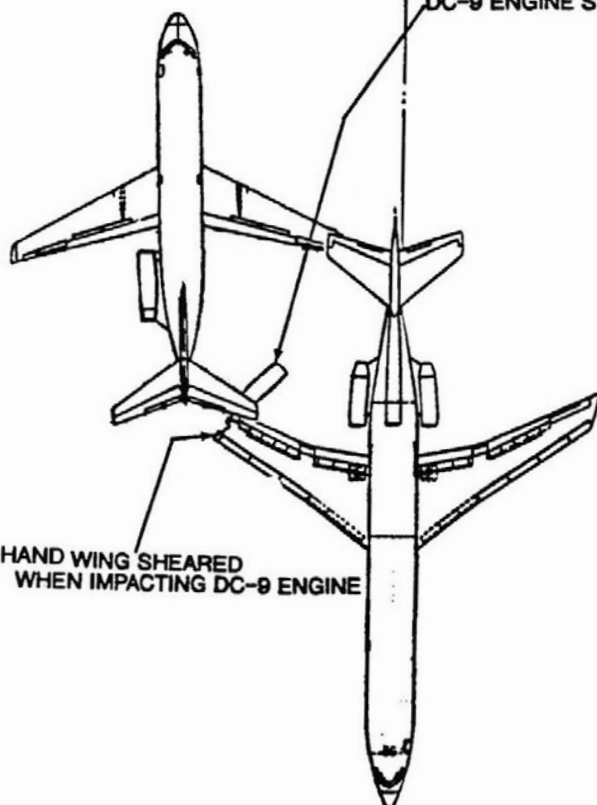
Figure 5b.--Impact sequence.

DC-9 ENGINE SHEARED OFF

RIGHT HAND WING SHEARED
WHEN IMPACTING DC-9 ENGINE

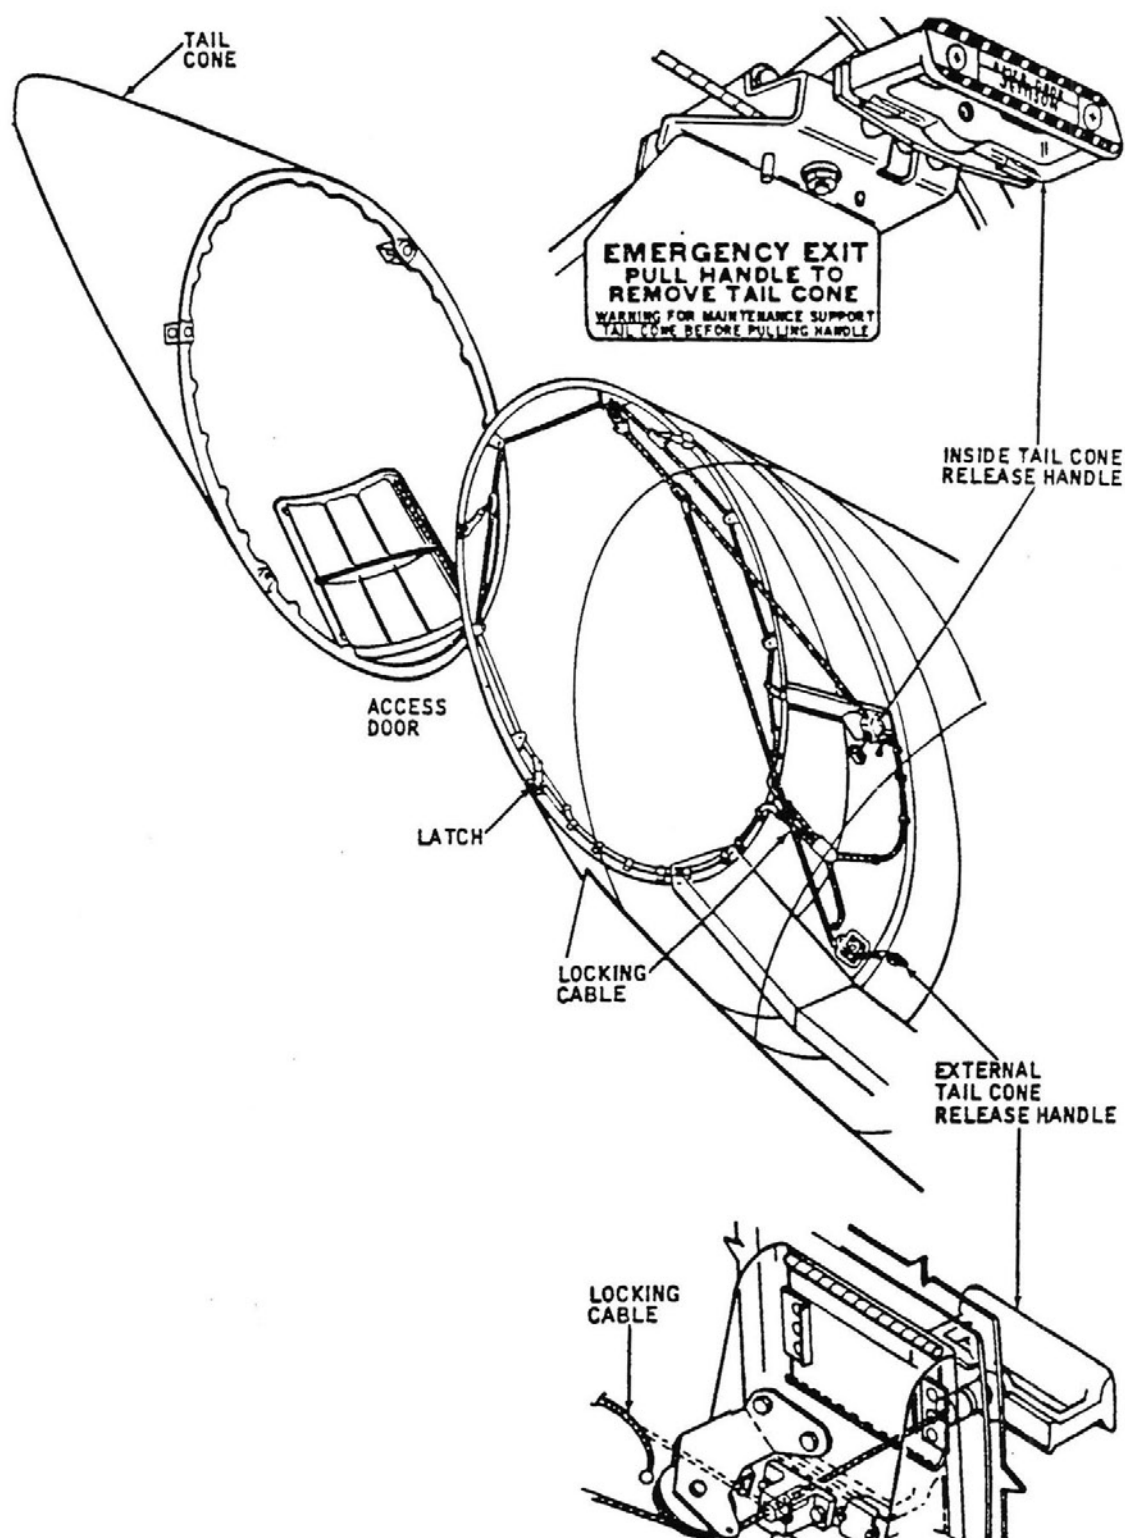
Figure 6.--Tailcone assembly.

The interior tailcone release handle was found out of its normally stowed position, free of its retaining clips, and its safety wire was not found. The handle was also rotated about 60° clockwise from its normal stowed position. Because of soot deposits on the handle, the lifting and identification of fingerprints was impossible. The red and white colored placard on the fuselage sidewall near the handle was readable through an even coating of soot, and the soot was not disrupted.

Although the routing of the tailcone release mechanism cabling was found to be in accordance with the Douglas DC-9 Maintenance Manual, there was excessive slack in the cable. Three of the four tailcone release latches were in their fully closed positions. The upper left latch was engaged but rotated counterclockwise 1/2 inch from its fully closed position. When tested, all four latches rotated within the limitations imposed by the cable system.

During an attempt to reinstall the release handle into its housing for further testing, handle's shaft was found to be fractured and separated near where the shaft jointed the main portion of the handle. The separated piece of the shaft remained within the lock housing and prevented the locking cable from being released. The main portion of the interior release handle was attached only through the release cable, which passes through the handle shaft.
