## **Takeoff stall in icing conditions, USAir Flight 405, Fokker F-28, N485US, LaGuardia Airport, Flushing, New York, March 22, 1992**

## AIRCRAFT ACCIDENT REPORT

TAKEOFF STALL IN ICING CONDITIONS

USAIR FLIGHT 405

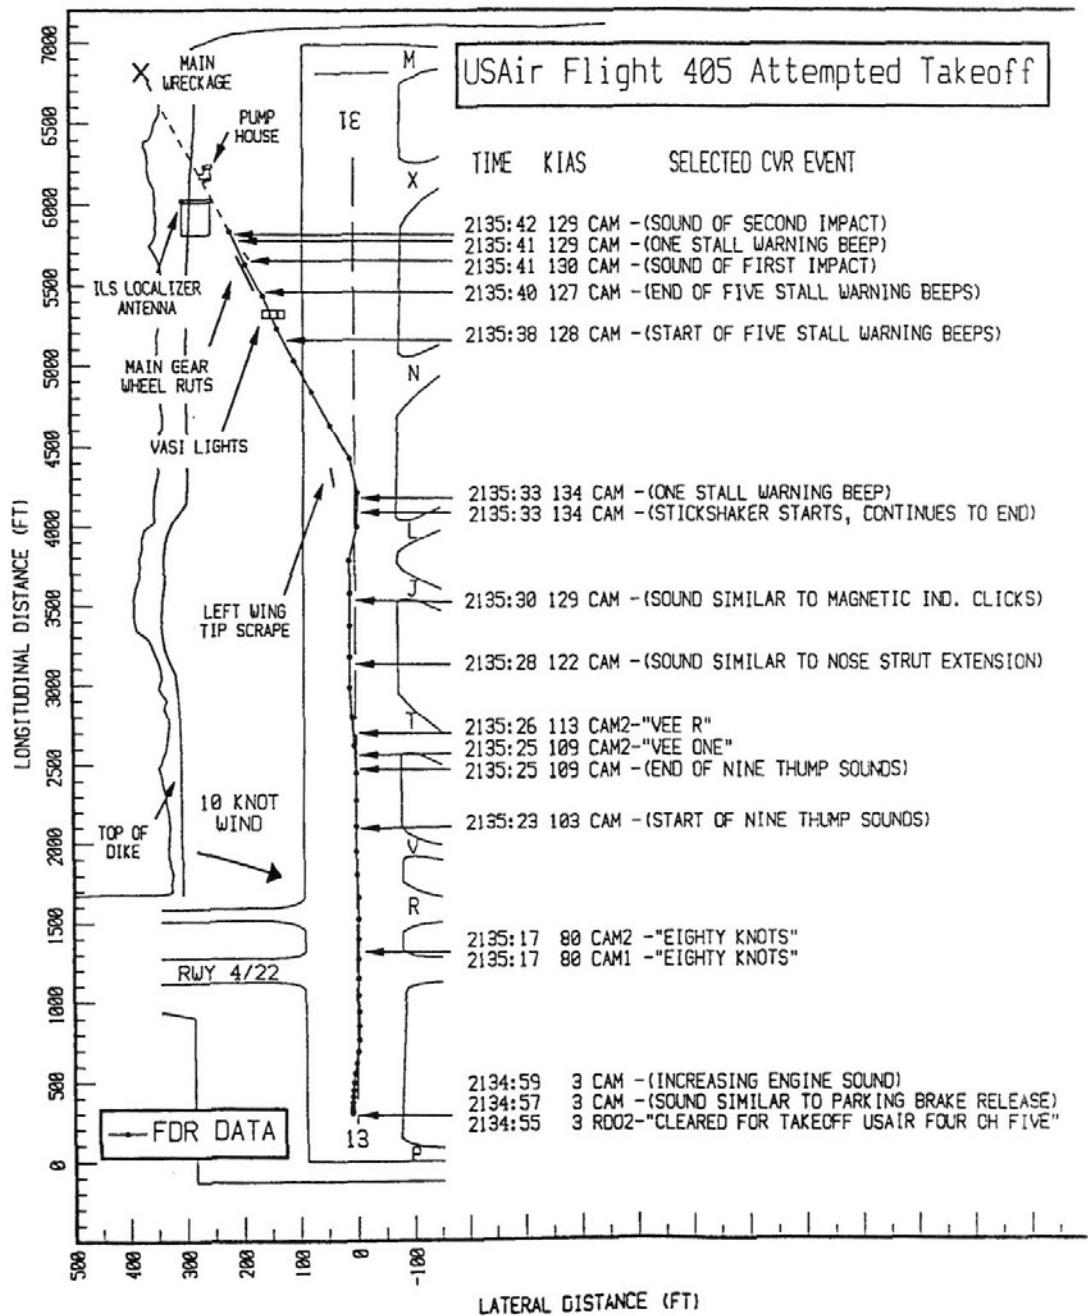
Figure 1.--Ground track and selected CVR sounds.

in the airframe." The first officer stated that they began rolling to the left, "just like we lost lift." He stated that as the captain leveled the wings, they headed toward the blackness over the water and that he joined the captain on the controls. The first officer said that they seemed to agree that the airplane was not going to fly and that their control inputs were in unison. He did not remember any aileron input, and there were no "heavy control inputs." They used right rudder to maneuver the airplane back toward the ground and avoid the water. They continued to try to hold the nose up to impact in a flat attitude. He said that there was at least one cycle of nose pitch oscillation accompanying the buffet. The first officer stated that he did not touch the power levers. The last thing he remembered was an orange and white building that disappeared under the nose. He recalled a flash, a jolt, a rumbling along the ground, and then a sudden stop.

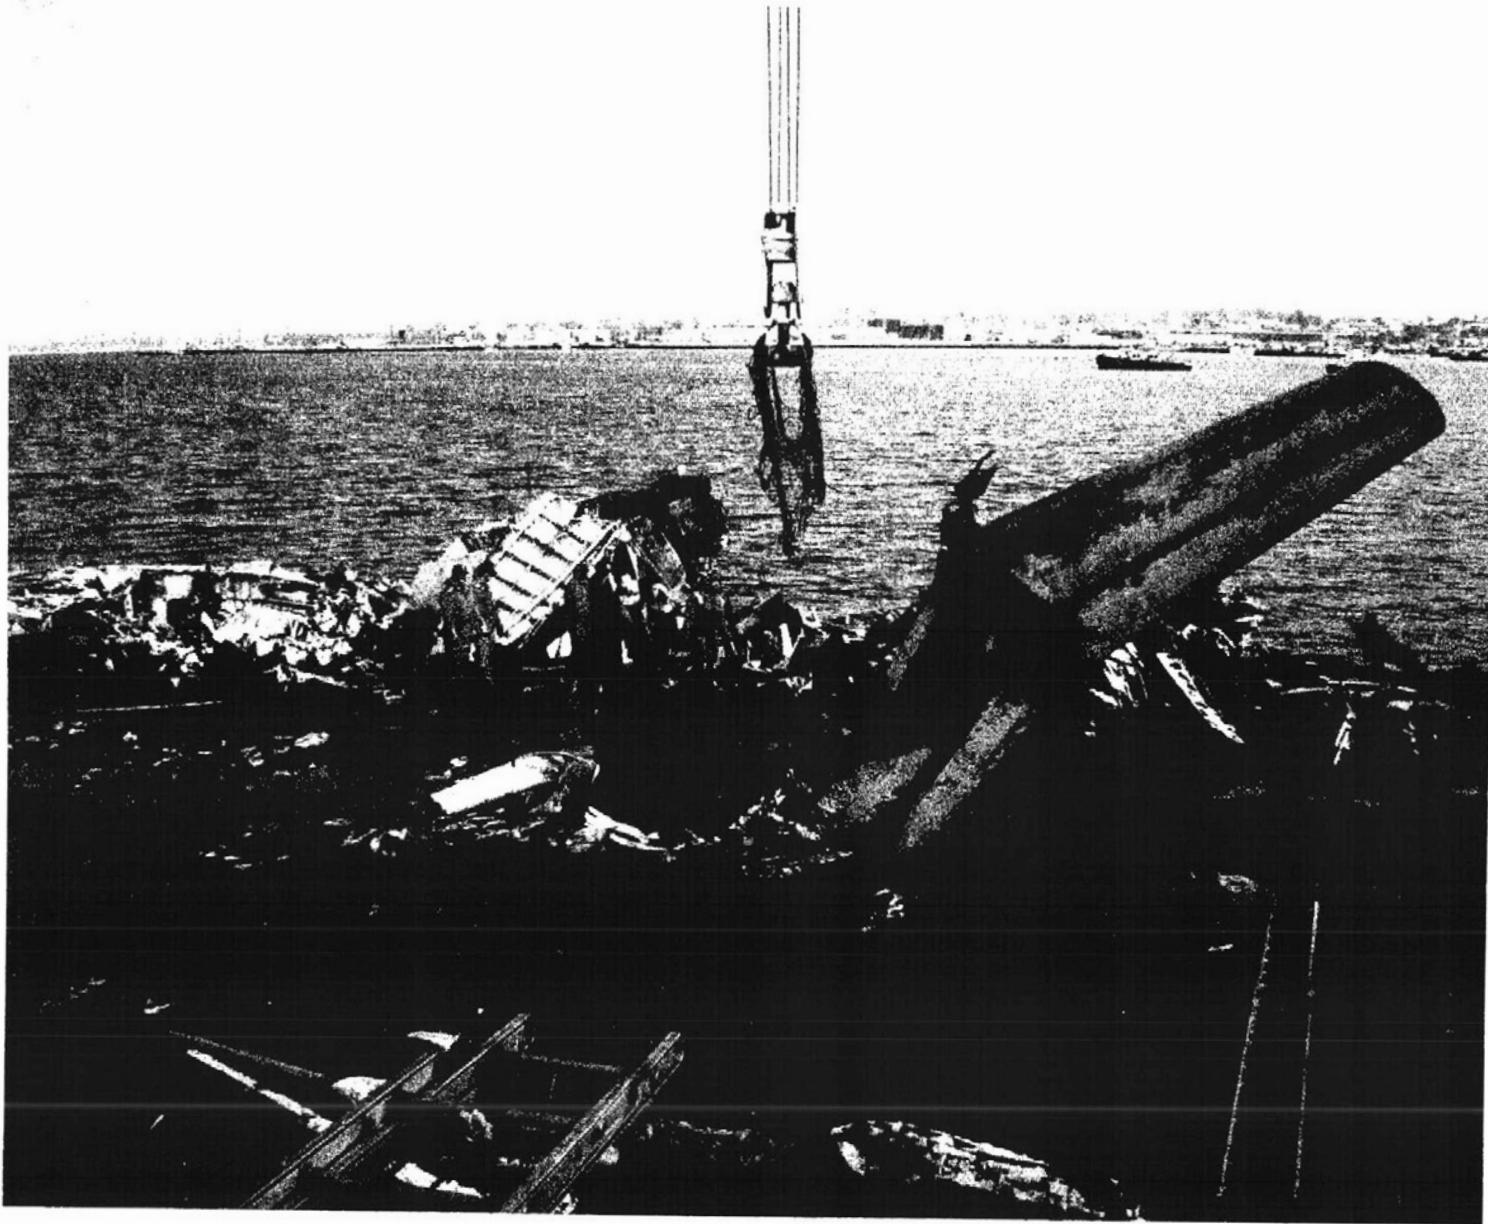
The main wreckage came to rest to the left side of runway 13, partially inverted at the edge of Flushing Bay. Parts of the fuselage and cockpit were submerged in the water. (See figure 5). The initial ground contact scrape marks from the airplane were approximately 4,250 feet from the threshold of runway 13 and about 36 feet left of the runway centerline and ranged from 5 feet to 65 feet long. Aluminum particles and paint chips were found on these scrape marks. About 200 feet farther along the runway, plexiglass lens cover pieces were found that matched the plexiglass from the left wing tip. There were no other impact marks found on the runway that could be associated with the airplane. The elevation of the accident site was 6.7 feet msl.

Figure 5.--Main wreckage of USAir flight 405.
