In-Flight Engine Separation, Japan Airlines, Inc., Flight 46E, Boeing 747-121, N473EV, Anchorage, Alaska, March 31, 1993

Investigative Body: National Transportation Safety Board (NTSB), USA

IN-FLIGHT ENGINE SEPARATION
JAPAN AIRLINES, INC., FLIGHT 46E
BOEING 747-121, N473EV
ANCHORAGE, ALASKA
MARCH 31, 1993

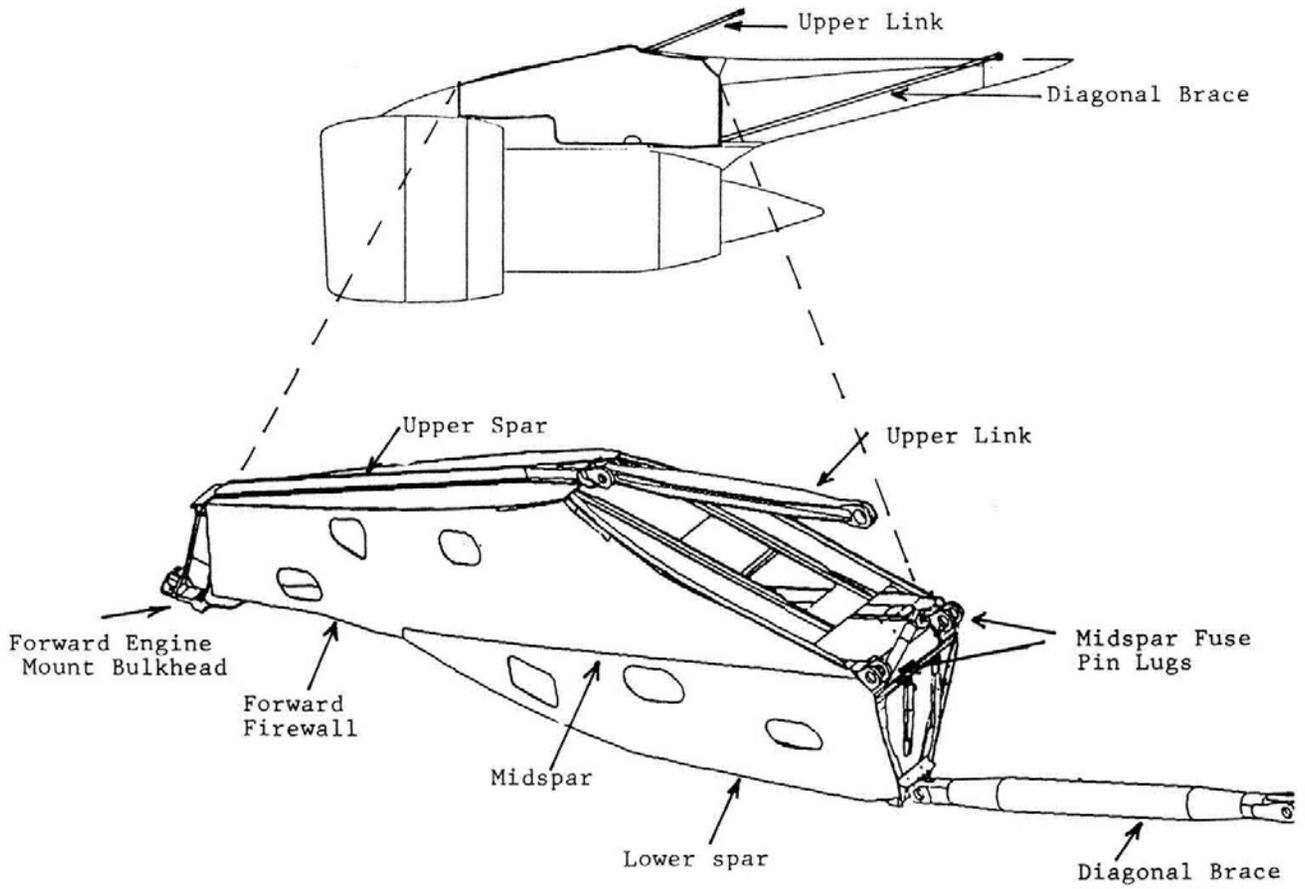
Figure 2.--Pylon structure.

The No. 2 engine pylon was separated into four pieces as a result of three principal fracture areas. These fractures were located just aft of the forward engine mount bulkhead, along a jagged vertical plane aft of the rear engine mount bulkhead, and around the inboard midspar fuse pin fitting. The two forward pieces of the pylon remained attached to the engine through the forward and rear engine mounts. Examination of the fractures around the perimeter of the break aft of the forward engine mount bulkhead revealed features typical of overstress separations, with the exception of a small, flat fracture region in the firewall web.

The flat fracture area was approximately in the middle of the web, on the outboard side of the web centerline. The fracture was a lateral fracture about 2 inches long through the thickness of the web and was aft of the third transverse stiffener behind the forward engine mount bulkhead. The location of this fracture area is indicated in figure 3. Investigators cut the flat fracture area from the remainder of the firewall and examined it in detail with a bench binocular microscope and a scanning electron microscope. The mating fracture faces had been heavily rubbed. Despite the rubbing, isolated areas of fatigue striations, indicative of through-the-thickness propagation, were noted. Compression buckling of the firewall web extended from the fatigue crack area forward to the outboard side of the pylon at the second transverse stiffener. Inspection of the other three pylons on the airplane found no similar cracks.

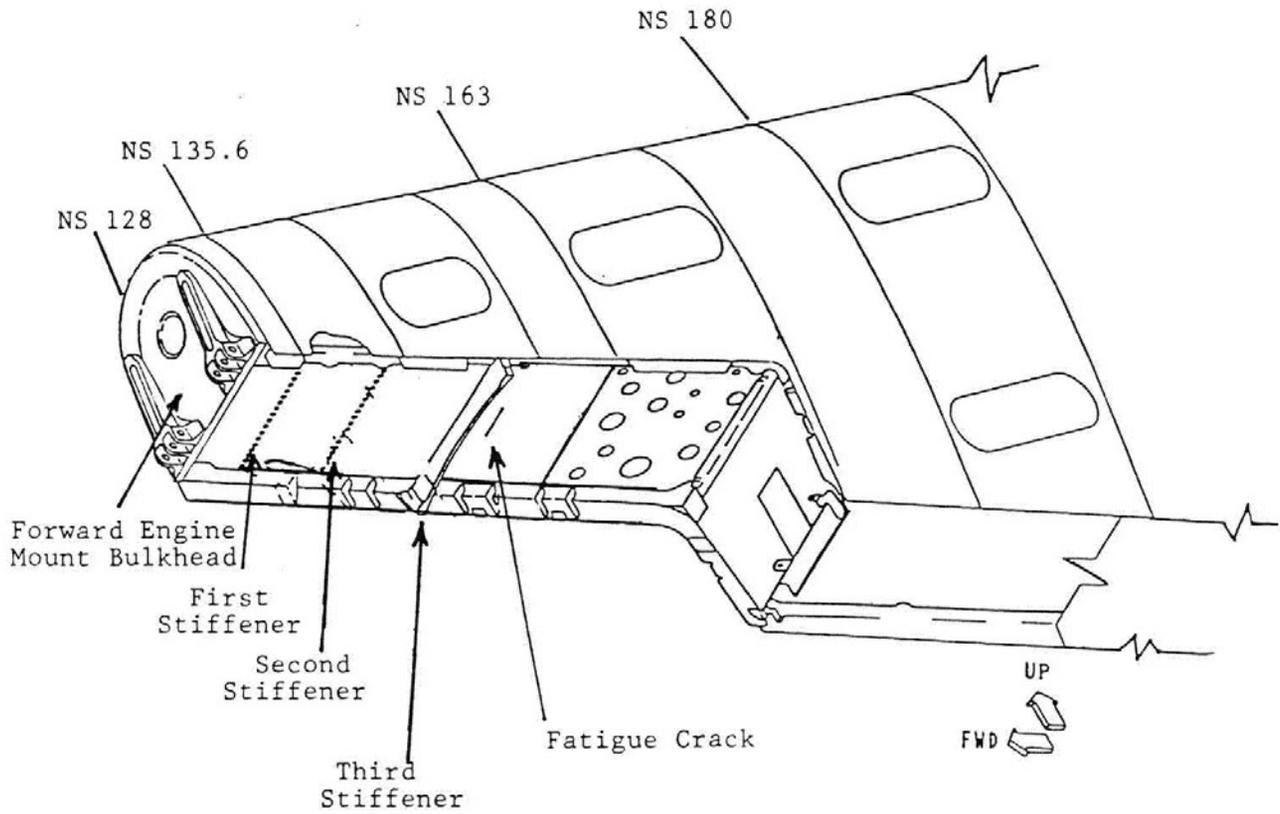
Figure 3.--Flat fracture area.

The two fatigue cracks that were found in the No. 2 engine pylon structure were subjected to metallurgical examinations. One of the fatigue cracks was a lateral fracture about 2 inches long and was in the web of the pylon forward firewall, just aft of the third transverse stiffener behind the forward engine mount bulkhead. This fatigue crack was lateral to the web. Although most of the features of this crack had been obliterated by rubbing, a few isolated areas of fatigue striations were found. The orientation of the striations indicated that the cracking propagated through the thickness of the web. The web material (nickel alloy) and construction appeared to comply with specification requirements. There was no evidence of damage or defects that may have contributed to initiation of the fatigue cracking.

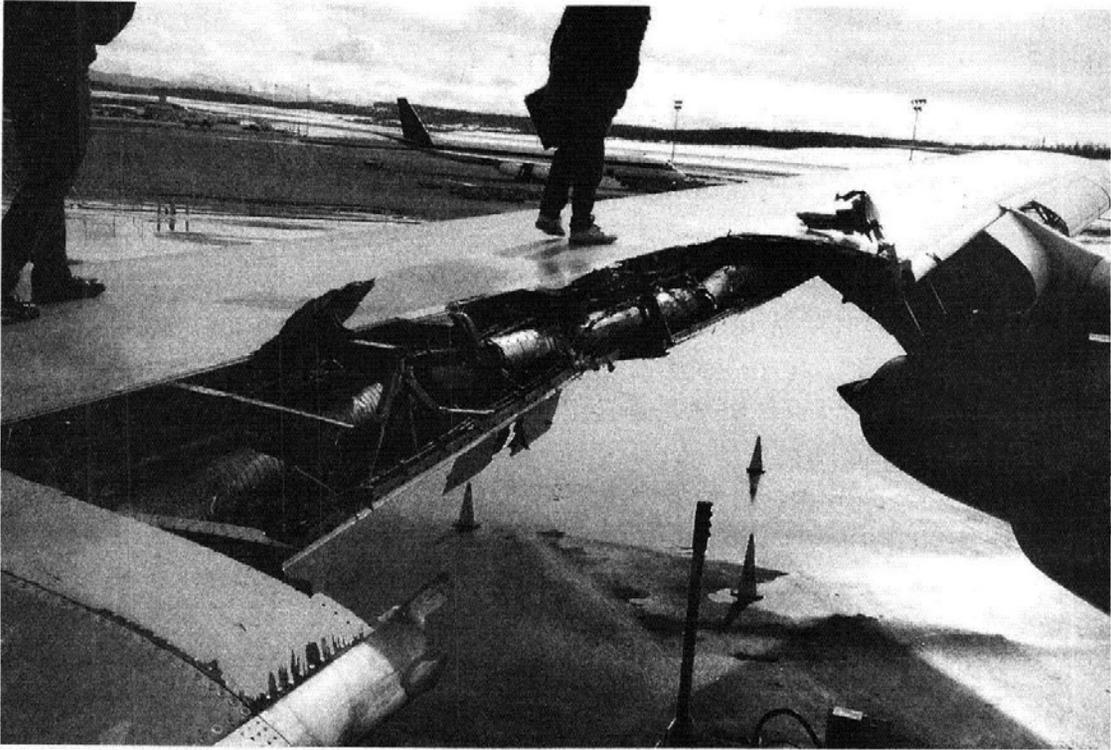
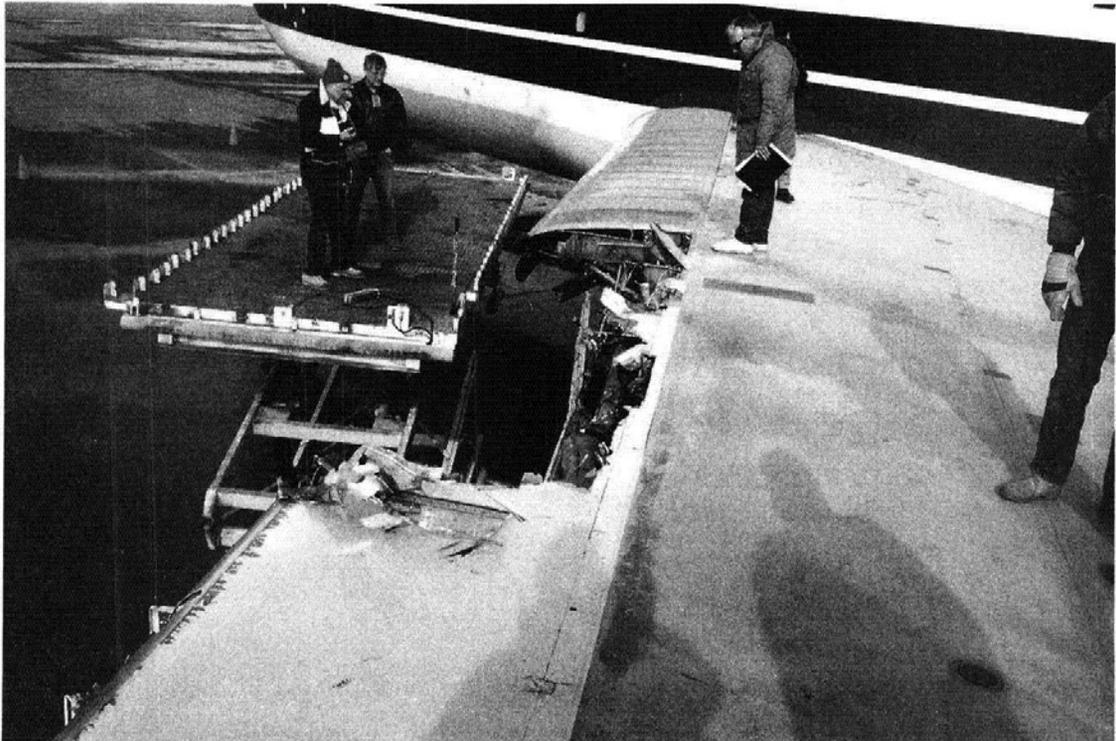
Figure 4.--Left wing damage.

All of the entire upper surface fixed leading edge panels from approximately inboard leading edge station (ILES) 695 to ILES 930 on the left wing were missing (see figure 4). The wing leading edge "D" beam and thermal anti-ice duct from ILES 695 to ILES 930 on the left wing were missing. The leading edge variable camber (VC) flaps Nos. 7, 8, 9, and 10, including their drive motors, torque tubes, and 50 percent of all the linkage had been torn from the wing. Additionally, all of the leading edge flap support ribs were either missing or partially missing in this area.

The pneumatic duct was pushed against the wing front spar and was crushed and separated in three places. The lower fixed leading edge panels were intact; however, their forward edges were bent upward over most of the span between the No. 1 and No. 2 engines.

The D beam and thermal anti-ice duct portions, as well as many of the VC flap folding nose sections, were crushed and appear to have been struck by a large, heavy object. The recovered VC flap portions were split in the spanwise direction. The leading edge flap support ribs were broken near the front spar's upper chord attachment and the rib post lug tension tube attachment. The appearance of these fractures and the position of the rib portions that were still attached to the front spar were consistent with an upward and outboard motion of the object that impacted the structure. The VC flap linkage parts that were recovered exhibited compression and torsion damage that was also consistent with this motion. Some parts of the wing's upper surface fixed leading edge honeycomb panels smelled of fuel. A puncture in the No. 4 spoiler was consistent with an object that entered on the upper surface and exited on the lower surface, when the spoiler was deployed. The remaining punctures, gouges, and dents were typical of impact with small objects.

Other damage was found on the wing's trailing edge outboard fore, mid, and aft flaps, inboard aft flap outboard corner, spoiler No. 4, the lower fixed trailing edge panel aft of the "sailboat" fairing, and the left side of the lower rudder. This damage consisted of punctures and tears. Dents, scrapes, and scratches were found on the left wing upper and lower skin panels as well as on the left stabilizer leading edge. Figure 4 shows the damage to the leading edge of the wing.
