Inadvertent In-Flight Slat Deployment, China Eastern Airlines Flight 583, McDonnell Douglas MD-11, B-2171, 950 Nautical Miles South Of Shemya, Alaska, April 6, 1993

AIRCRAFT ACCIDENT REPORT

INADVERTENT IN-FLIGHT SLAT DEPLOYMENT
CHINA EASTERN AIRLINES FLIGHT 583
McDONNELL DOUGLAS MD-11, B-2171
950 NAUTICAL MILES SOUTH OF SHEMYA, ALASKA
APRIL 6, 1993

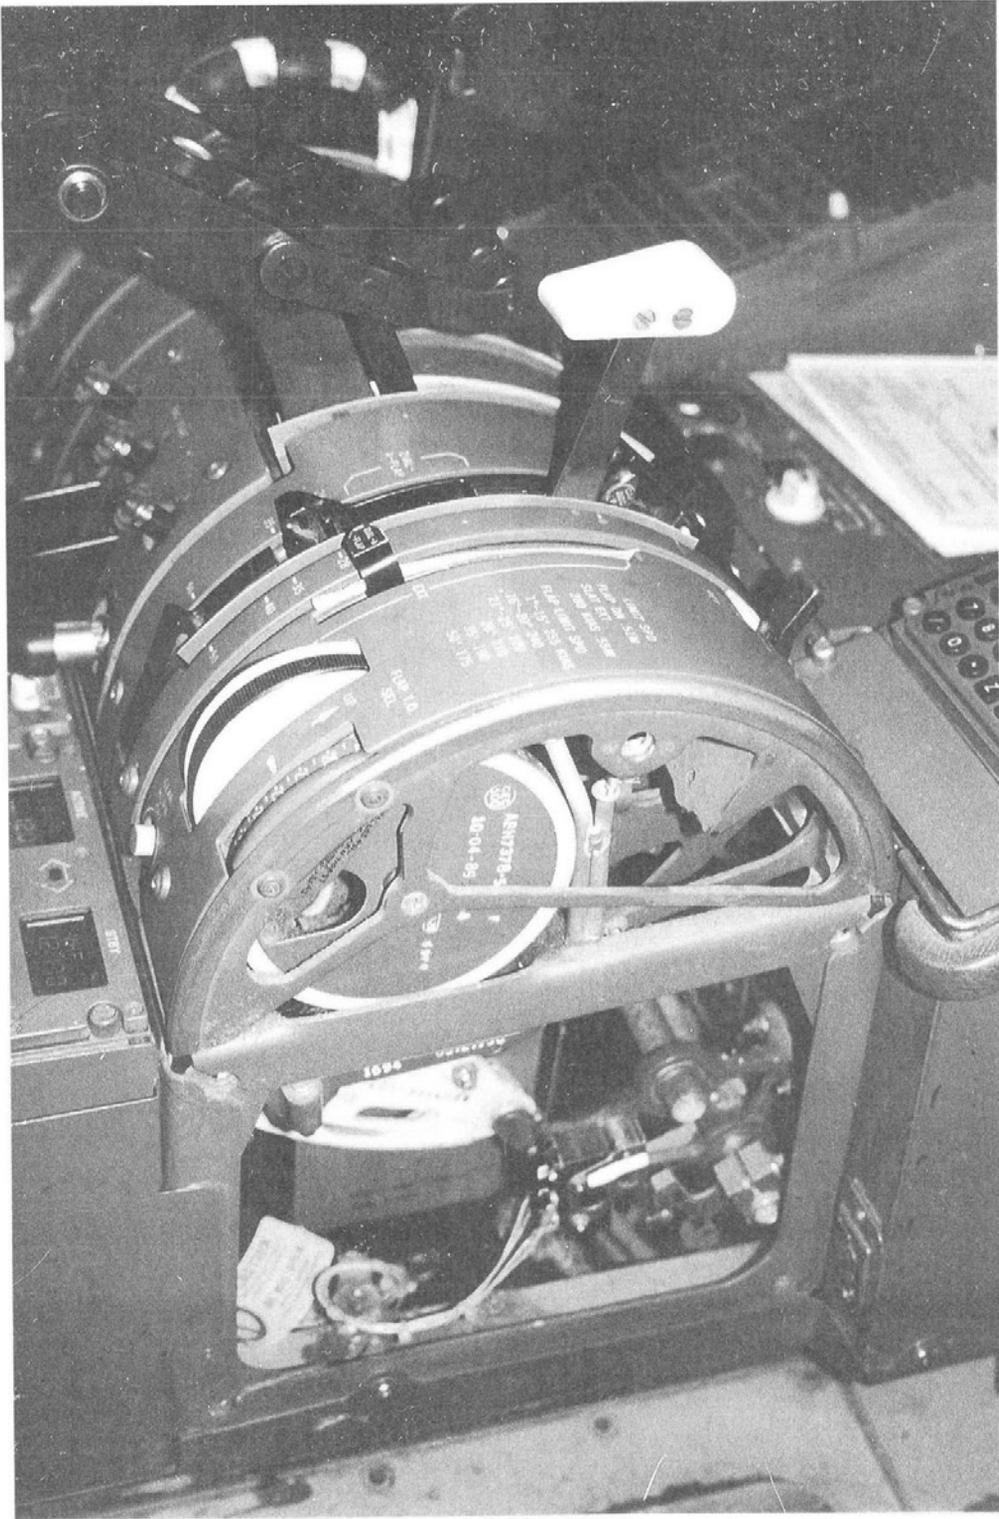
Figure 5.--Closeup view of flap/slat handle in cockpit.

The National Transportation Safety Board determines that the probable cause of this accident was the inadequate design of the flap/slat actuation handle by the Douglas Aircraft Company that allowed the handle to be easily and inadvertently dislodged from the UP/RET position, thereby causing extension of the leading edge slats during cruise flight. The captain's attempt to recover from the slat extension, given the reduced longitudinal stability and the associated light control force characteristics of the MD-11 in cruise flight, led to several violent pitch oscillations.

The flap/slat handle was found to operate normally through its range of movement. Examination of the slat stow lever revealed that when the lever was pushed forward (the disconnect position), then released, the lever did not return to its normal position.⁷ The lever was operationally tested several times, and it was determined that it could not be manipulated in such a manner that would cause or permit an uncommanded slat extension.

DAC recommended the installation of a protective cover over the zero degree detent gate of the flap/slat handle. The modification was prompted by an uncommanded extension of the slats when the pilot on an airplane that had been modified per S/B 27-18, depressed the zero degree detent gate while the flap/slat handle was stowed in the retract detent.

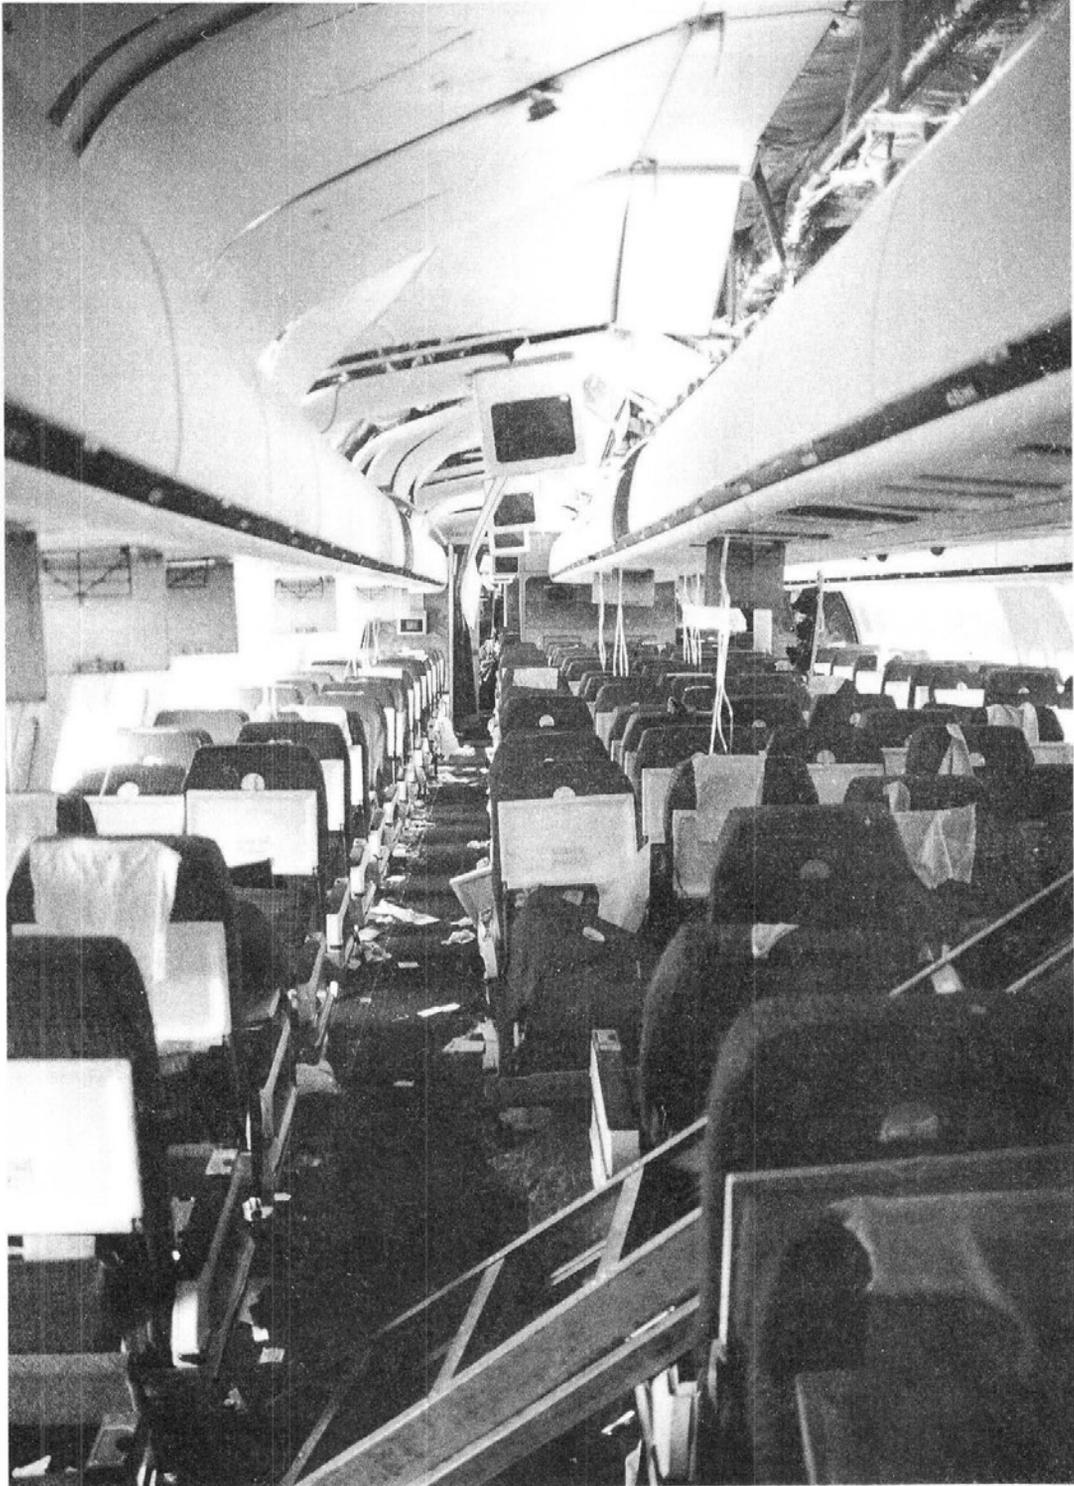
Figure 7.--Passenger cabin interior.

The primary damage occurred to the interior structure and seats in the coach class section. The damage to the passenger seats ranged from slight deformation to distortion and/or complete collapse of the seat arm rests and seat backs. (See figure 7).

Several passenger service units (PSUs) in the coach class section sustained impact damage when they were struck by passengers. The damaged PSUs had been displaced or pushed up into their mounting structure. Twenty oxygen masks, in various parts of this cabin section, were found deployed as a result of damage to the PSUs.

Numerous ceiling panels in the forward coach cabin and all of the ceiling panels in the aft cabin of the coach section were damaged, and some were displaced upward against their support frames. About 80 percent of the ceiling cross beams, which support the ceiling panels in the aft section of the airplane, were found crimped, separated or bent.
