In-flight loss of propeller blade and uncontrolled collision with terrain, Mitsubishi Mu-2B-60, N86SD, Zwingle, Iowa, April 19, 1993

Investigative Body: National Transportation Safety Board (NTSB), USA

IN-FLIGHT LOSS OF PROPELLER BLADE
AND UNCONTROLLED COLLISION WITH TERRAIN
MITSUBISHI MU-2B-60, N86SD
ZWINGLE, IOWA
APRIL 19, 1993

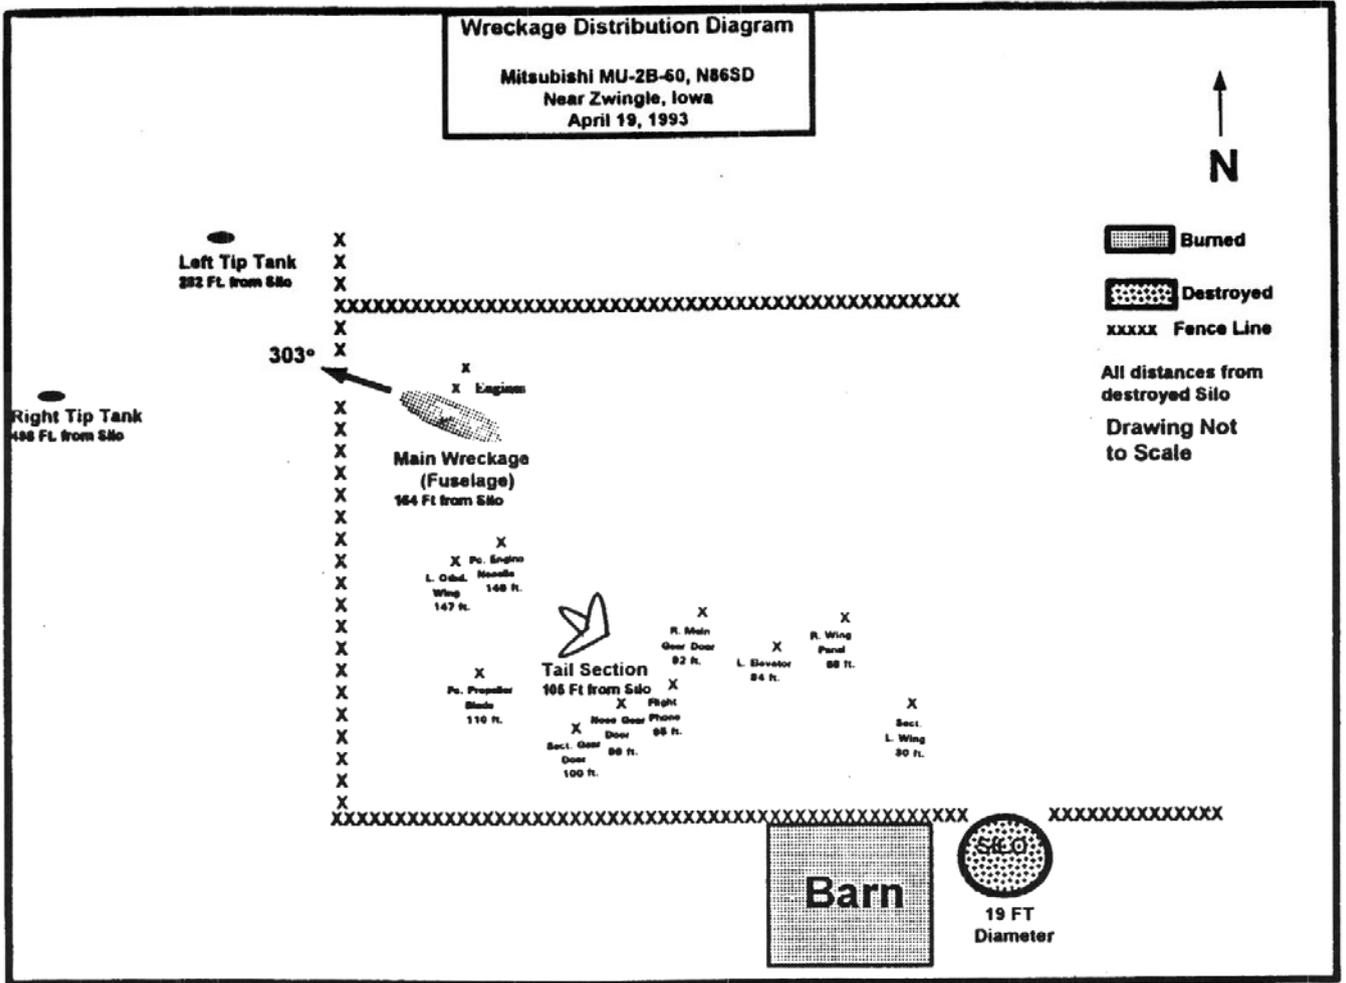
Figure 2.--Debris field diagram.

The airplane came to rest on a heading of 303 degrees magnetic in a barnyard. During the postcrash fire, about 75 percent of the fuselage was consumed by fire. The wreckage path began at a demolished 75-foot concrete and steel silo and continued for about 498 feet on a magnetic heading of between 290 and 320 degrees. The farthest pieces of airplane debris that were found were the left and right tip tanks, which showed minor frontal damage and no fire damage. The fuselage was found to be heading 303 degrees and was largely consumed by fire from the front to the aft pressure bulkhead. (See figures 2 and 3).

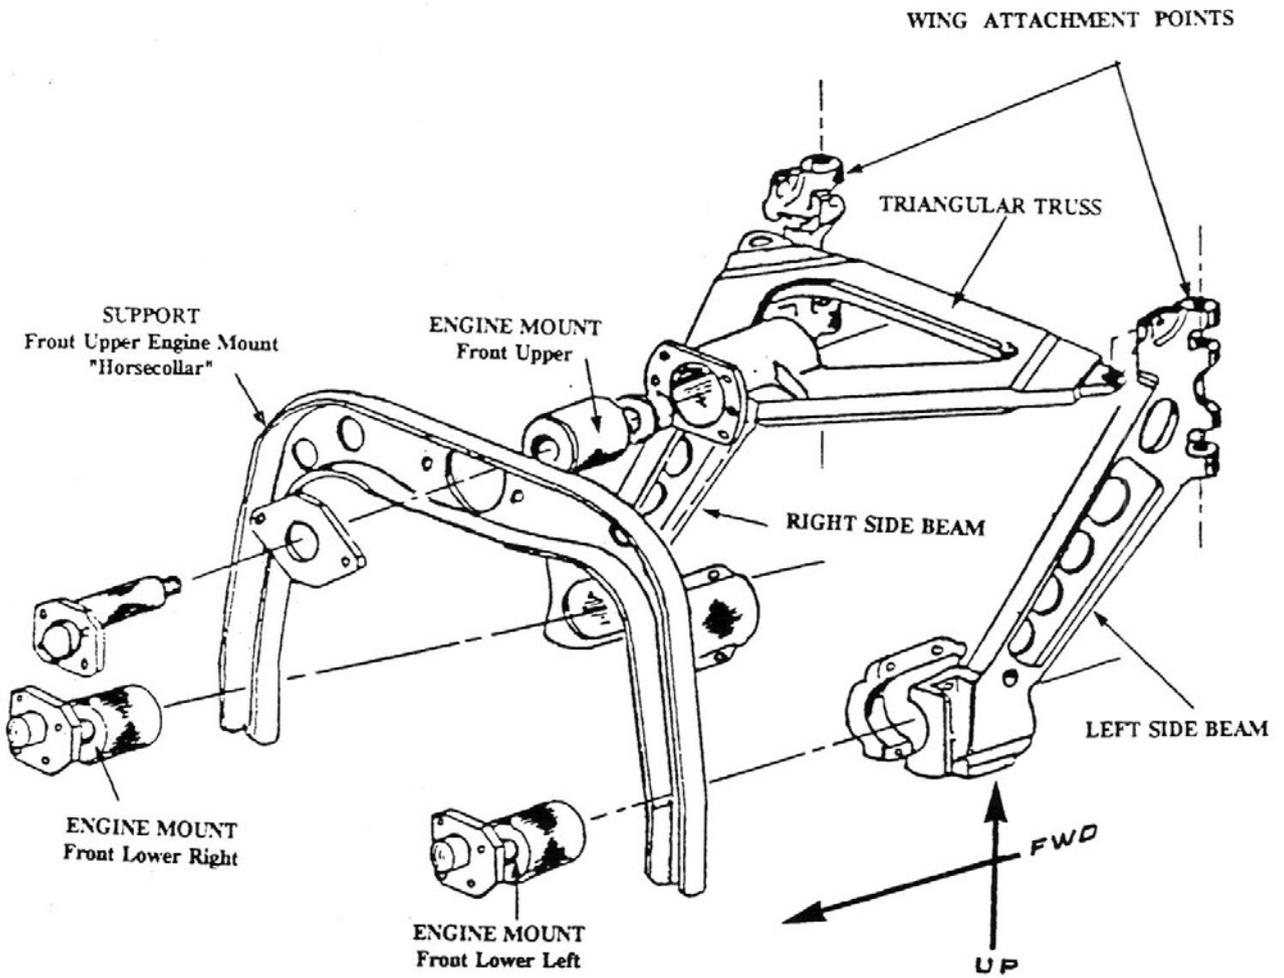
Figure 4.--Engine mount diagram.

The left side panel beam separated from the front wing spar, with the beam hinge type attachment and bolt intact; the separation occurred at the wing spar riveted joint. (See figure 4). The left beam was bent at mid length to the right (aft looking forward) approximately 50 degrees and slightly twisted in a clockwise direction. The cover and vibration isolator were intact and relatively free of damage. The engine mount spindle plate was attached to the vibration isolator; however, the spindle plate separated from the accessory gear box (AGB) when the threaded inserts were stripped from the cast aluminum AGB housing. The inserts made multiple imprints at the attach point on the engine. The right beam also separated at the wing spar in tension and in a forward direction. The separation was at the web just aft of the vertical bolt. However, the right beam was not bent or twisted. The spindle on the right beam spindle plate failed at the minor diameter, and the separated piece of the spindle remained with the vibration isolator.

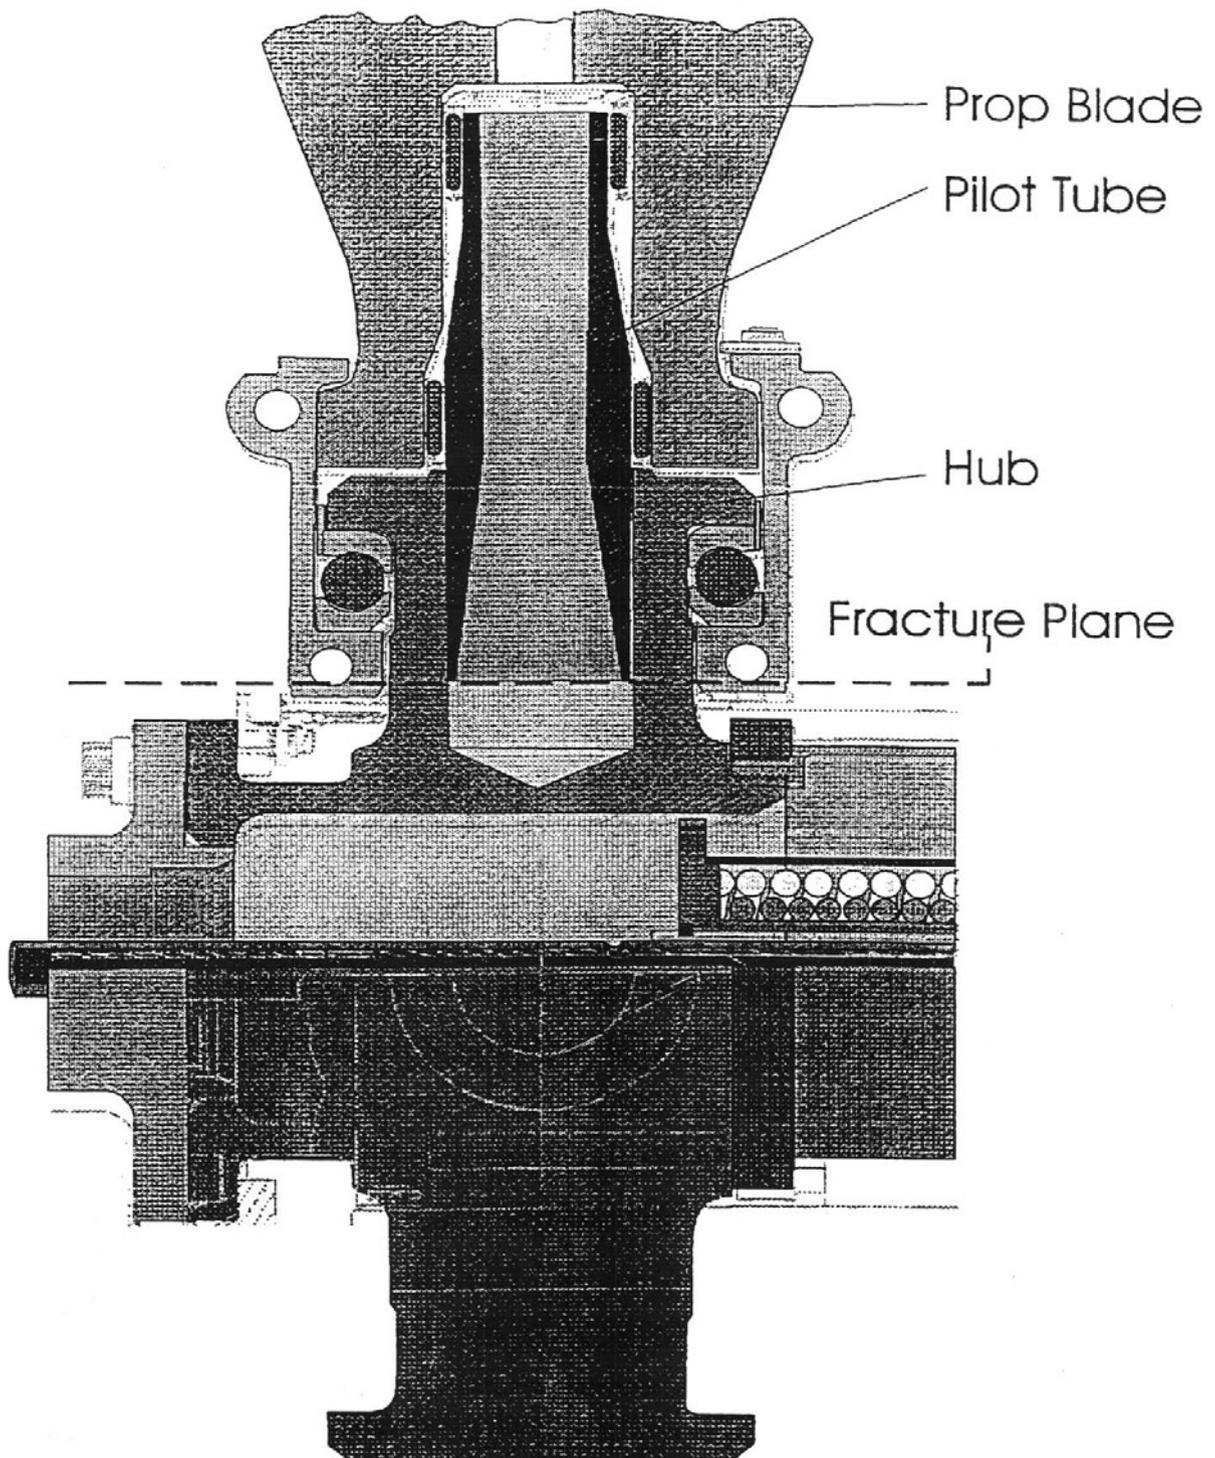
Figure 5.--Cross section of propeller hub arm.

The examination of the left propeller revealed that the fracture in the separated hub arm was the result of a fatigue crack that initiated from the inside diameter of the pilot tube hole in the hub arm. Figure 5 is a drawing of a cross section through the hub arm of the Hartzell HC-B4 propeller, with the location of the fracture indicated. Figure 6 is a view looking inboard on the fracture surface on the main portion of the propeller hub. The circumferential location of the origin area of the fatigue crack was at the 7:30 position, looking inboard at the fracture, with forward at the 12:00 position. This portion of the hub arm would experience maximum tensile stresses during normal operation of the propeller (forward thrust). The axial location of the origin was about 0.020 inch outboard of the bevel on the inboard end of the pilot tube. The fatigue cracking propagated through about 45 percent of the hub arm cross section before final fracture occurred.

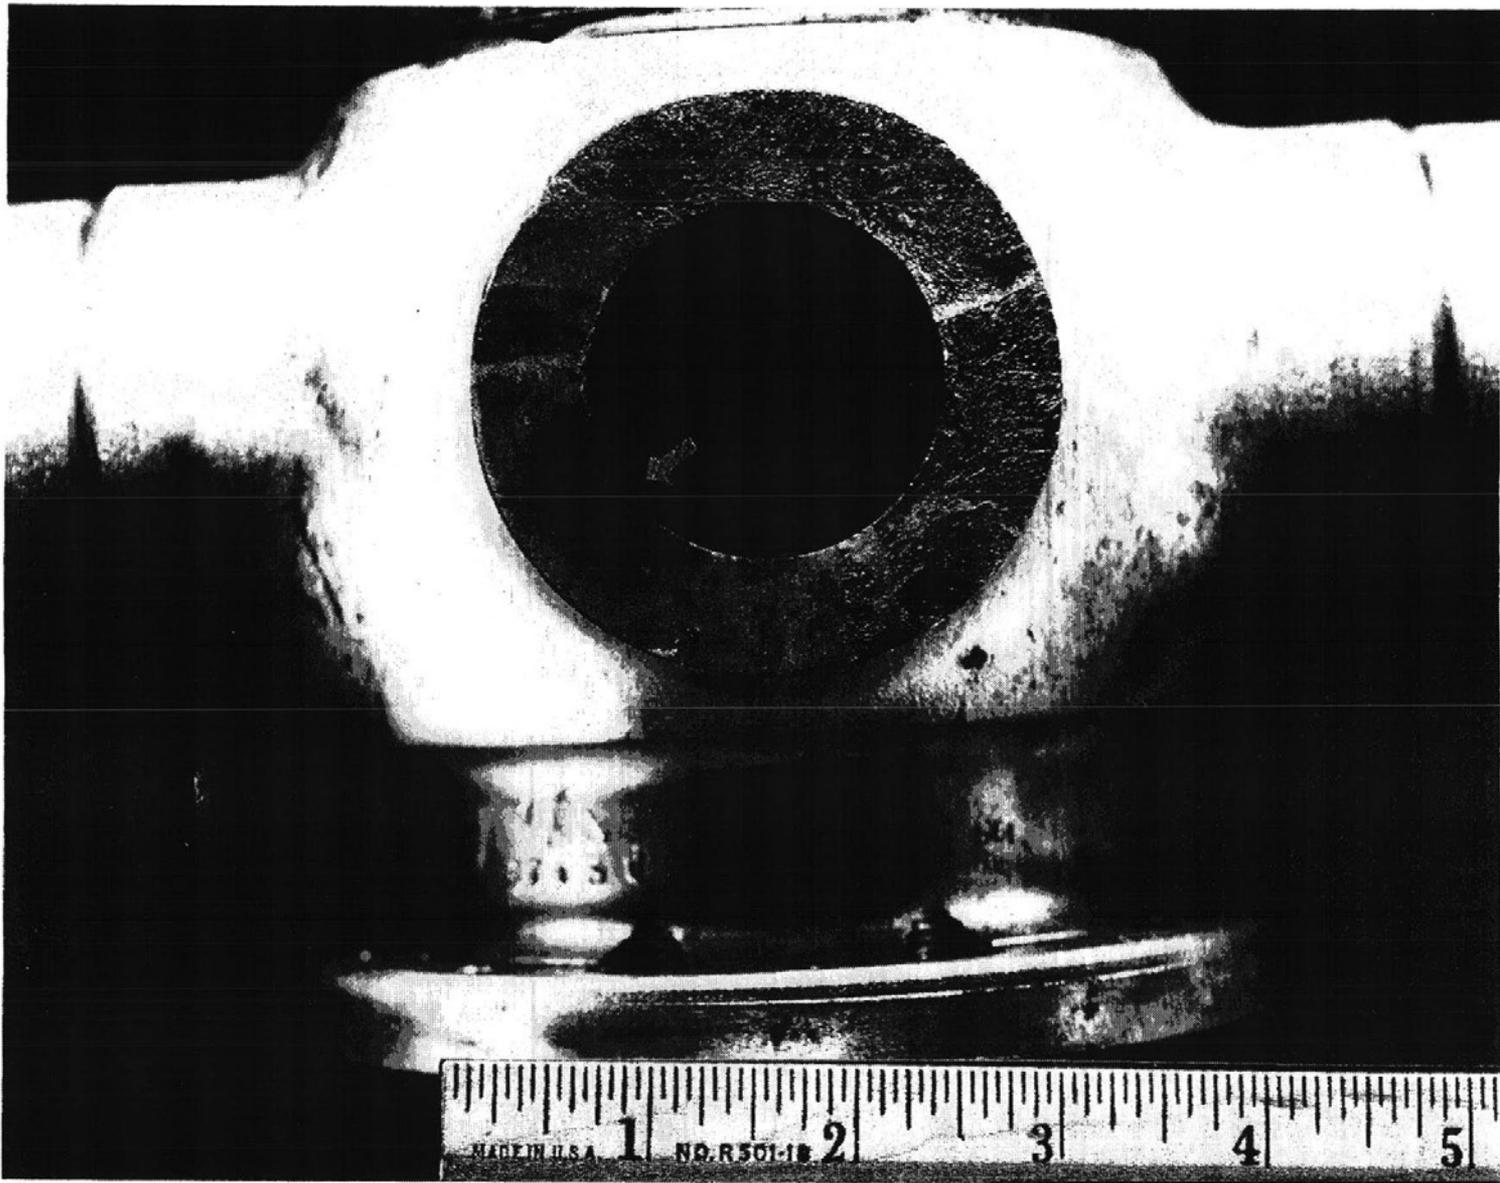
The origin area contained a large number of ratchet marks,⁹ indicative of fatigue crack initiation from a large number of individual initiation sites. The approximate width of the origin area was 0.33 inch.

A portion of the fracture adjacent to the fatigue origin area contained a distinct, semicircular, darkly discolored area that extended over a width of 0.75 inch and to a depth of slightly less than 0.2 inch from the pilot tube hole surface. There appeared to be two separate curvilinear initiations of fatigue cracking from the end of the discolored fracture area. The larger initiation stemmed from an area of the discolored crack front closer to the 7:00 position of the hub and the other, which was smaller, was closer to the 8:00 position. Initial fatigue cracking from these reinitiation areas was relatively clean (not discolored); however, after a short distance, the fracture was again discolored in thin rings, after which the fatigue

Figure 6.--Hub arm fracture surface. Arrow indicates fracture origin.

crack fronts appeared to merge to a single crack front. The remaining fatigue fracture outside these rings contained lesser amounts of discoloration with increasing distance from the origin. Examination of the fracture with a scanning electron microscope showed that some areas of the fatigue crack region outside the darkly discolored portion contained features with an intergranular appearance (fracturing between grains).

The surface of the pilot tube hole in the vicinity of the fatigue crack origin area contained general corrosion damage (primarily in the form of corrosion pits). However, the number of individual initiation sites was far greater than the number of corrosion pits. A narrow gap with corrosion deposits extended between the inboard end of the pilot tube and the inside diameter surface of the pilot tube hole in the hub arm. The surface of the pilot tube hole also contained burnished machining marks.¹⁰ The origin area was along one of these machining marks for a substantial portion of its width.
