Flight Into Terrain During Missed Approach, USAir Flight 1016, DC-9-31, N954VJ, Charlotte/Douglas International Airport, Charlotte, North Carolina, July 2, 1994

AIRCRAFT ACCIDENT REPORT

FLIGHT INTO TERRAIN DURING MISSED APPROACH
USAIR FLIGHT 1016, DC-9-31, N954VJ
CHARLOTTE/DOUGLAS INTERNATIONAL AIRPORT
CHARLOTTE, NORTH CAROLINA
JULY 2, 1994

**Adopted: April 4, 1995
Notation 6413A**

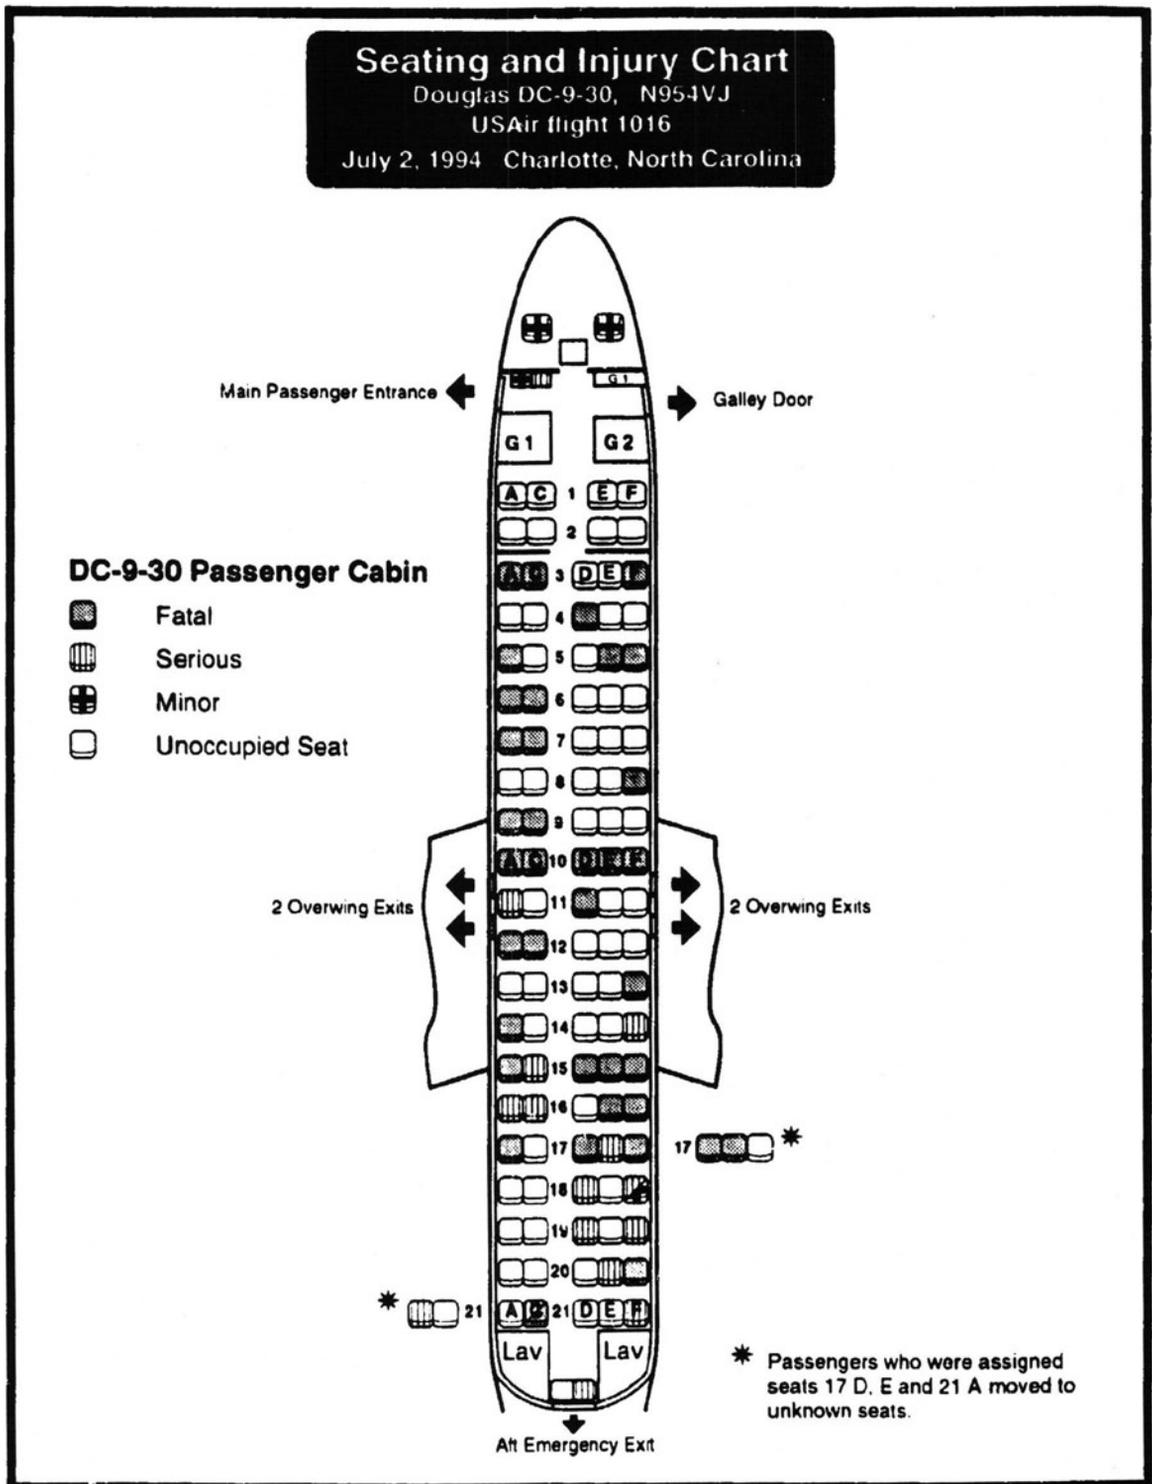
Figure 3.--Cabin diagram.

A 9-month-old infant, who was unrestrained in her mother's lap in seat 21C, sustained fatal injuries. The mother was unable to hold onto her daughter during the impact sequence. Seat 21C was intact and the surrounding cabin structure sustained minor deformation. Additionally, the impact forces in this area were calculated to have been within human tolerances. According to passengers, a flash fire swept through the inside of the cabin during the impact sequence; examination found no evidence of either fire or smoke impingement in this area of the cabin. (See figure 3.)

The two lap children were seated in 18F and 21C. The 18-month-old female infant was lying across seats 18E and 18F. This infant sustained serious injuries, and her mother sustained minor injuries. The other lap child, a 9-month-old female infant, was being held by her mother in 21C and sustained fatal injuries. According to the mother, she was unable to maintain a secure hold on her child during the impact sequence.

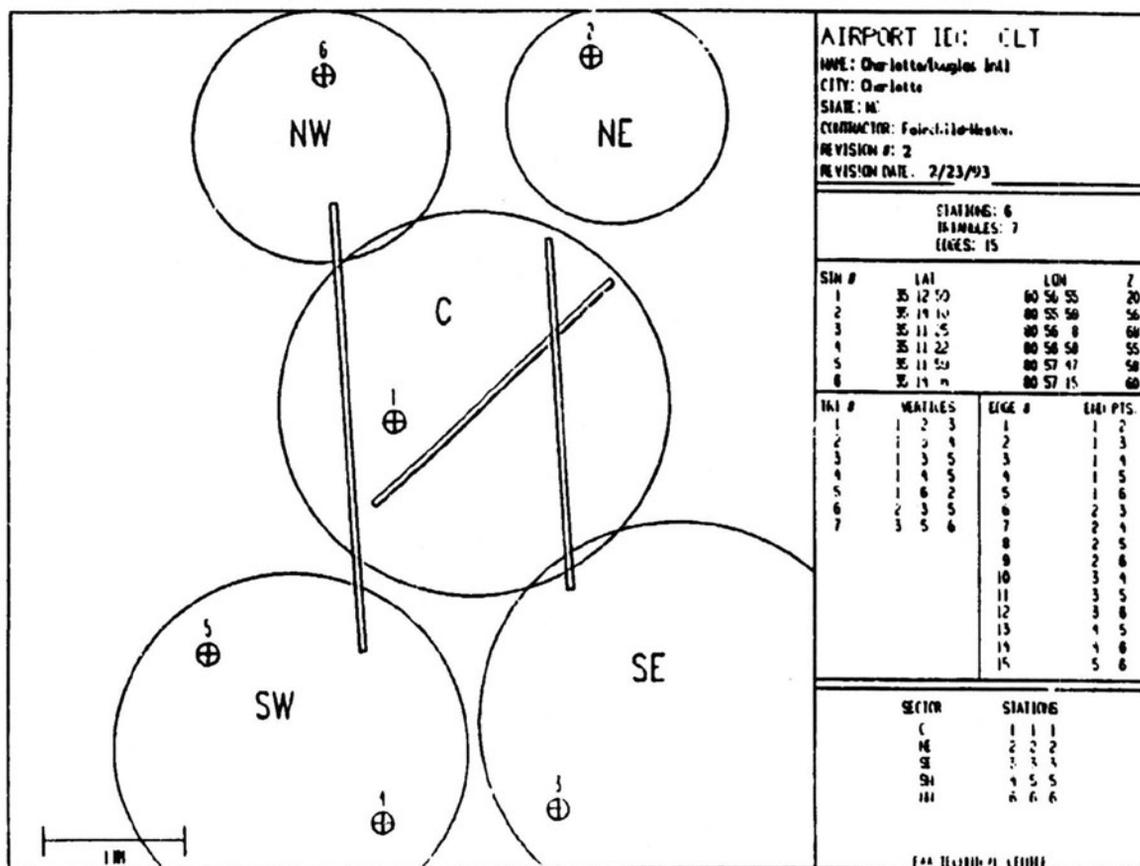
LLWAS SENSOR LOCATIONS

Although the Charlotte LLWAS system was recertified after the accident, it was the subject of several internal communications within the FAA between April and June of 1993. The system was identified as having problems, specifically, "inaccurate reporting of wind conditions." The Safety Board found that while funding requests for system upgrades were made, there had been no modifications to the system at the time of the accident. In addition, on August 4, 1994, the FAA cited in its written response to the Safety Board regarding the performance of the Charlotte LLWAS system "...at the time of the installation of the CLT LLWAS, the concern was to detect gust fronts, not microbursts" and the siting "...standards were less stringent than those now currently used." The FAA further stated that a Site Performance Evaluation Study (SPES), conducted at Charlotte after the accident, determined that sensor 2 (northeast boundary) and sensor

6 (northwest boundary) were sheltered by obstacles "...significant enough to degrade the system."

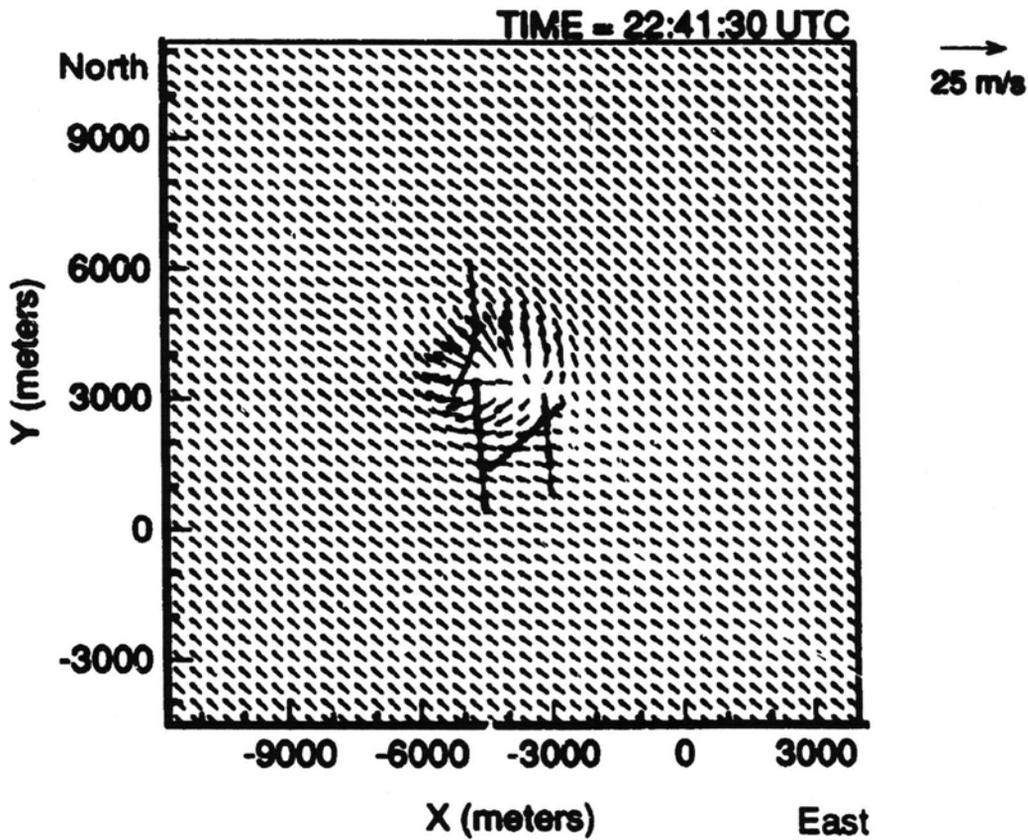
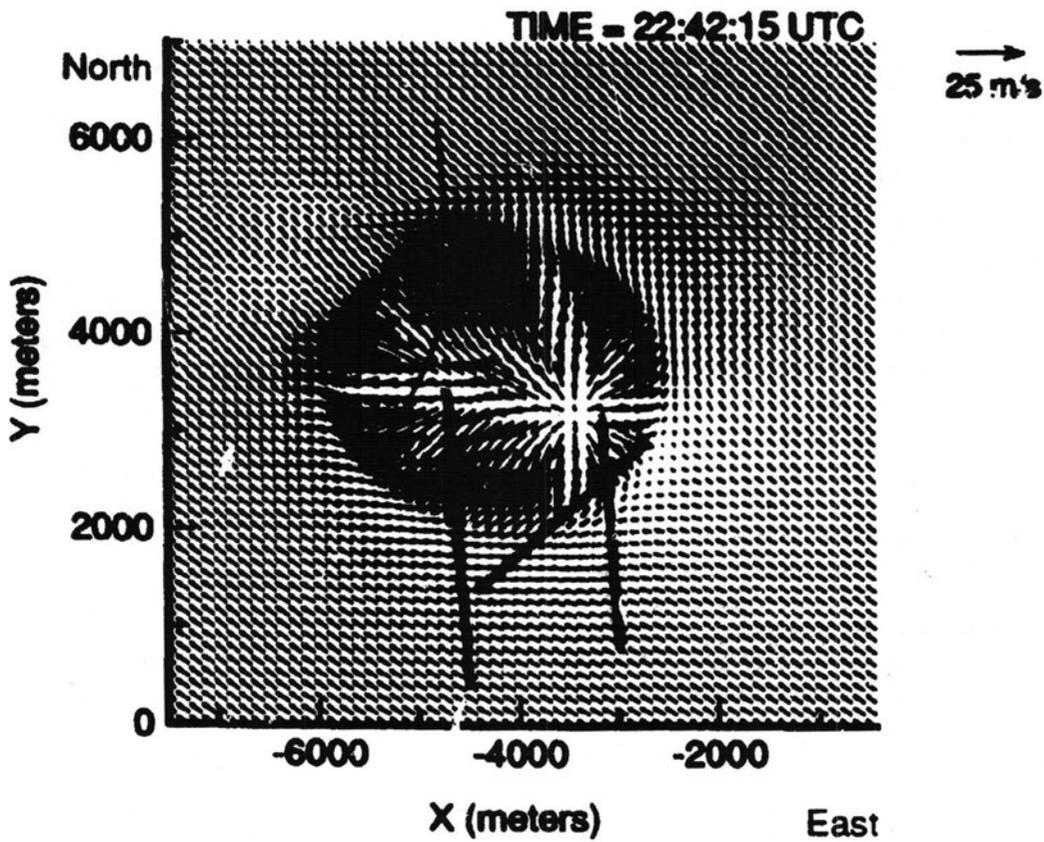
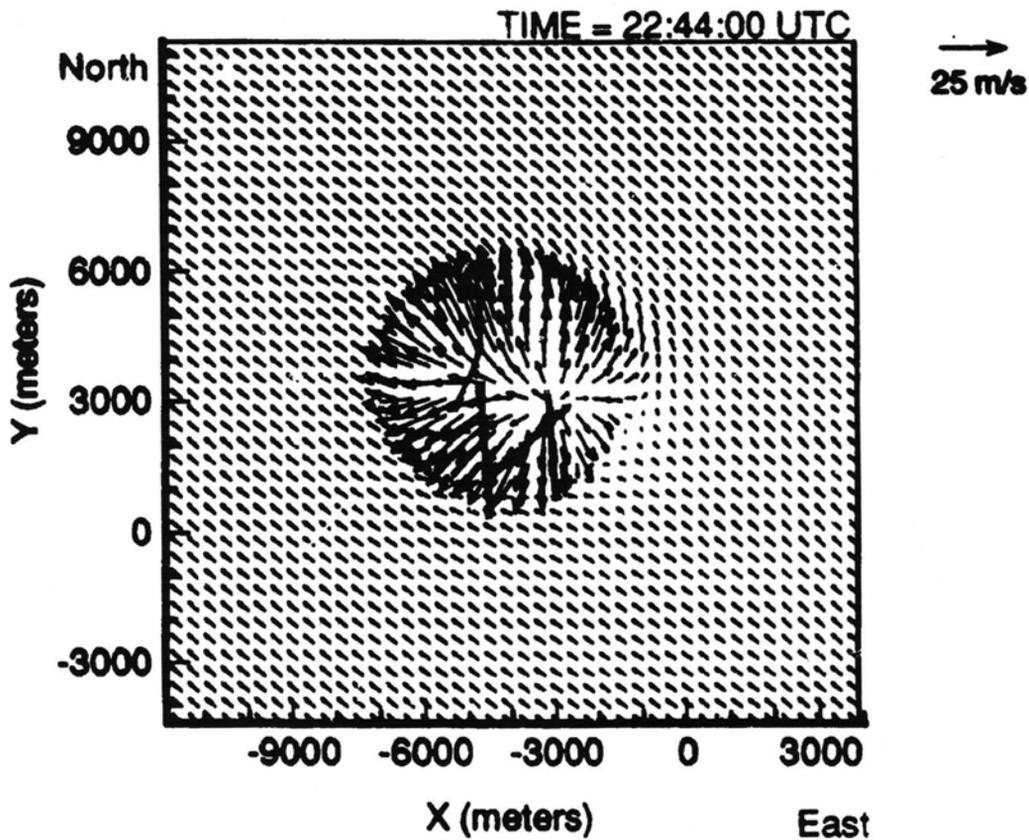
TASS CLT MICROBURST SIMULATION

1755....Regions of downward velocities greater than 10 m s^{-1} approximately represent the regions of downward air motion. These were located primarily from 0.8 to 3.0 km agl from 1733 to 1742, and contained downward air motions of about 2 to 4 m s^{-1} , except at the time of the crash (1743), when downward air motion of greater than 1 m s^{-1} could be inferred below 0.5 km agl.... A strong convective storm produced heavy precipitation at the time of the accident; strong vertical motions are likely to have been present very close to where the crash occurred; and the strongest inferred downdraft below 0.5 km agl occurred at the time of the crash.

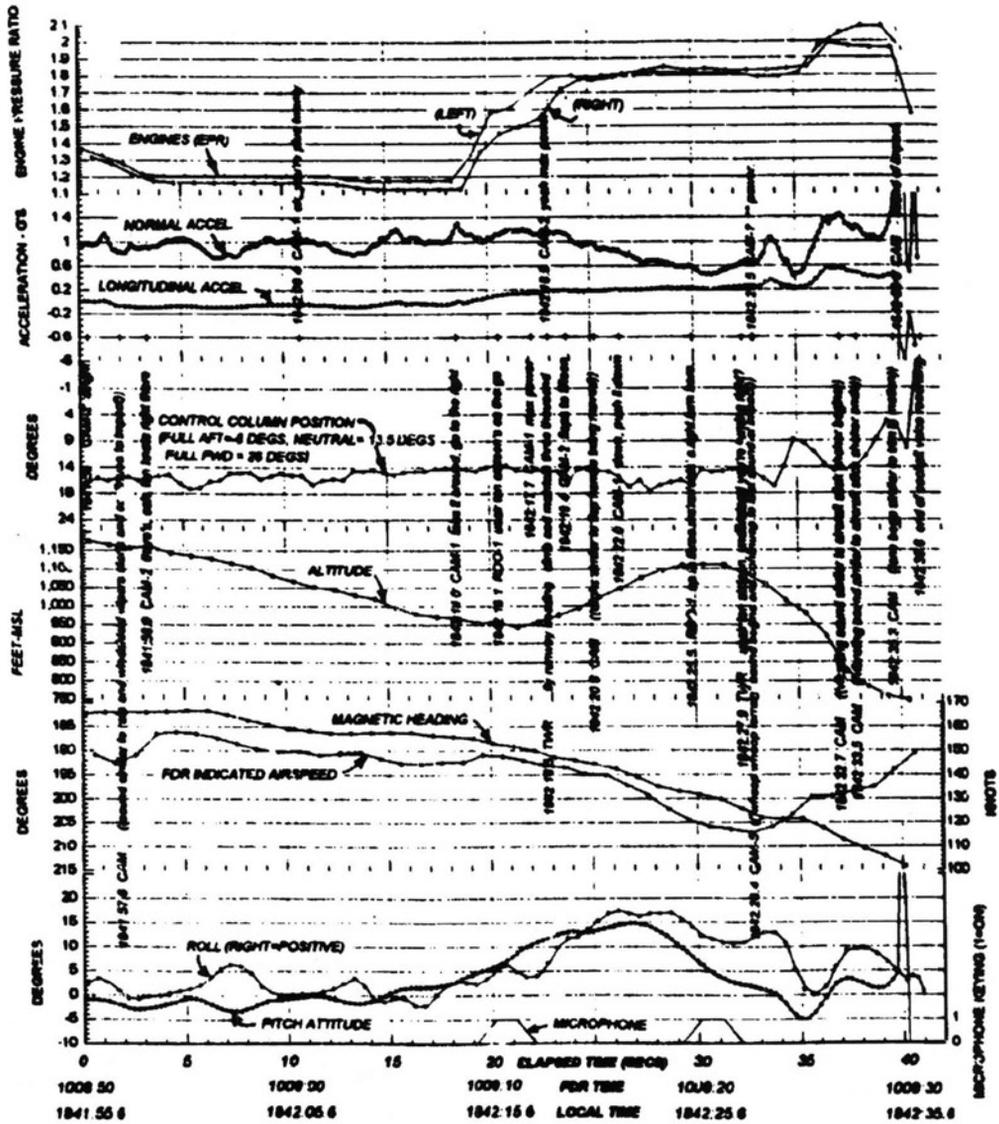
USAIR FLIGHT #1016 FLIGHT DATA RECORDER (FDR) GRAPHS

The FDR sustained no impact damage; and the quality of the recording was excellent with no loss of data. The recorded information covered 25 hours of flight, including the 24 minutes of flight from Columbia until the end of the recording. The FDR contained the following 11 parameters: time; pressure altitude; indicated airspeed; heading; roll and pitch attitudes; captain's control column position; vertical and longitudinal acceleration forces (G); left and right engine EPR; and VHF radio keying.
