In-Flight Icing Encounter and Loss of Control, Simmons Airlines, d.b.a. American Eagle Flight 4184, Avions de Transport Regional (ATR) Model 72-212, N401AM, Roselawn, Indiana, October 31, 1994, PART II

AIRCRAFT ACCIDENT REPORT

IN-FLIGHT ICING ENCOUNTER AND LOSS OF CONTROL
SIMMONS AIRLINES, d.b.a. AMERICAN EAGLE FLIGHT 4184
AVIONS de TRANSPORT REGIONAL (ATR)
MODEL 72-212, N401AM
ROSELAWN, INDIANA
OCTOBER 31, 1994

VOLUME II: RESPONSE OF BUREAU ENQUETES-ACCIDENTS
TO SAFETY BOARD'S DRAFT REPORT

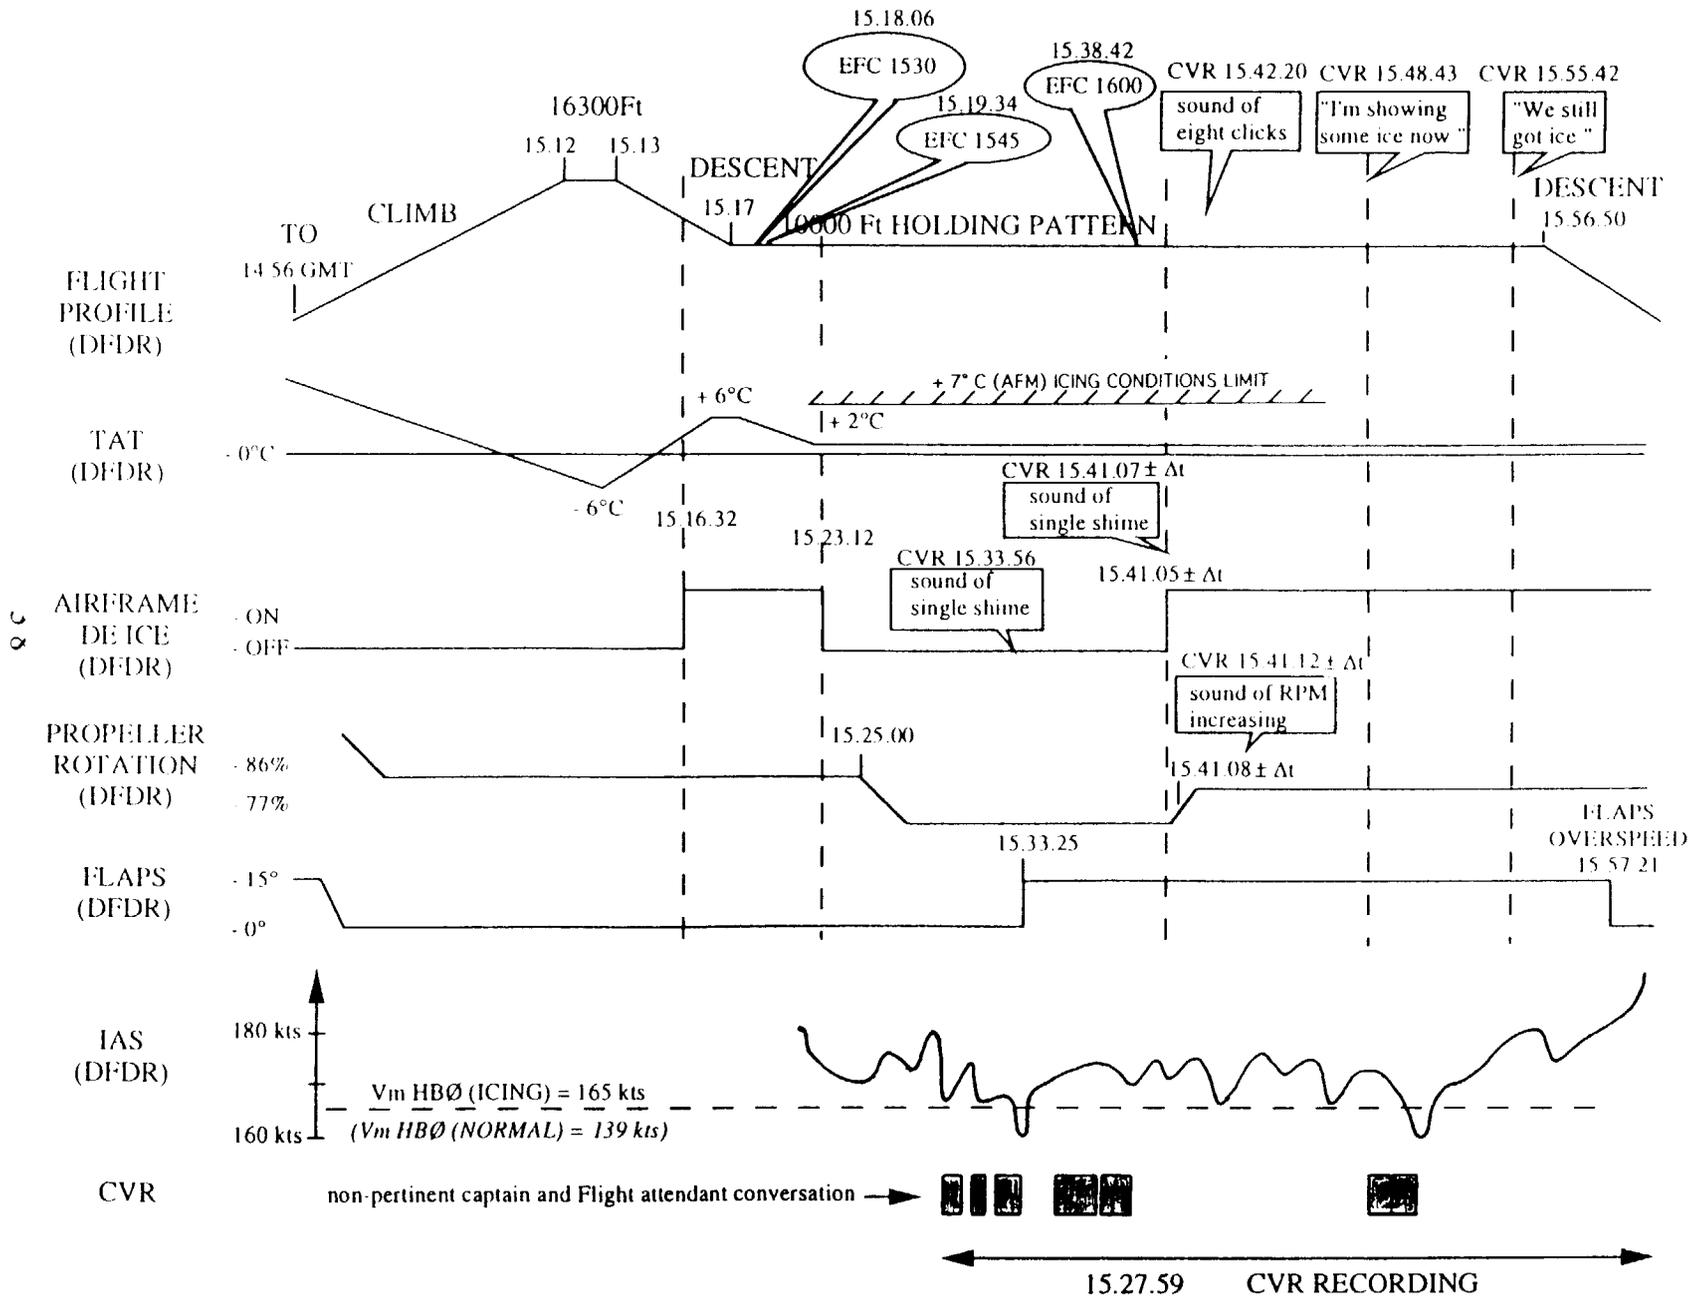
FIGURE 1 : FLIGHT 4184 PROFILE AND MAJOR DFDR EVENTS

The last seconds of DFDR data indicate a rapid, large input on the elevator.

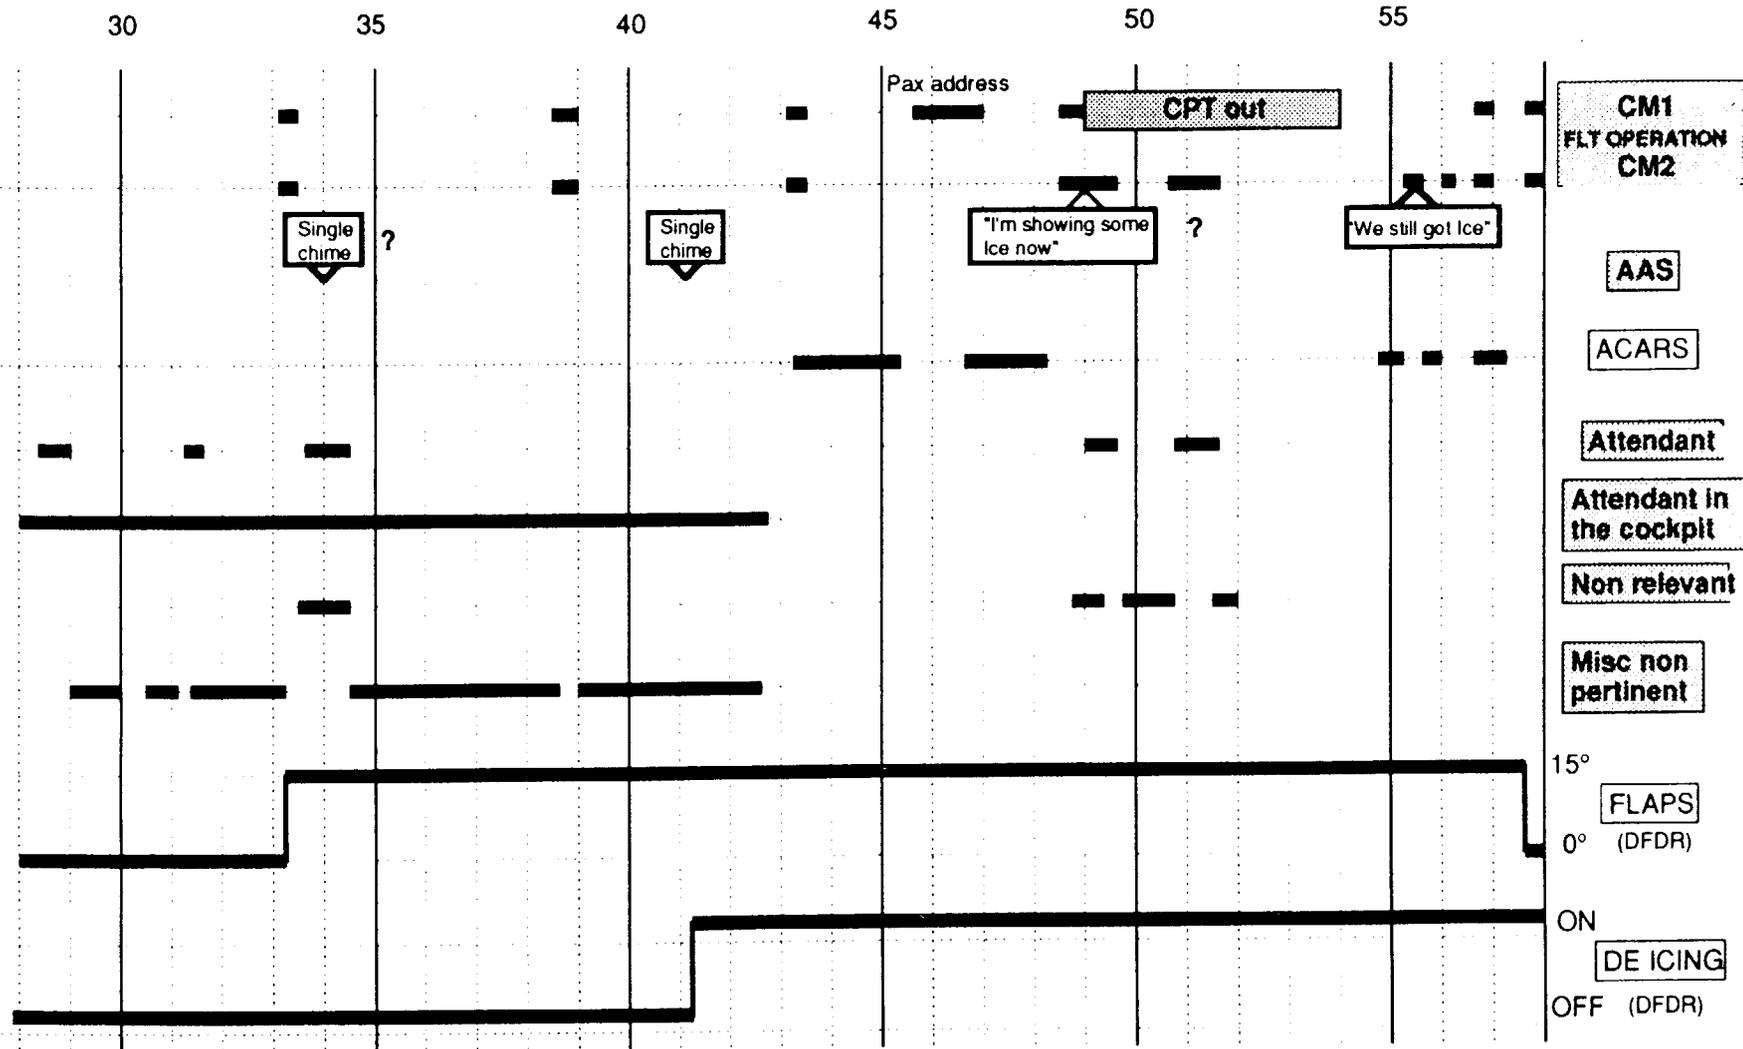
FIGURE 2 : FLIGHT 4184 CVR TIME HISTORY

Flight 4184 CVR transcript by NTSB was highly unedited

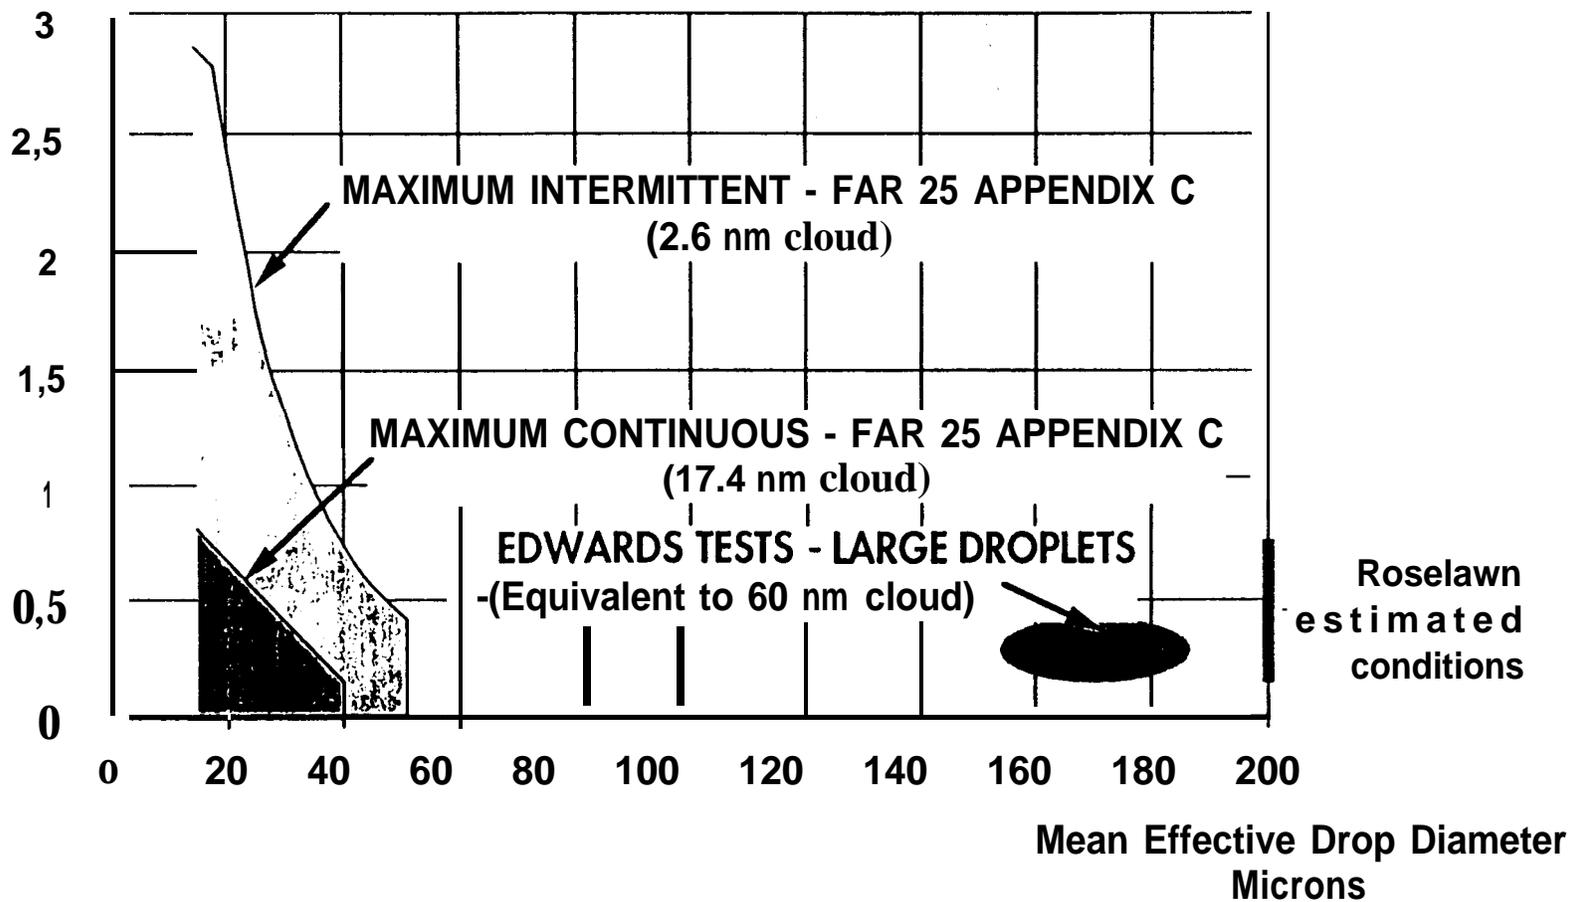
ROSELAWN conditions were far outside App "C" certification envelope

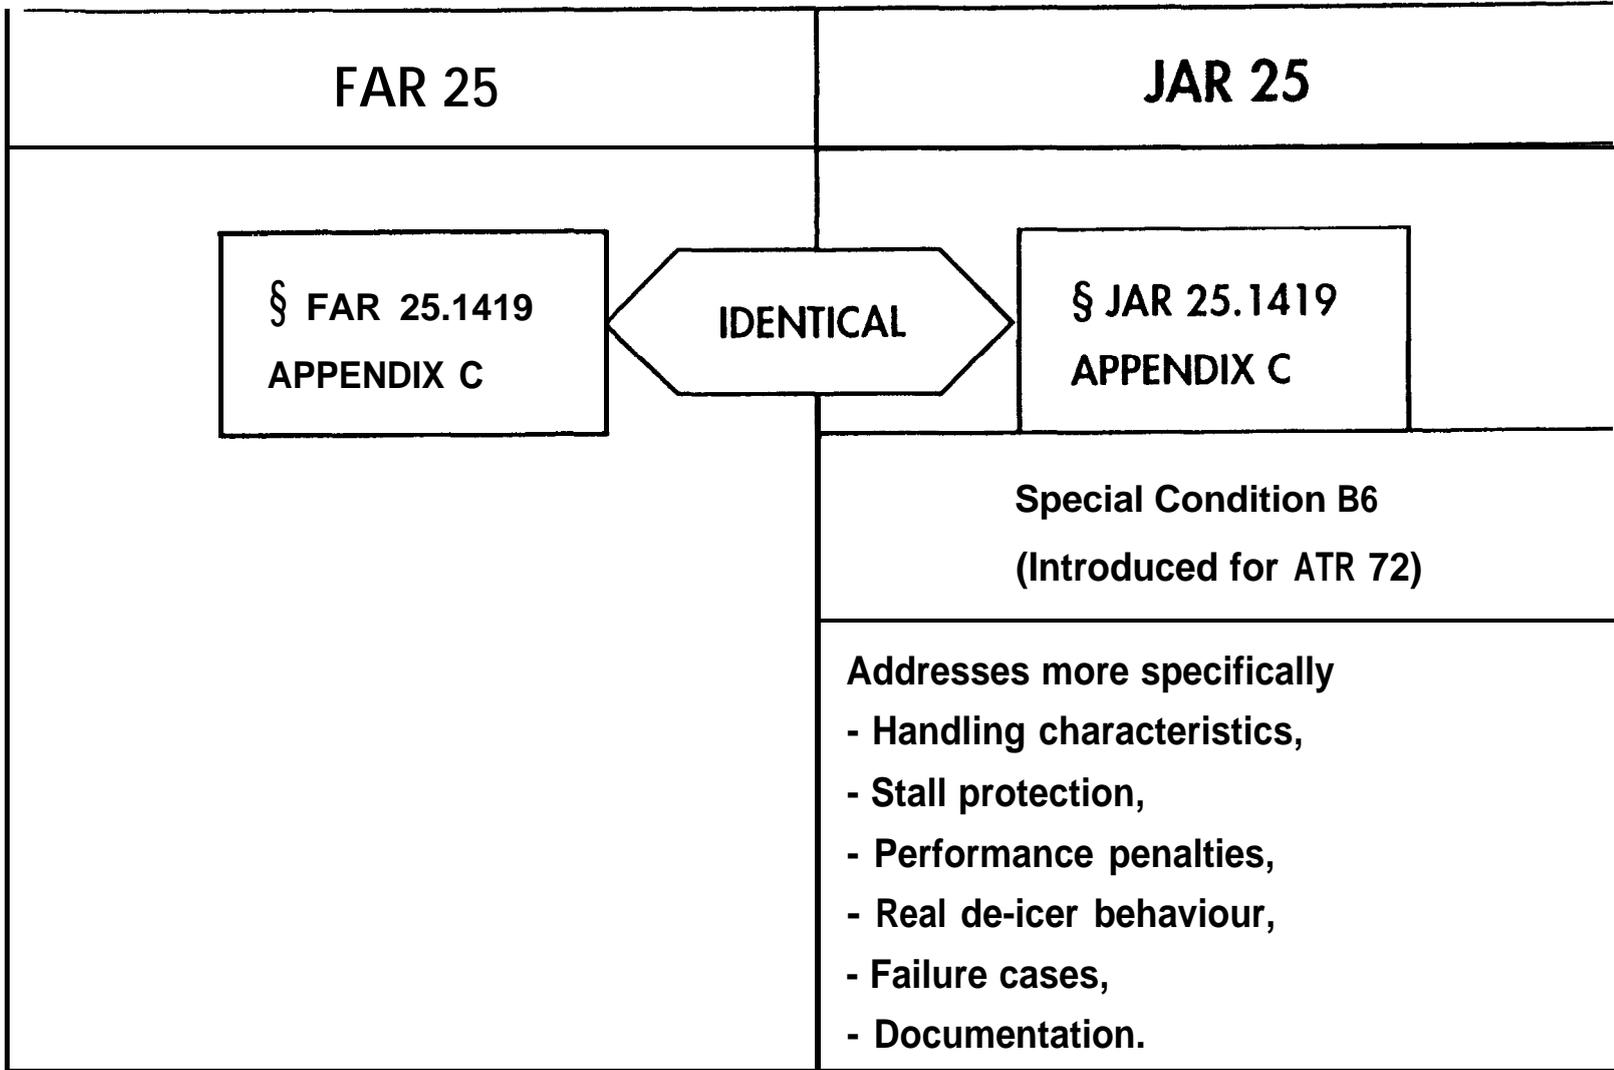
ATR 72 Icing Certification Standard encompassed current FAR 25.1419

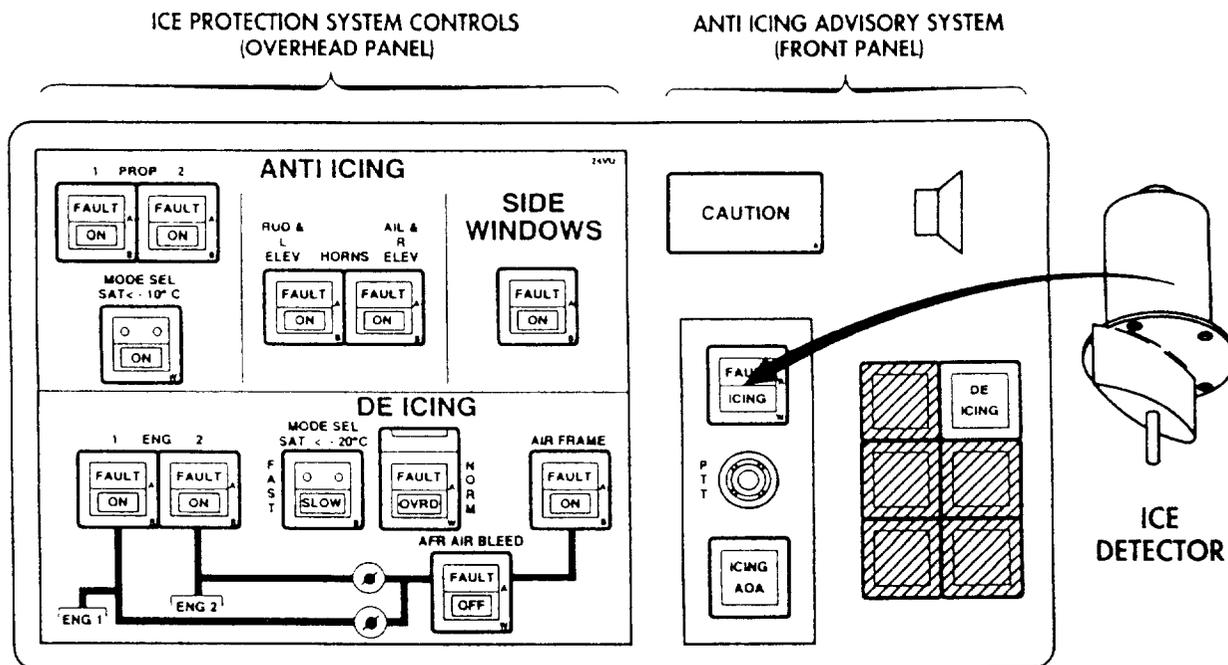
FIGURE 12 : ATR 72 ANTI-ICING ADVISORY SYSTEM (AAS)

ATR 72 ANTI-ICING ADVISORY SYSTEM (AAS) : An effective warning logic to back up crew awareness

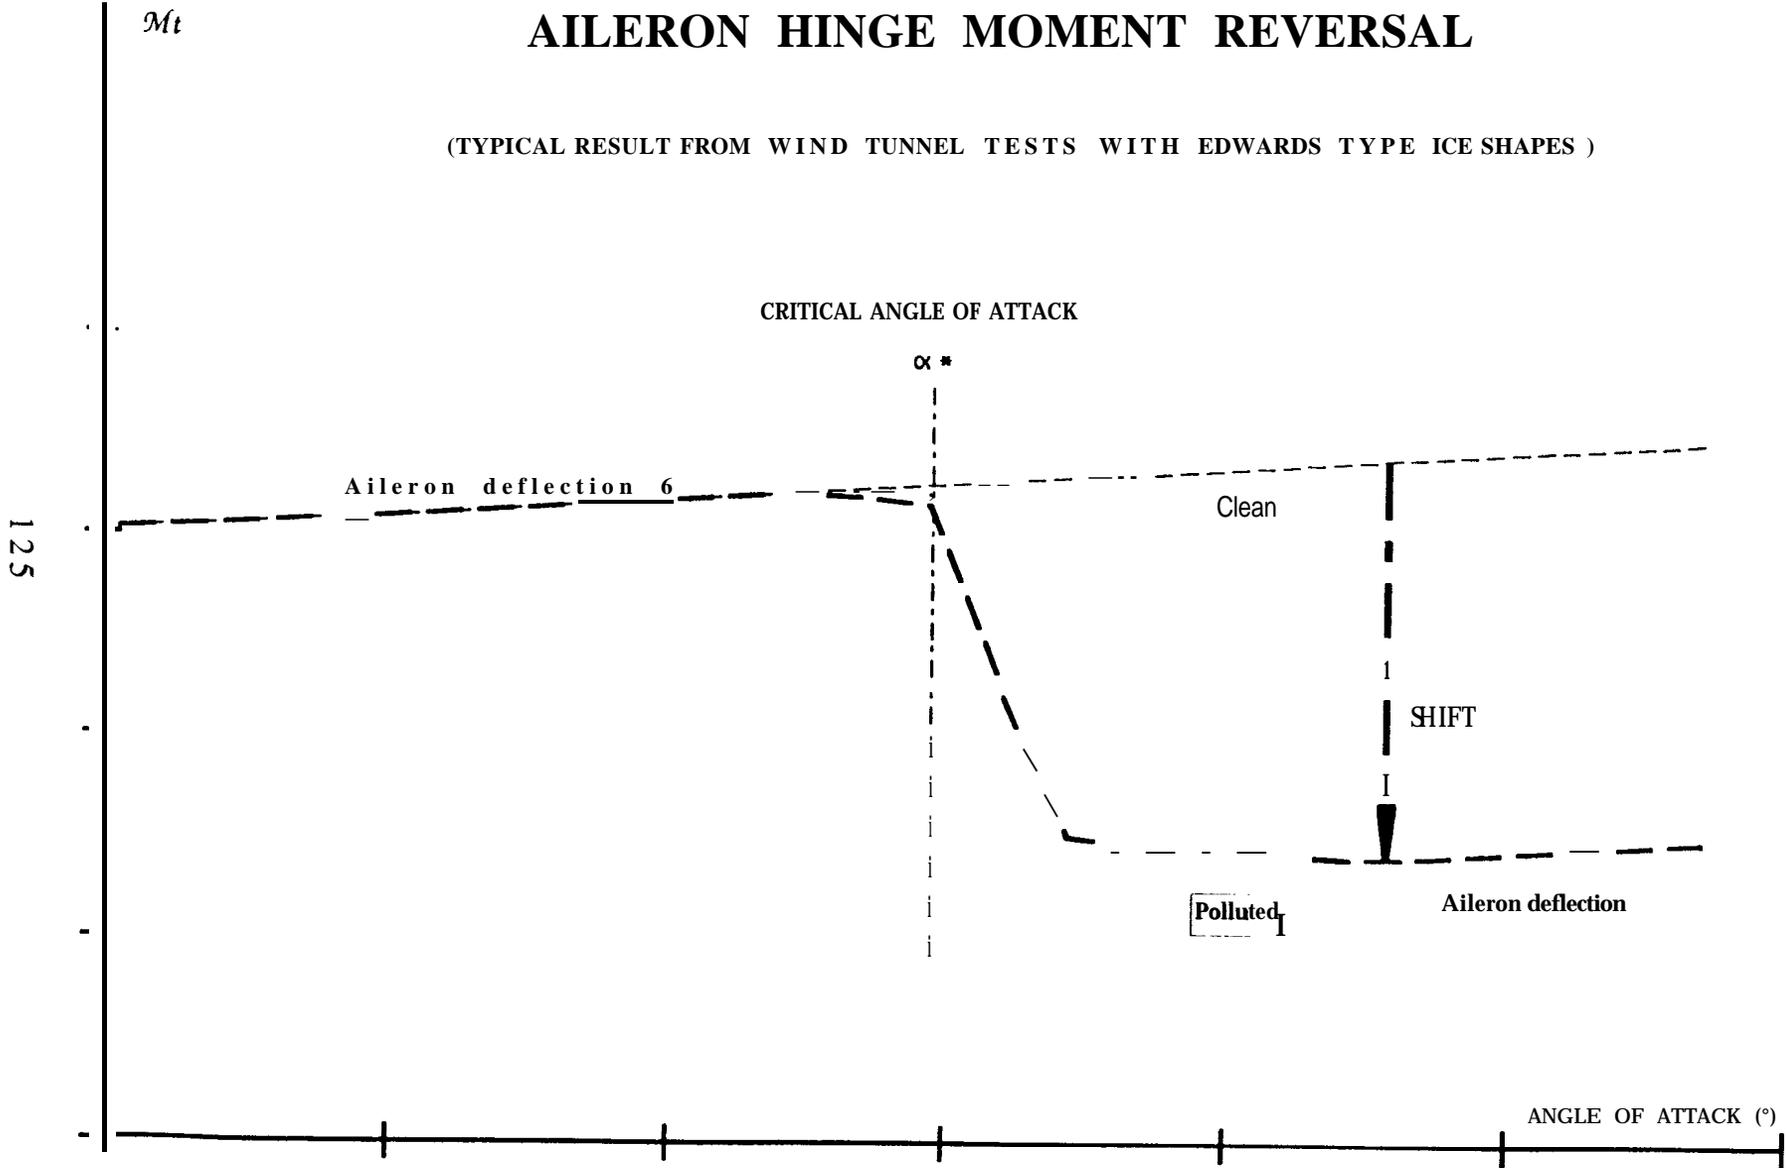
FIGURE 13 : HINGE MOMENT REVERSAL IDENTIFICATION

AILERON HINGE MOMENT REVERSAL

(TYPICAL RESULT FROM WIND TUNNEL TESTS WITH EDWARDS TYPE ICE SHAPES)

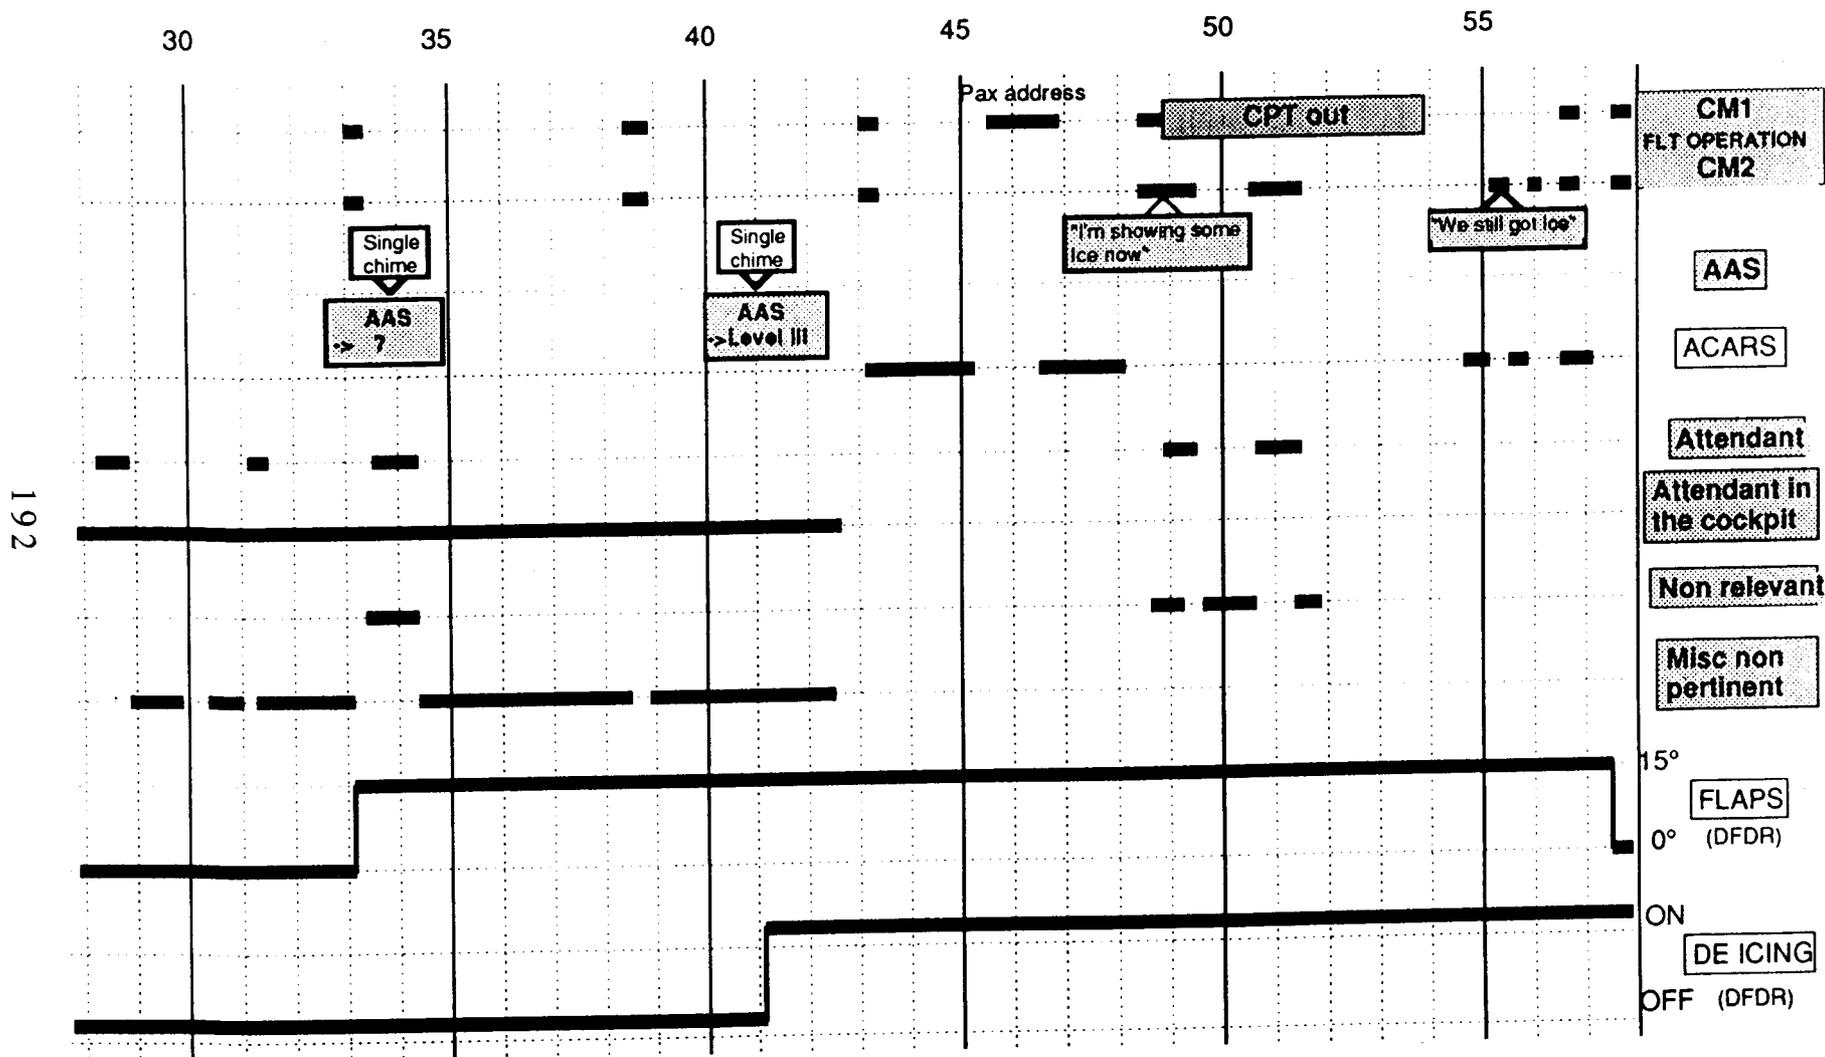
FIGURE 14 : FLIGHT 4184 CVR TIME ANALYSIS

More than 15 mn of Non Relevant & Non Pertinent conversations

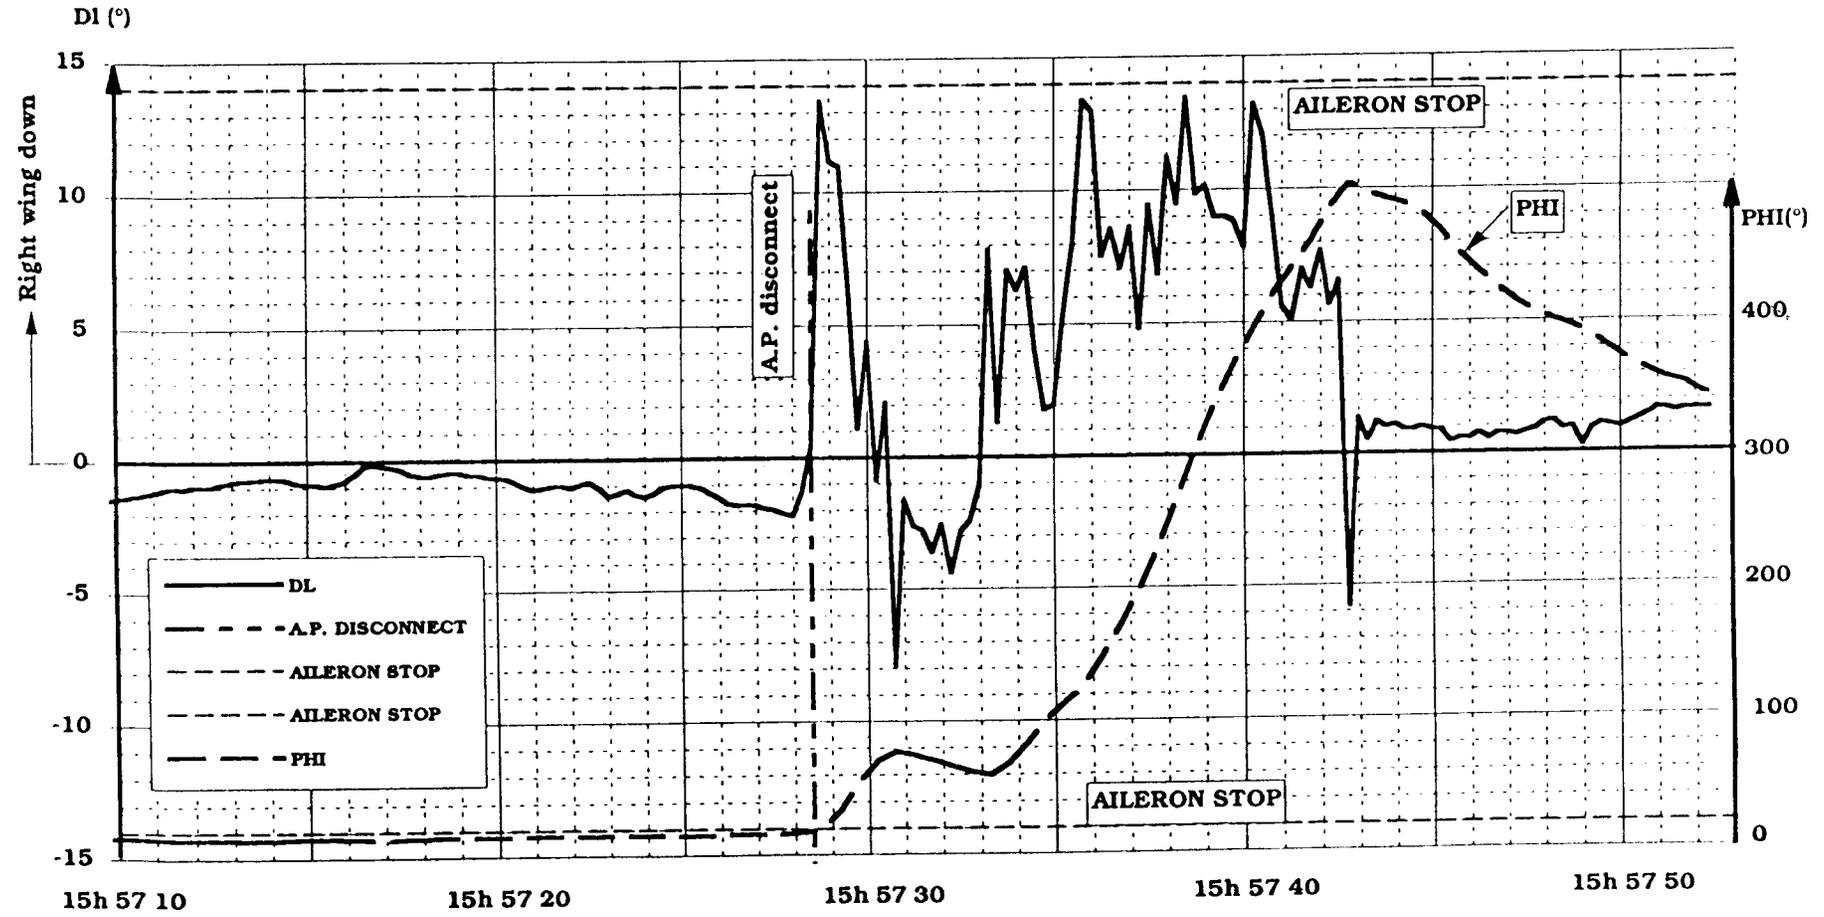
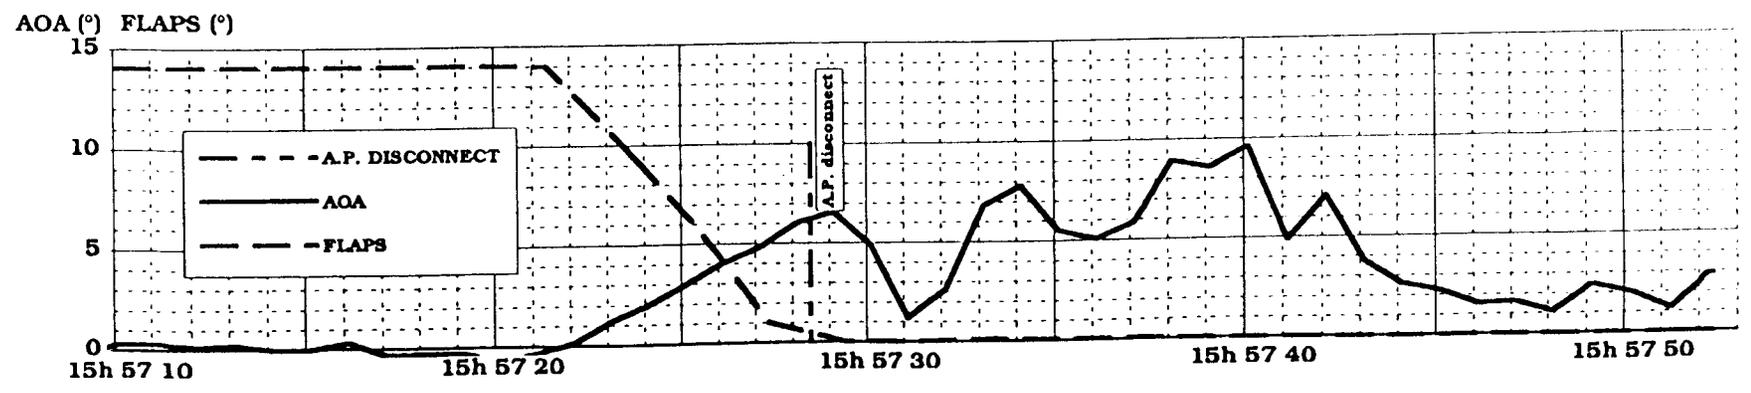
FIGURE 15 : ROLL CONTROL INPUTS / ACTIVITY AFTER ROLL UPSET

In addition, the CVR transcript shows that there was almost no discussion between the flight crew in respect to how to respond to the roll upset. Following the initiation of the roll, there was no discussion between the flight crew members regarding the aircraft's attitude or airspeed, nor was there any conversation between them in respect to how to respond to the aircraft's attitude. Further, the First Officer never asked for any help in controlling the aircraft or in responding to the event, nor is there any indication that the Captain exercised his command authority to take over the controls, nor to identify the unusual attitude of the aircraft or to appropriately comment the First Officer's inputs. This shows that the flight crew, probably disoriented, did not identify the unusual attitude nor understood the fast moving evolutions of the aircraft.

The flight crew's lack of appropriate control inputs and lack of communication was due in large part to the fact that they were preoccupied with multiple distractions prior to the roll upset which affected their situational awareness to such an extent that they were precluded from effectively responding after the roll upset which took them by surprise.

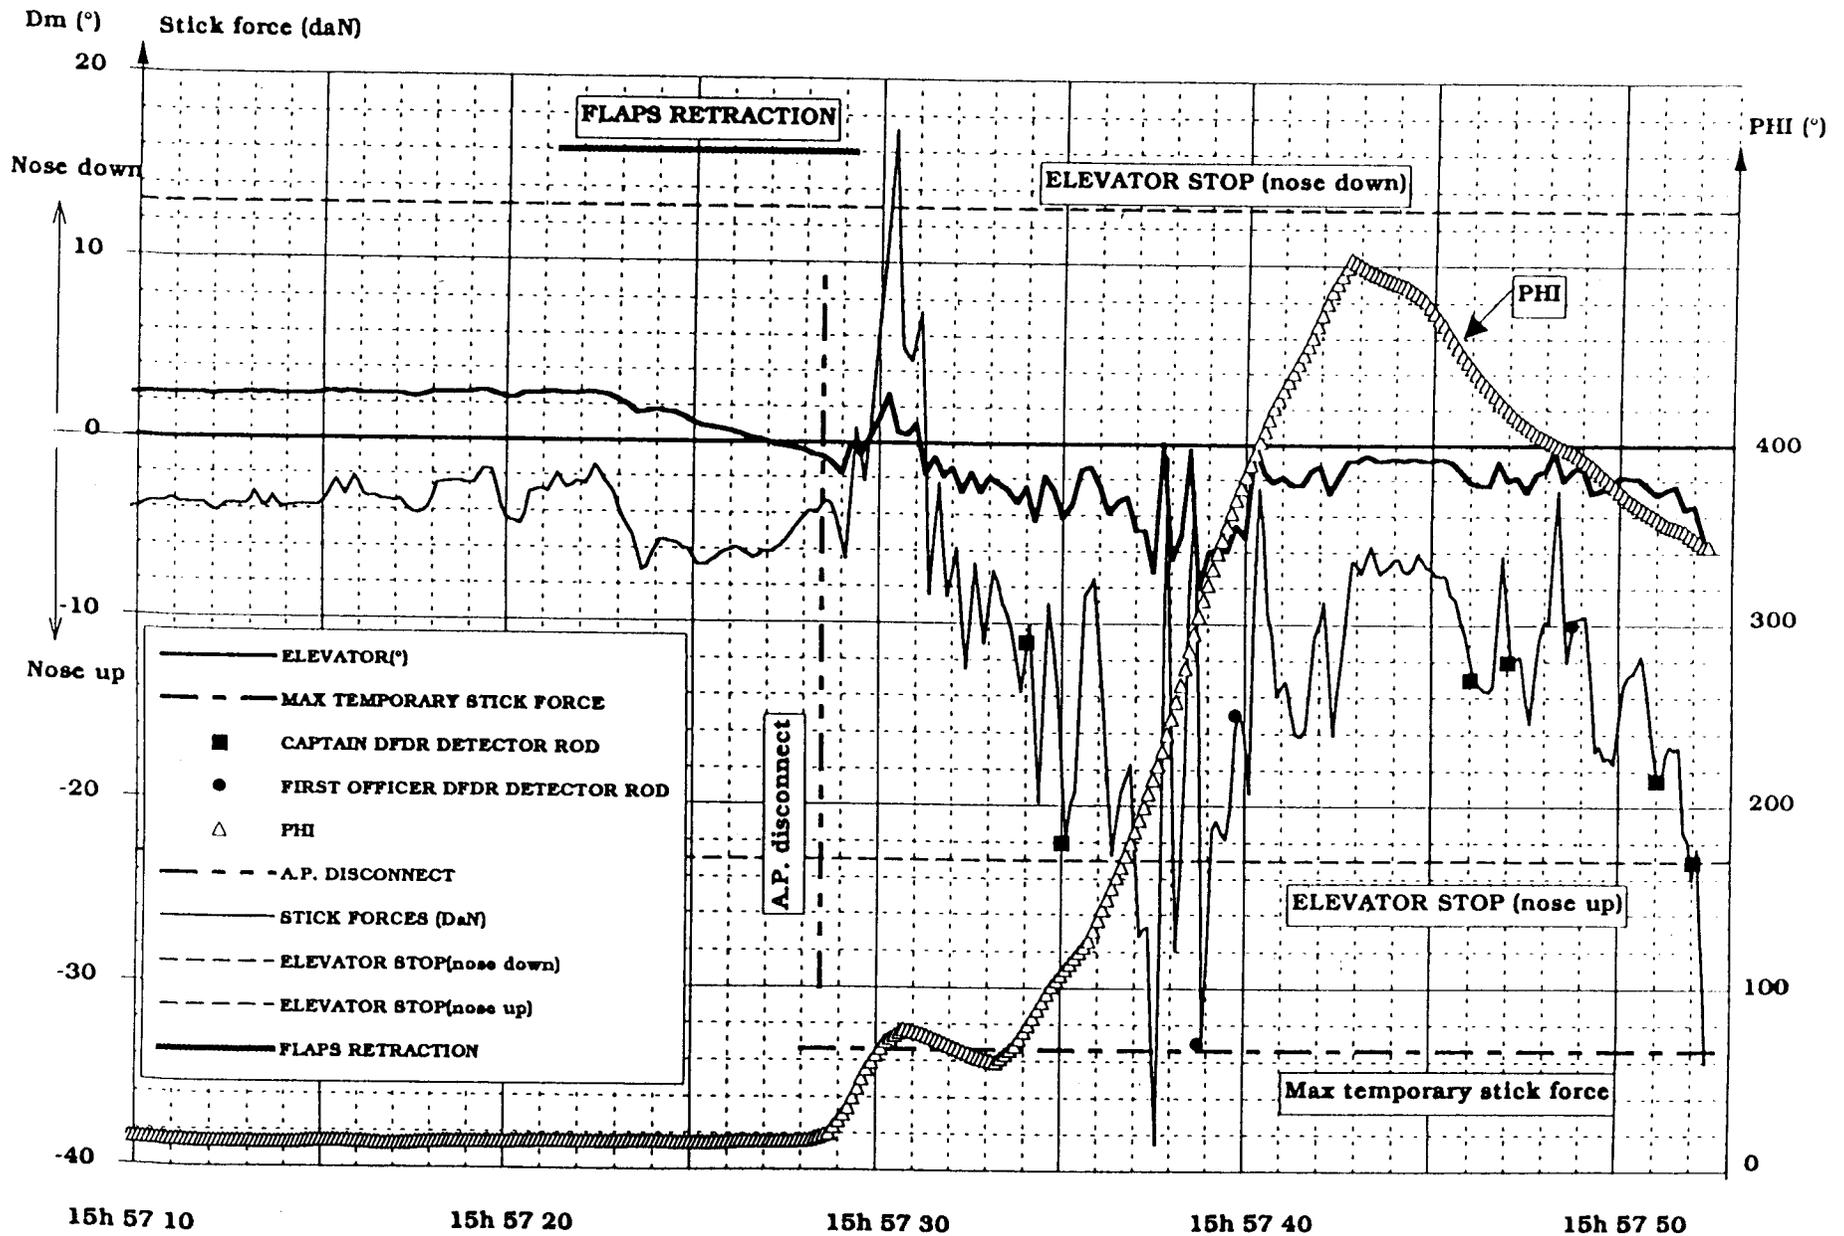
FIGURE 16 : PITCH CONTROL INPUTS / ACTIVITY AFTER ROLL UPSET

A limited control activity mainly during inverted flight

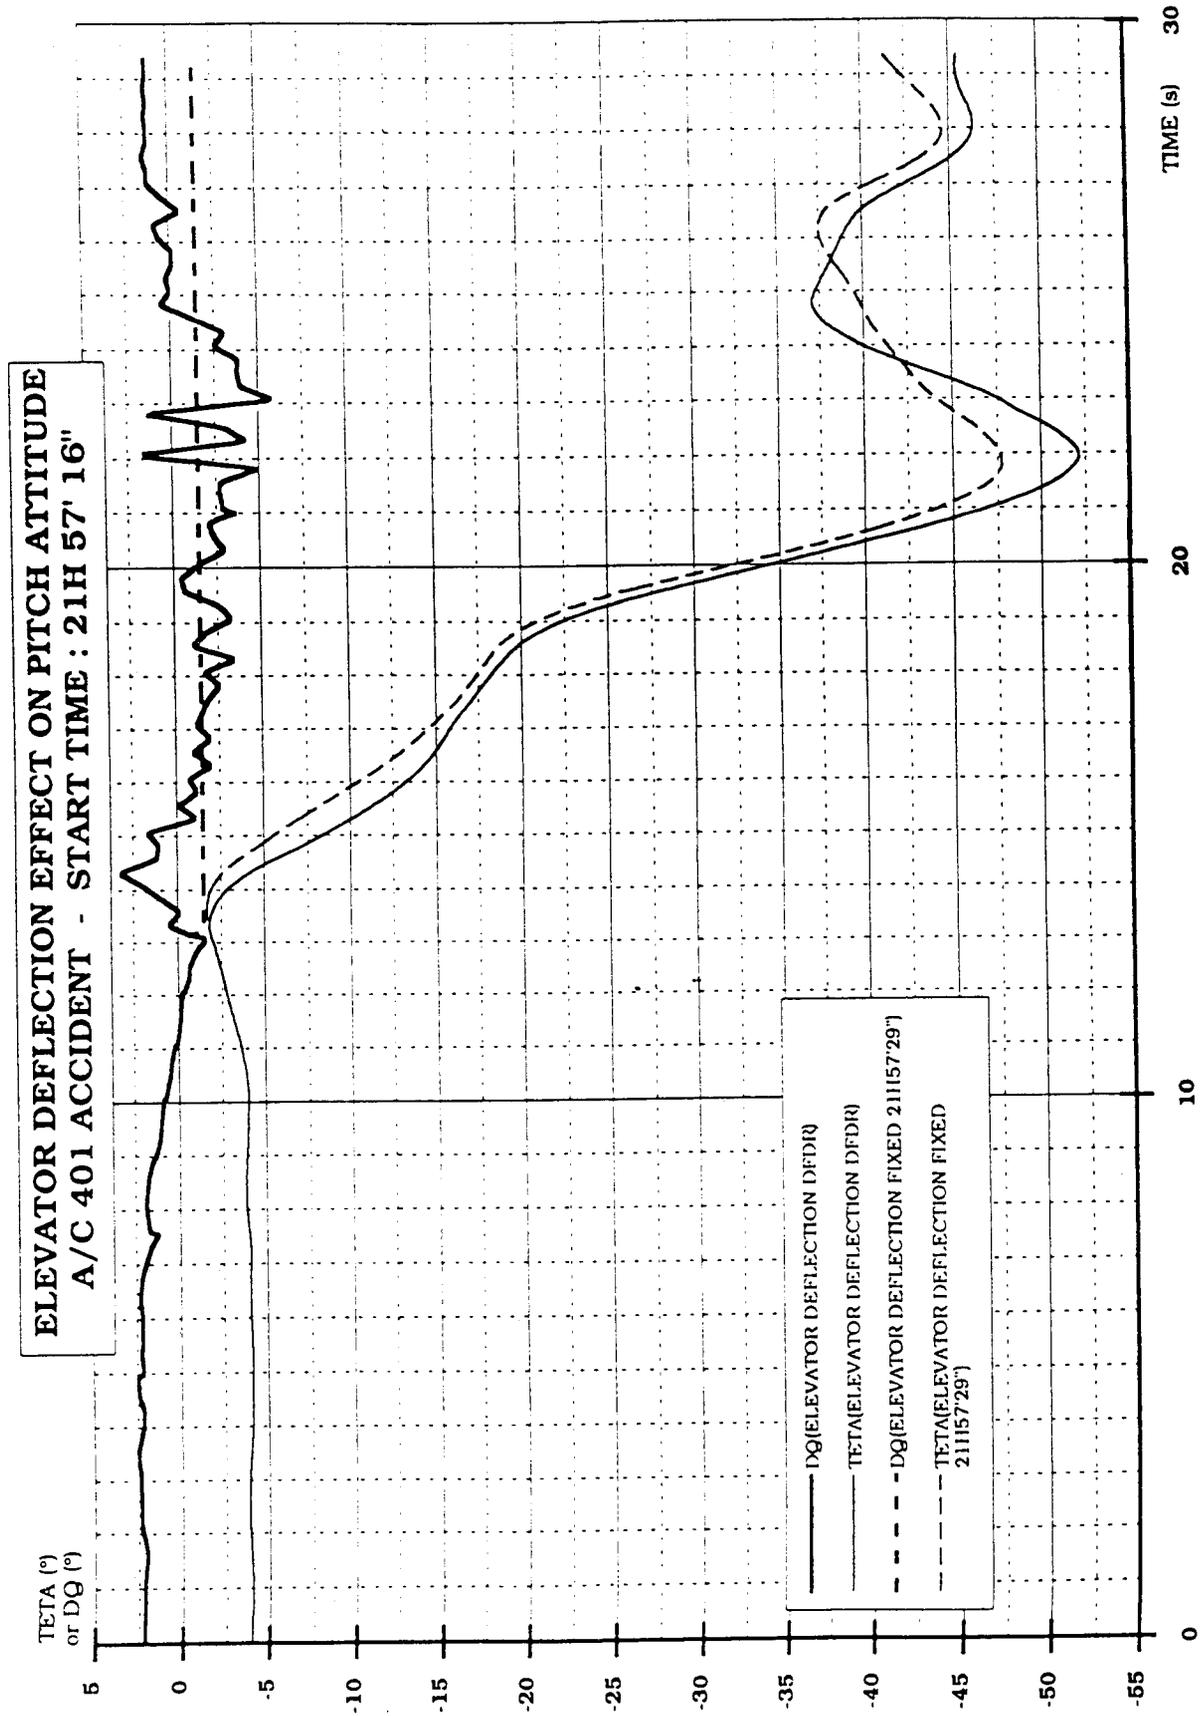
FIGURE 18 : EFFECT OF A CONSTANT PITCH INPUT ON RECOVERY

Moreover, assuming a counteracting steady deflection limited to 6° on the ailerons and applied after the maximum conventional crew reaction time used in cruise (3 seconds) after disconnection, the Flight path is rapidly controlled (fig. 19). The lateral attitude is kept close to wings level and the longitudinal attitude does not exceed 22° before returning to 0° .

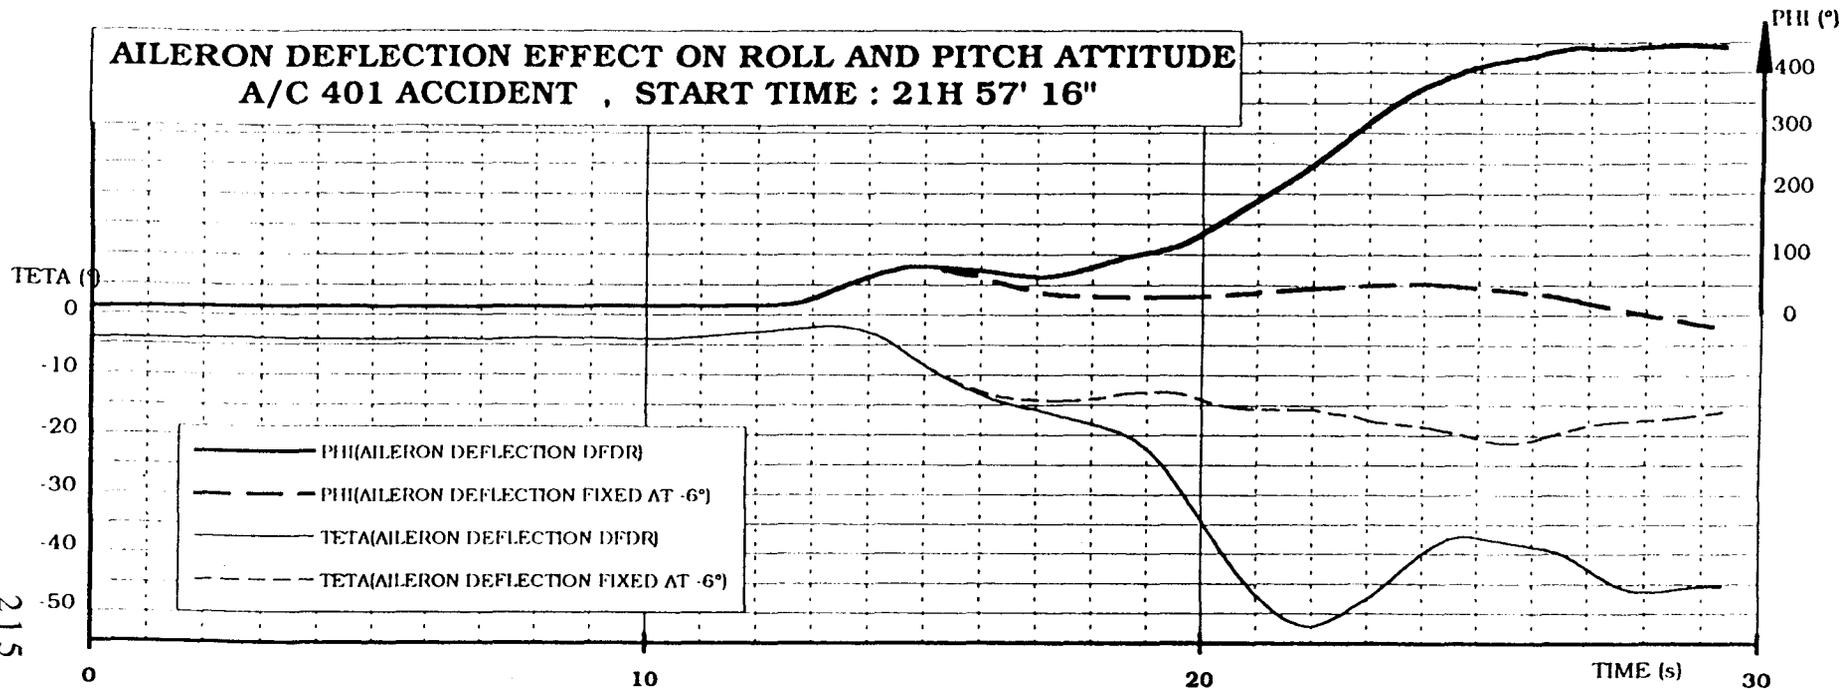
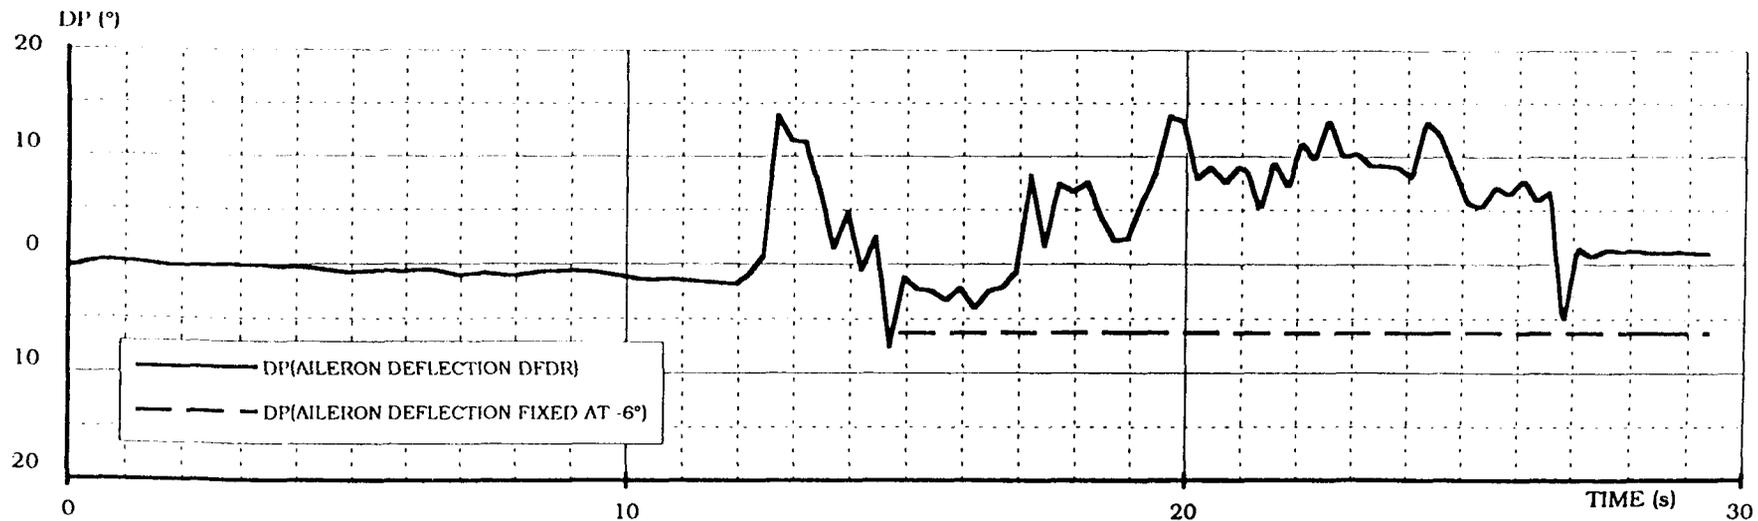
FIGURE 19 : RECOVERY CAPABILITY THROUGH CONSTANT ROLL INPUT

A constant 6° roll input after 3 sec would allow for recovery
