Uncontrolled collision with terrain, Flagship Airlines, Inc., dba American Eagle Flight 3379, BAe Jetstream 3201, N918AE, Morrisville, North Carolina, December 13, 1994

AIRCRAFT ACCIDENT REPORT

UNCONTROLLED COLLISION WITH TERRAIN
FLAGSHIP AIRLINES, INC., dba AMERICAN EAGLE
FLIGHT 3379, BAe JETSTREAM 3201, N918AE
MORRISVILLE, NORTH CAROLINA
DECEMBER 13, 1994

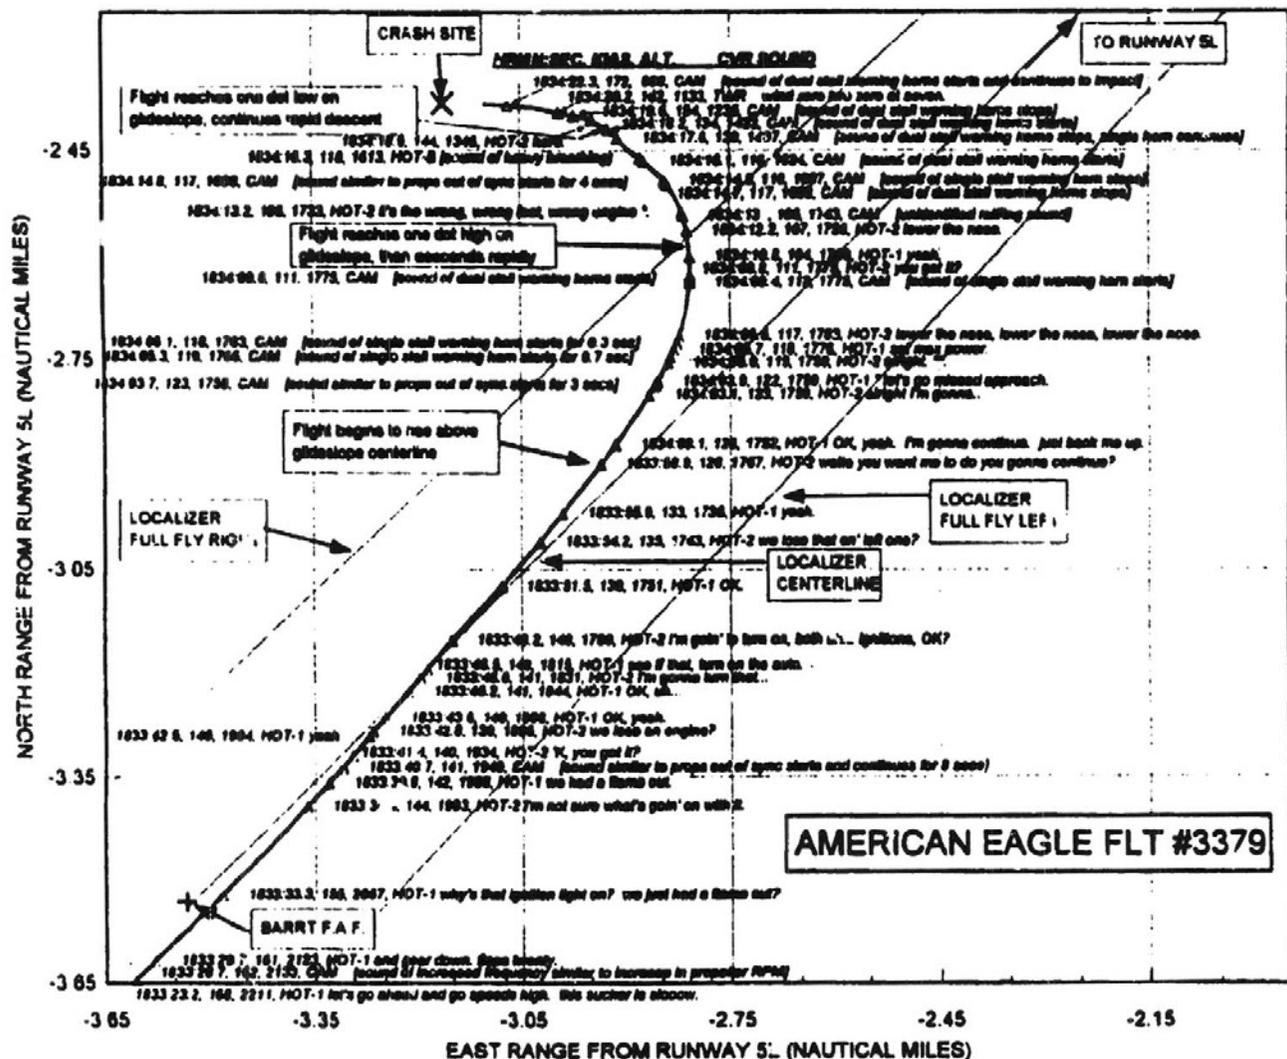
Figure 1.--Airplane ground track.

For the next several seconds, the airplane remained relatively level at approximately 1,800 feet, as the airspeed decreased from 140 knots to 122 knots, when the captain decided, "Let's go missed approach." In less than 2 seconds, at 1834:05.3, two momentary stall warnings occurred as the captain called, "Set max power," and the left turn rate increased. The first officer called, "Lower the nose, lower the nose, lower the nose," but the airplane remained at about 1,800 feet, and the airspeed continued to decay to approximately 119 knots as the left turn rate increased to about 5° per second.

At 1834:09.4, a stall warning horn started again, and was followed at 1834:09.6 by the dual stall warning horns. At this time, the airplane was still at 1,775 feet, and the airspeed had slowed to 111 knots. The first officer inquired, "You got it?," and the captain responded, "Yeah." The airspeed decreased to 103 knots at 1834:12, and the first officer said, "Lower the nose." At 1834:13.2, the first officer said, "It's the wrong, wrong foot, wrong engine." About this time, the rate of descent increased rapidly to more than 10,000 feet per minute. The rate of turn increased to about 14° per second at 1834:16, as the airspeed increased rapidly. There were several significant normal accelerations during this period. The airplane finally stabilized the last few seconds before impact at an airspeed of about 170 knots, a normal acceleration of 2.5 G absolute, and a heading of 290°.

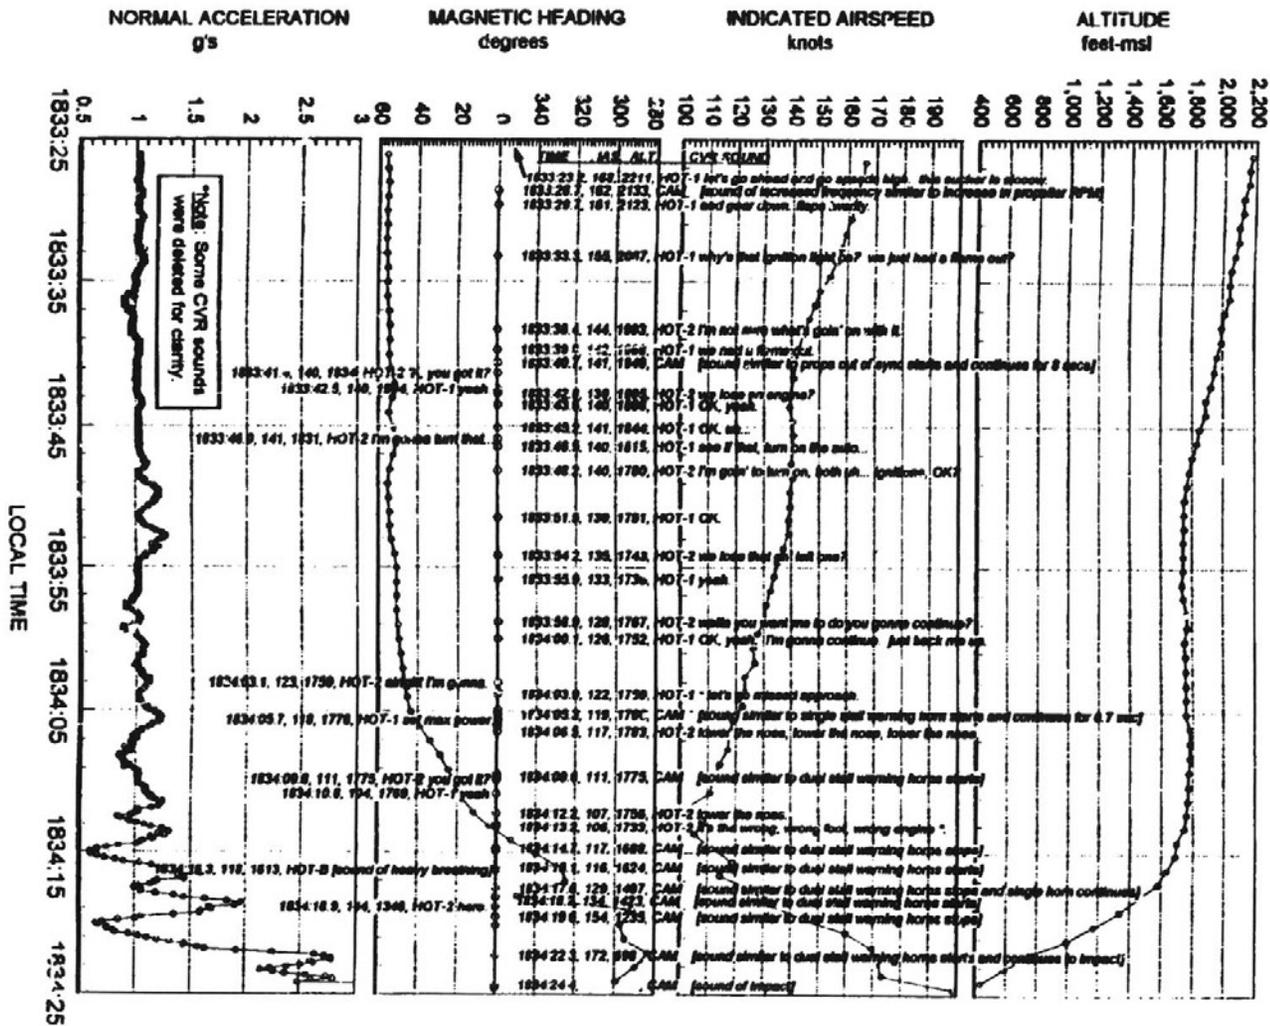
Figure 2.--FDR data.

The aircraft was equipped with a Loral Fairchild Model F800 digital flight data recorder (FDR), Part No. 17M703-274 (S/N 5379).¹² The FDR records pressure altitude, magnetic heading, indicated airspeed, vertical acceleration, and VHF [very high frequency] radio keying data on an elapsed time line for 25 hours before recording over the oldest data. The recorder was heavily damaged by impact forces, and the exterior casing had to be cut away to remove the crash-survivable memory module. This module was slightly damaged on the inside, but the tape was undamaged. The last 3.5 hours of data were transcribed to a disk file for processing. Figure 2 depicts the last minute of FDR/CVR data.

FINAL MINUTE OF FDR/CVR DATA - FLT 3379
